Offshore Platform Well Control Incident

Well incident in 8 1/2" hole section

Kick in 8 1/2" hole section

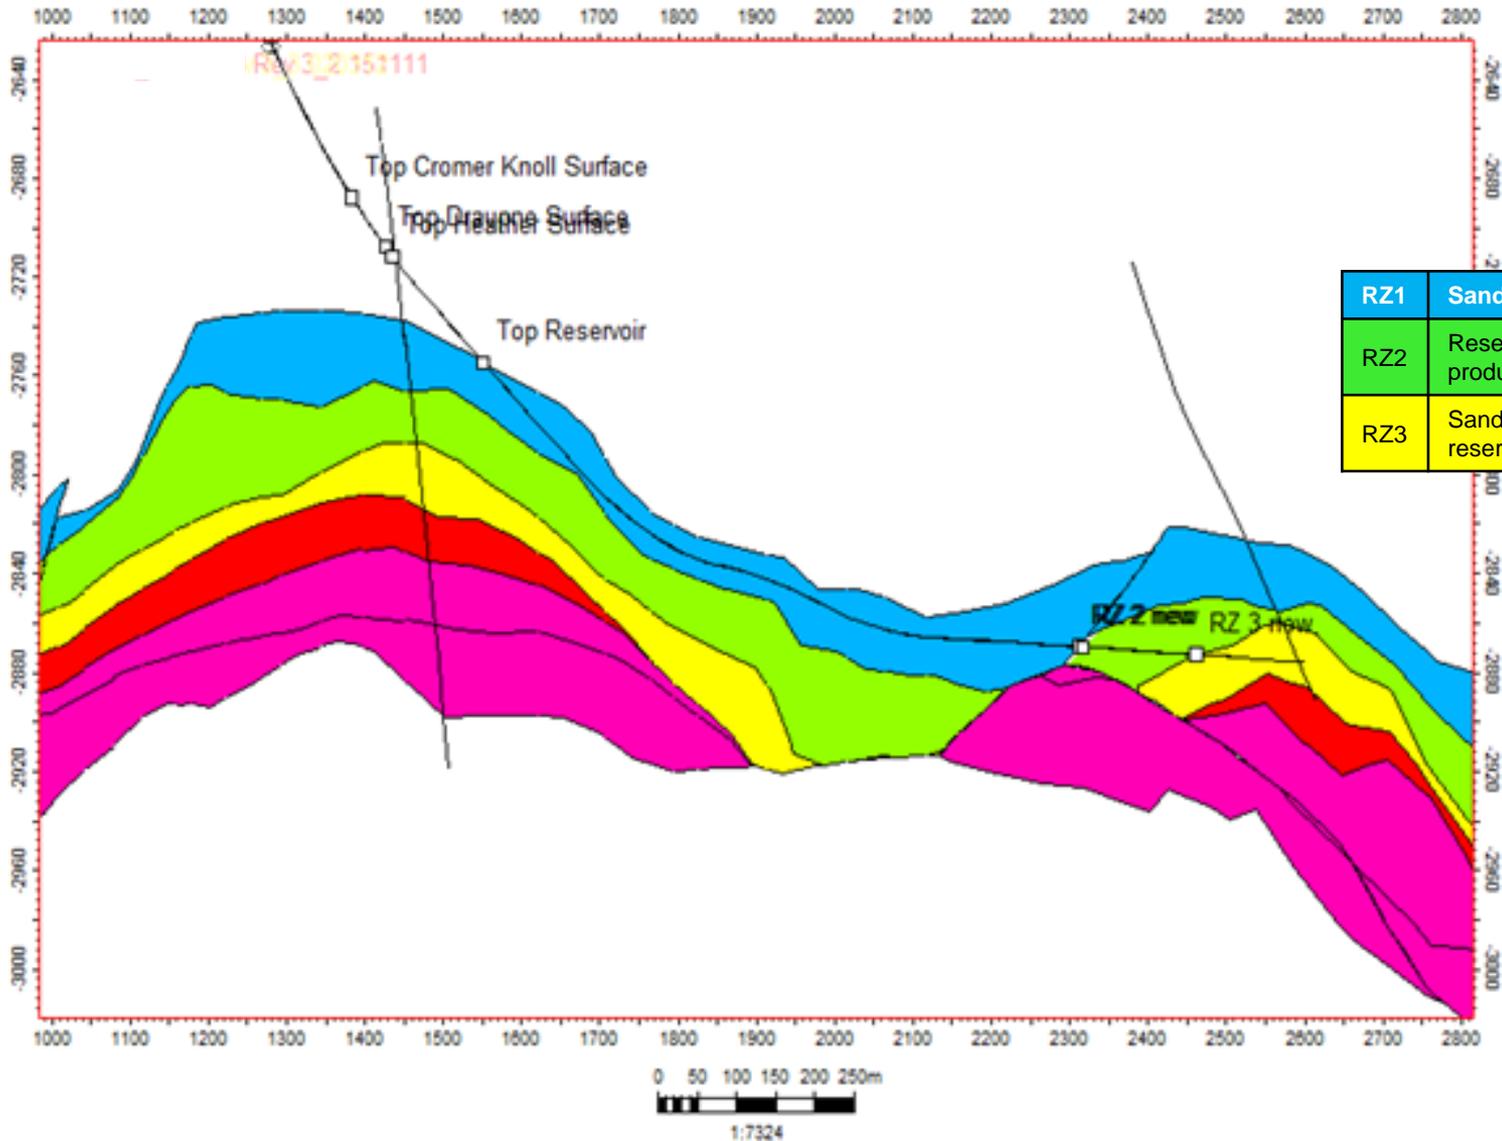
RZ1	Sand, top part of reservoir
RZ2	Reservoir, sealing – non producing
RZ3	Sand, lower producing reservoir

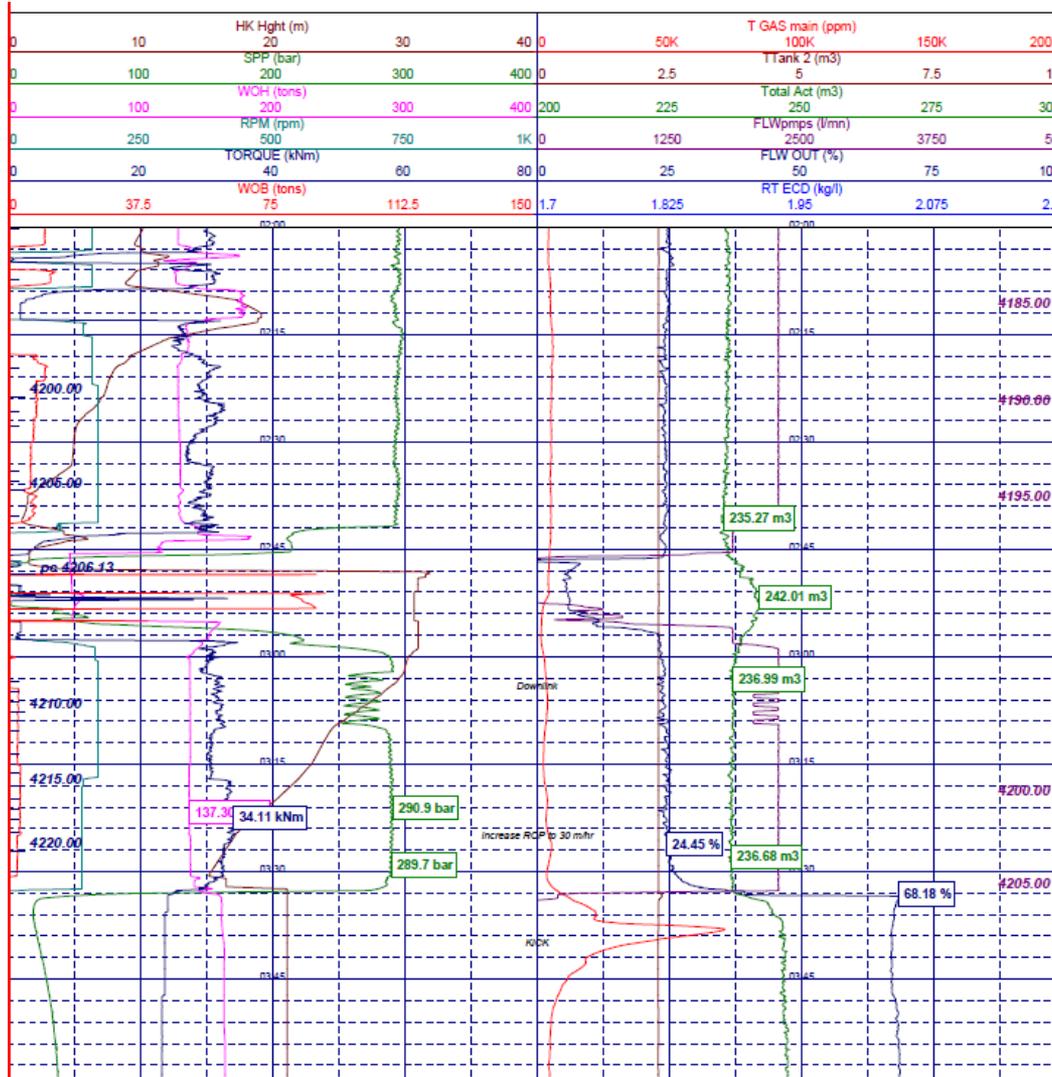
- A significant part of the driller's focus during the connection was towards the top drive position as a result of an earlier incident where the top drive collided with the pipe handling system.
- Furthermore, the camera picture in used on the drillers console was at an earlier stage changed from the flow line camera to the a derrick camera showing the top drive position.

Connection →

- Follow established drilling practices on positive drilling breaks by carrying out a Flow Check.
- Follow established drilling practices on Volume Control, both during drilling and at connections:
 - Driller keeping control on flow lines and trip tanks
 - Data operator keeping control on volumes and flow rates, including correct use of the threshold control possibilities available in the Mud Logging System's software.

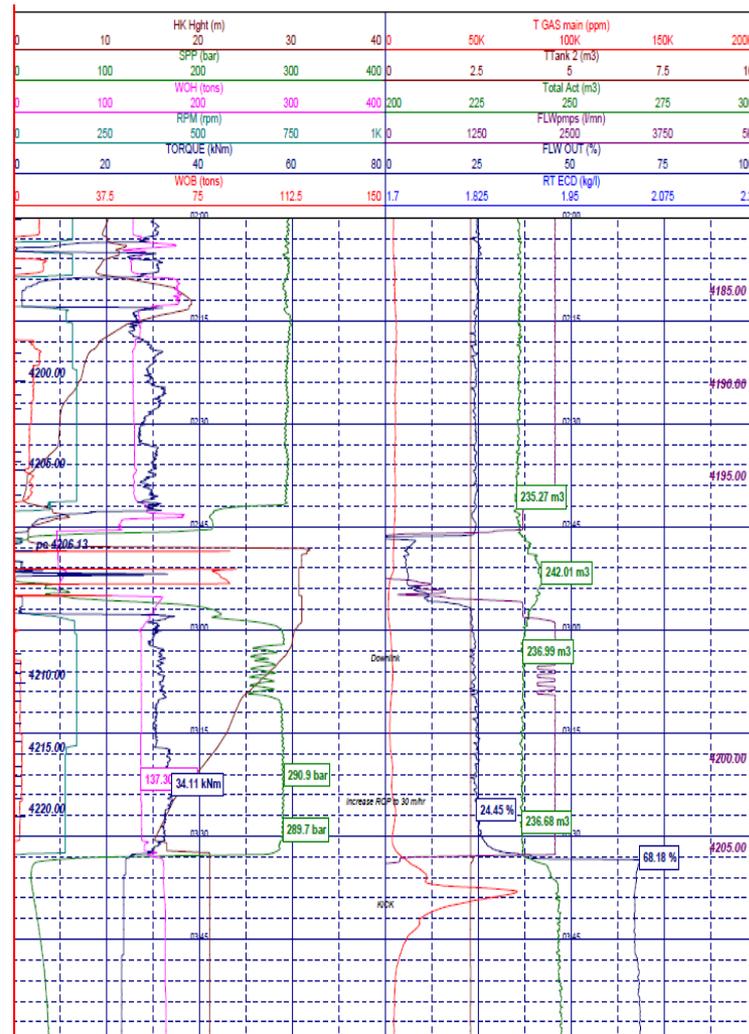
- Flow check?
- Alarms?
- Camera picture not changed back from derrick to flow line.
- Data engineers focus?

Connection →

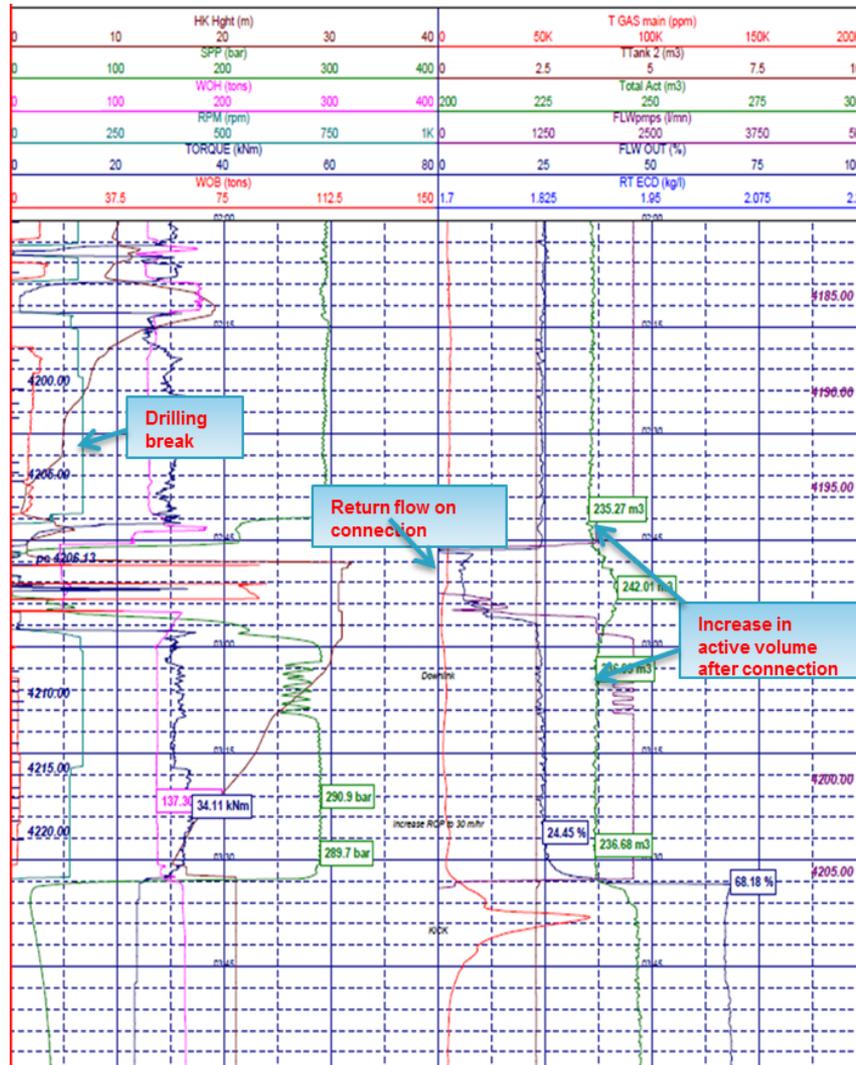
- Alarms?
- Focus on trends
- Driller and Data engineer are barriers.
- Continue drilling

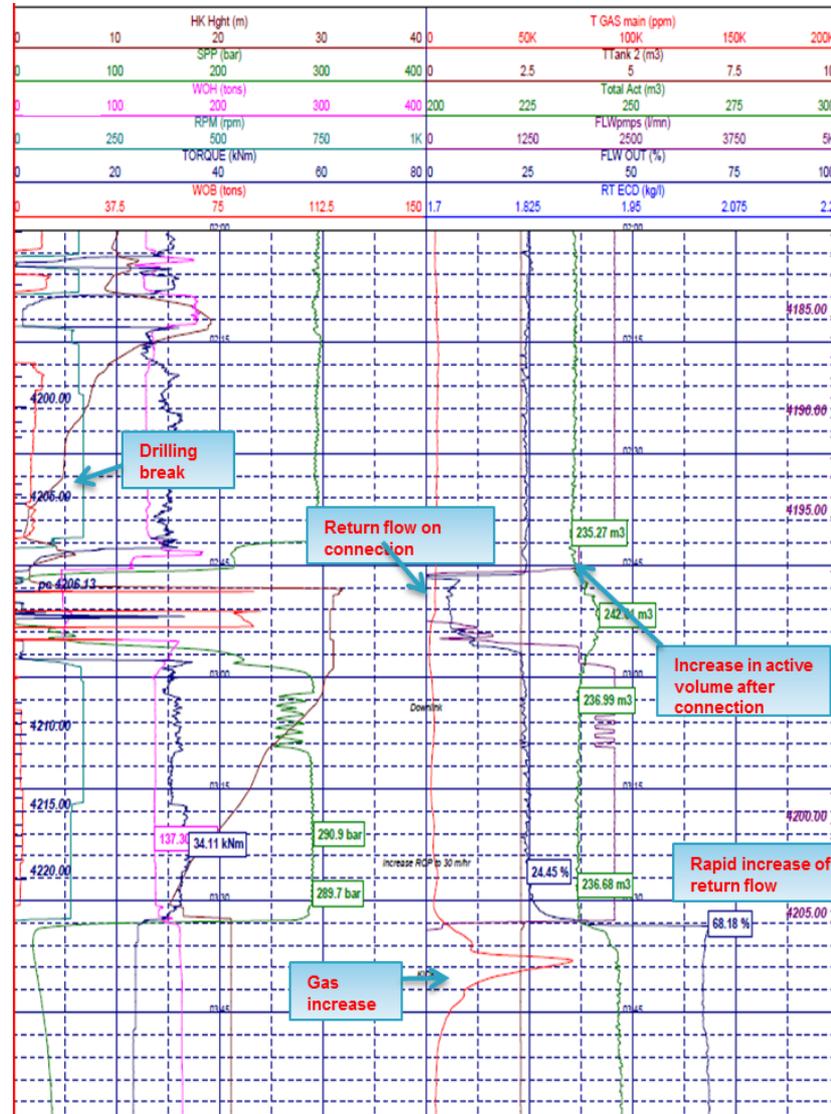
- Rapid return flow due to gas expansion in annulus
- Shut in BOP
- Gas circulated through poor boy
- Kick in 8 1/2" hole
