**”SHARING TO BE BETTER”**

# Incident Summary

**A well control incident occurred while drilling in 9 1/2" hole at 7328 feet (2234 m) MD with MW=14.5 ppg (1.74 SG). The situation developed after a power failure to both mud pumps at 10:25 hrs.**

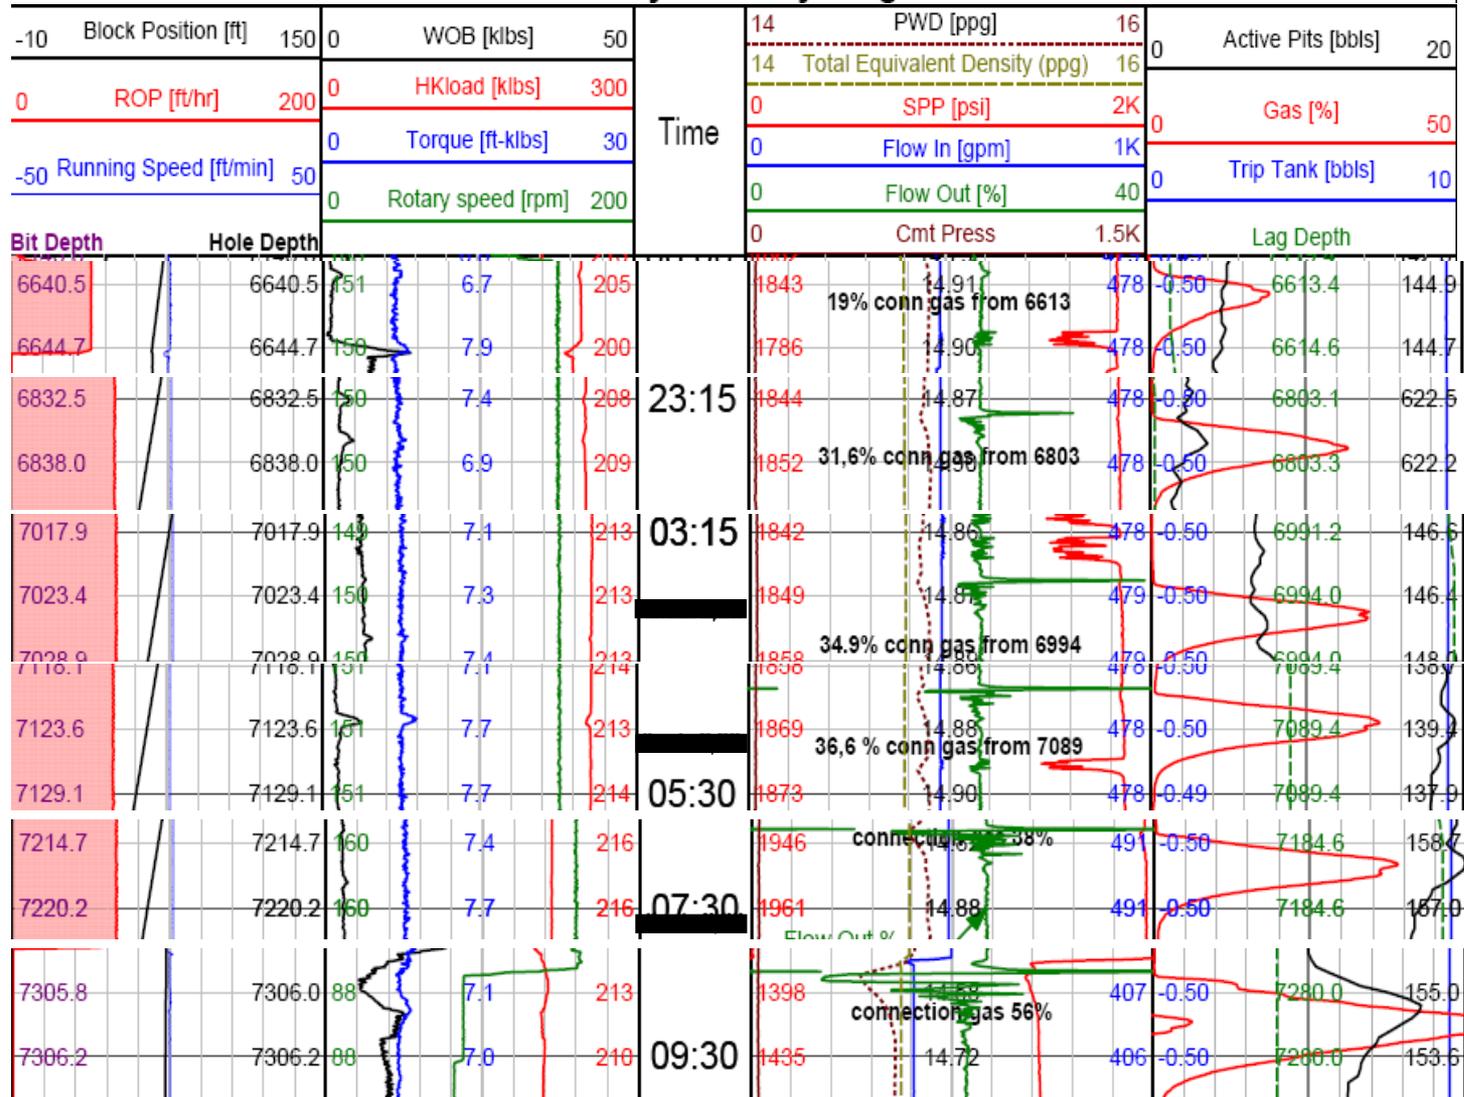
What can you see from this plot which would give you cause for concern ?

- Connection gas trend increasing
- ROP increase from 50 to 60 feet / hour

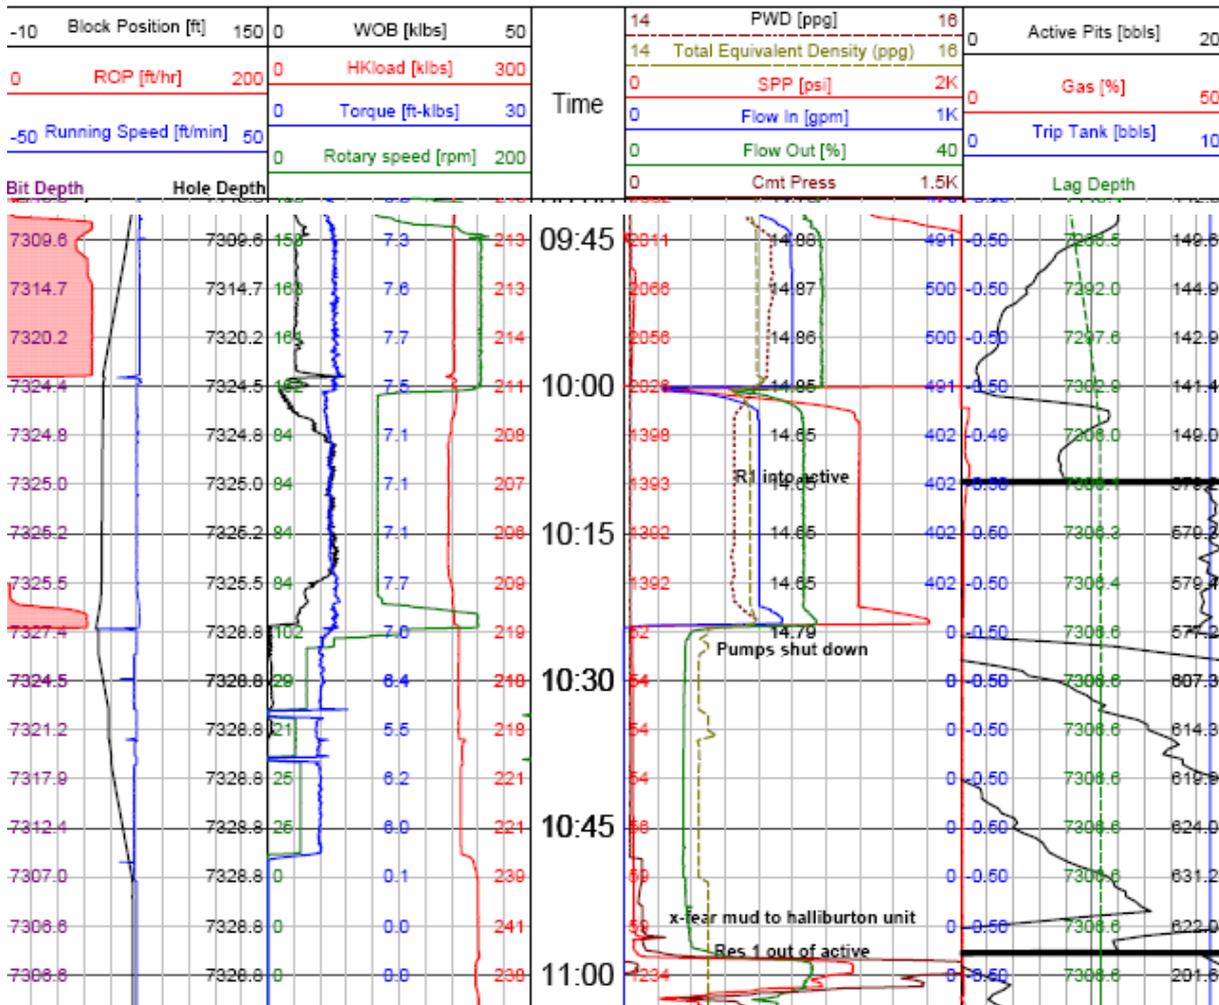
- 10:25 hrs – Power to pumps lost
- 10:48 hrs – Power to top drive lost

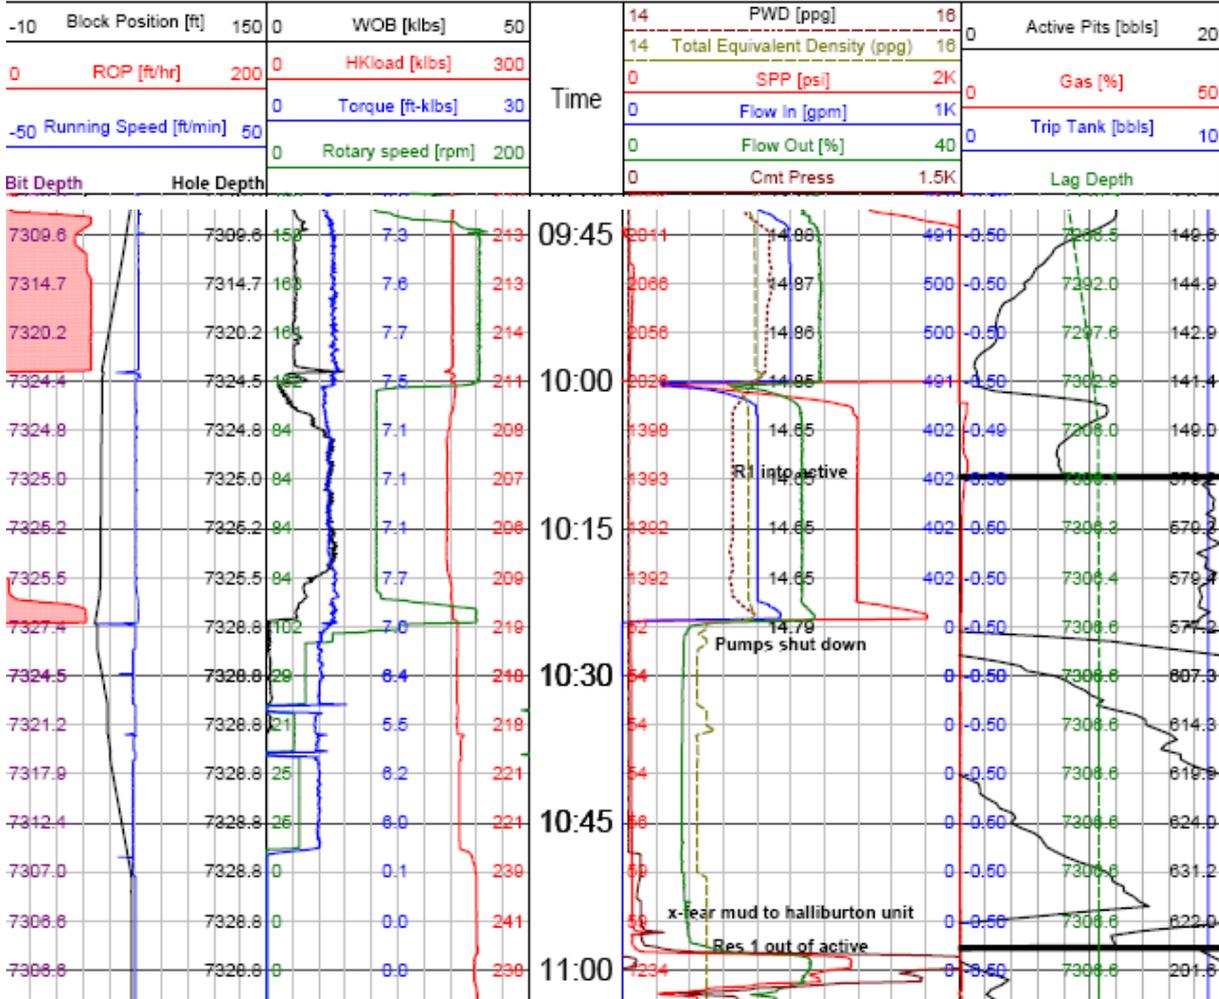
• 10:28 hrs– Power to pumps lost

• WELL LEFT OPEN

• 10:48 hrs – Power to top drive lost

• WELL REMAINS OPEN

• 10:50 hrs – Flowback = 57 bbl; +15 bbl over trend

• 10:58 hrs – Circulate 11 bpm with cement unit – lots of vibration

**WELL SHOULD HAVE BEEN MONITORED ON THE TRIP TANK**

**WELL SHOULD HAVE BEEN SHUT-IN**

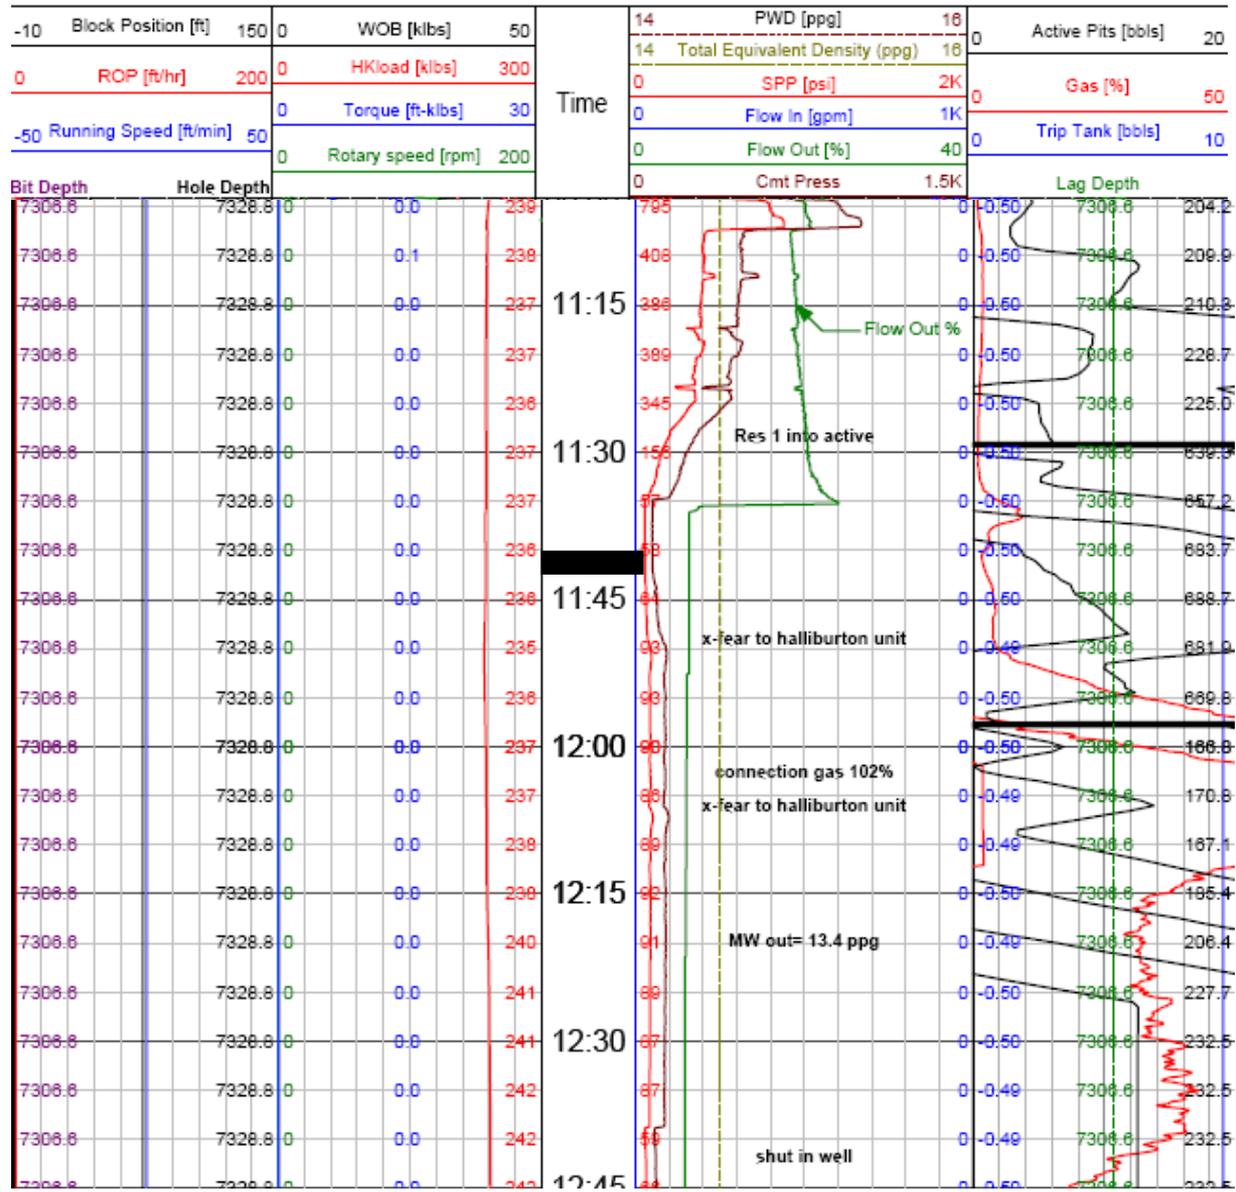
**10:58 – Circulate 5 bpm with cement unit - no vibration**

- Well remains open
- 11:25 – Drilling supervisor notes flow increasing & pit gain

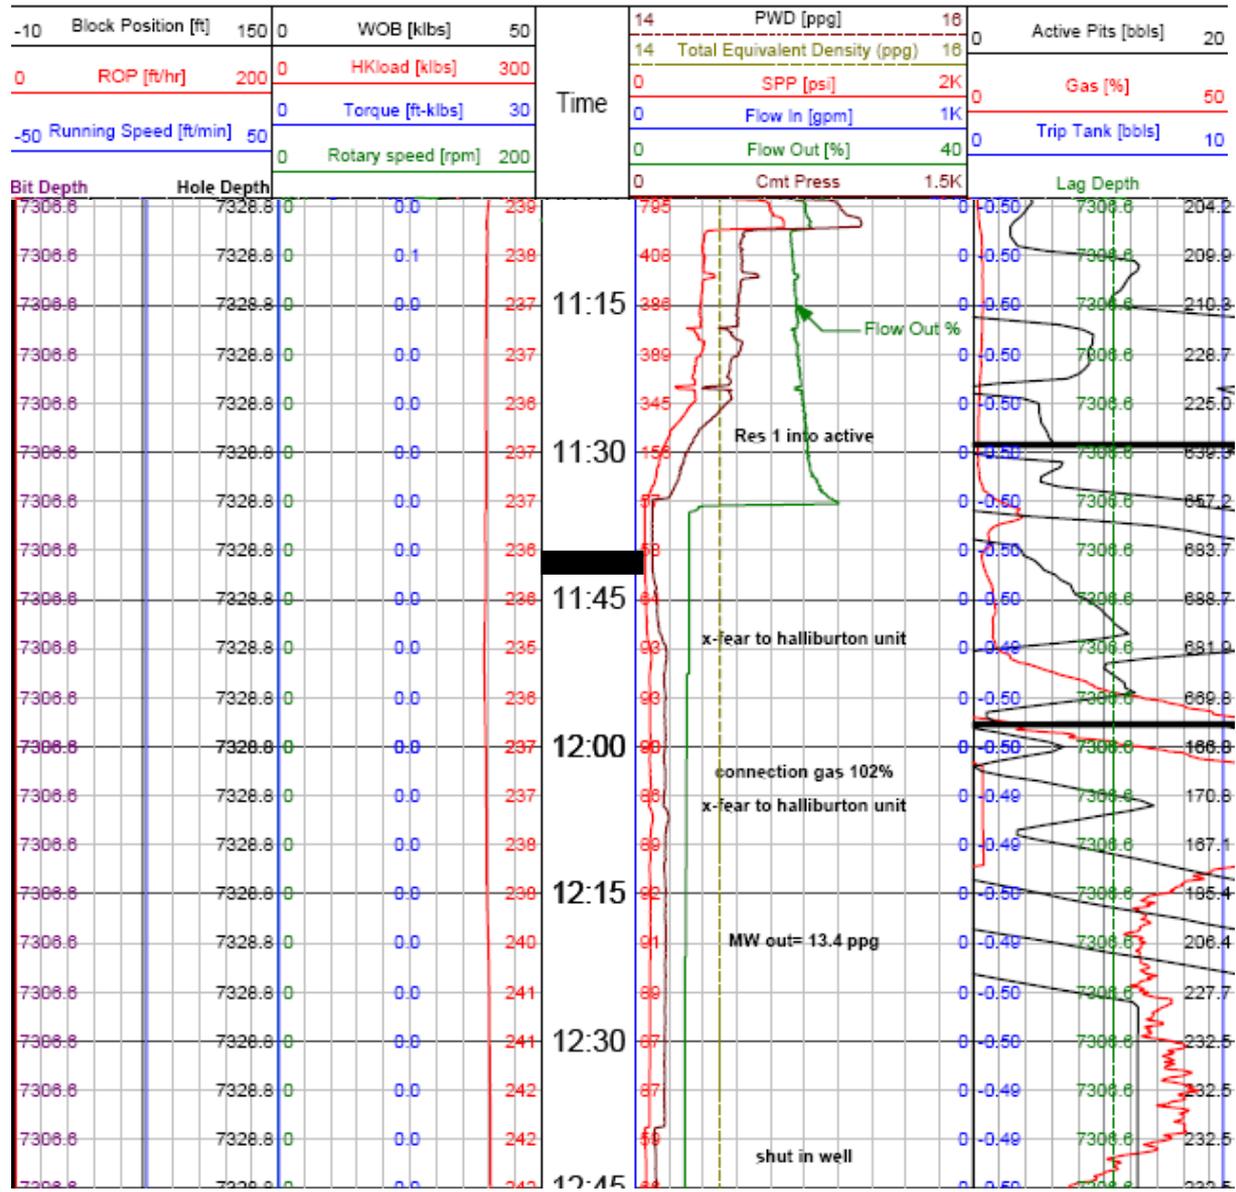
- 10:58 – Circulate 5 bpm with cement unit - no vibration
- Well remains open
- 11:25 – Drilling supervisor notes flow increasing & pit gain

**WELL SHOULD BE SHUT IN, PRESSURES OBSERVED & SITUATION FULLY ASSESSED.**

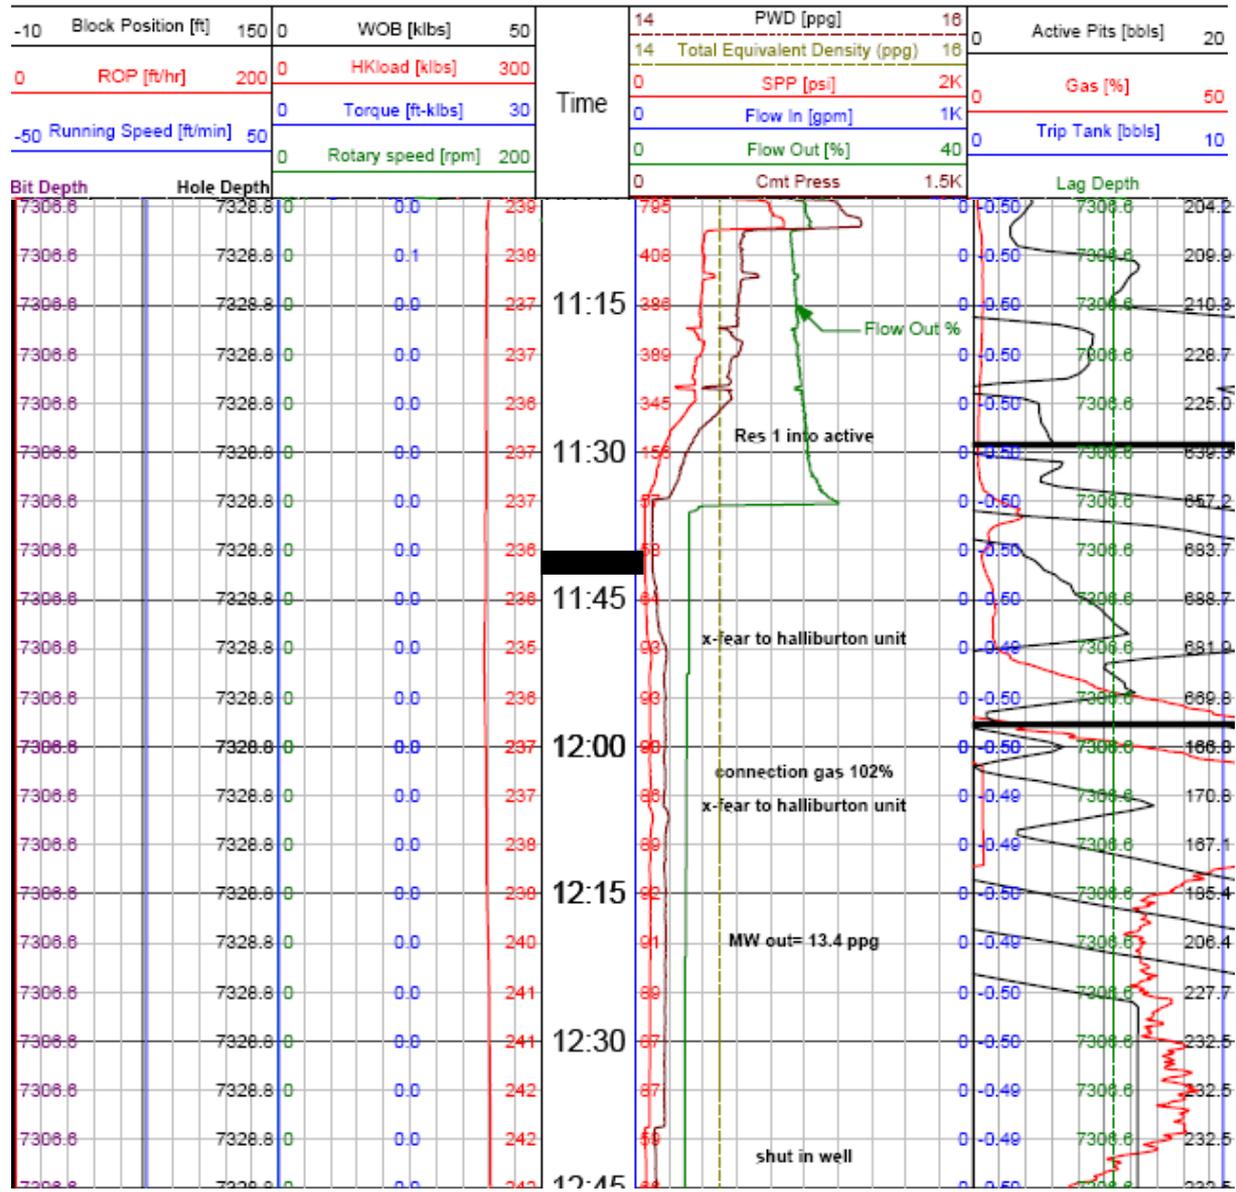
- 11:35 hrs – Decision made to circulate through open choke at 3 bpm
- 12:00 hrs – Return mud cut to 13.4 ppg
- 12:40 hrs – Pit level too high. Well shut in
