**INVESTIGATION REPORT OF THE
EXPLOSION INCIDENT OCCURRED ON
11/02/2015 IN THE FPSO CIDADE DE SÃO
MATEUS**

**SUPERINTENDENCE OF
OPERATIONAL SAFETY AND THE
ENVIRONMENT (SSM)**

AUGUST/2015

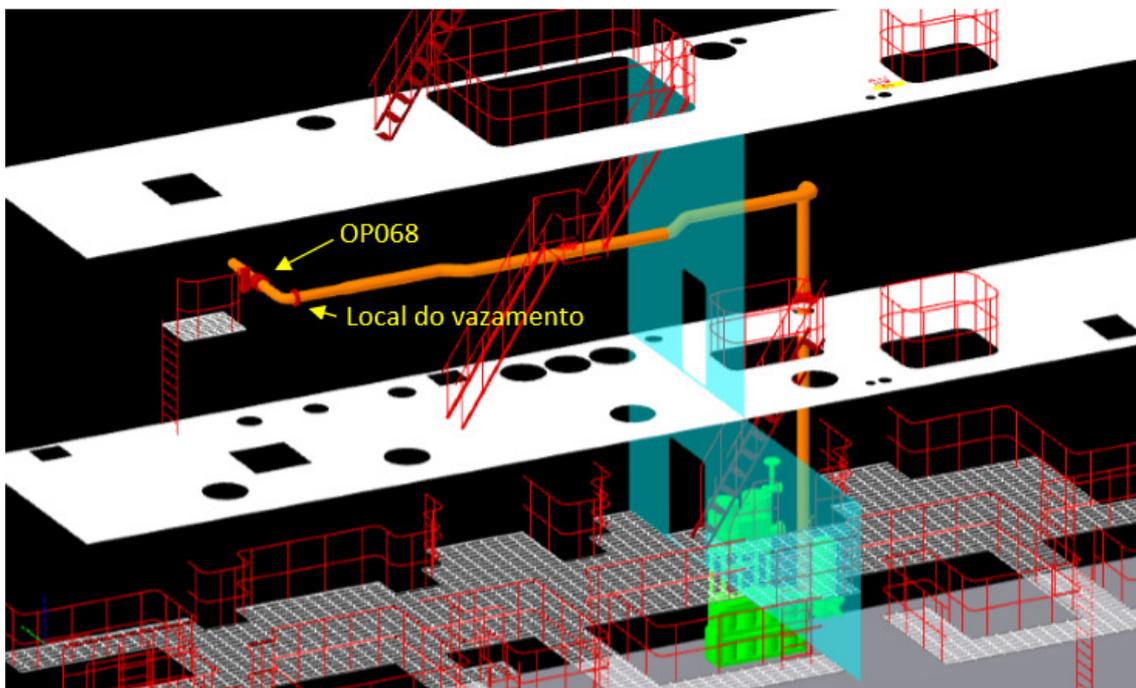
The leakage point was a flange located upstream of a valve (PB-068), connected directly to the tank bombordo slop (slop P), the fourth level below the main deck. At this time, the leak occurred as fillet in a pool of a dark-colored liquid of approximately 2 m on the ground. Figure 2 shows the position of the OP-068 valve and the location of the leak. Figure 3 shows the flange where the leak occurred in photograph taken before the crash.

Figure 2 - Position of the OP-068 valve and location of the leak

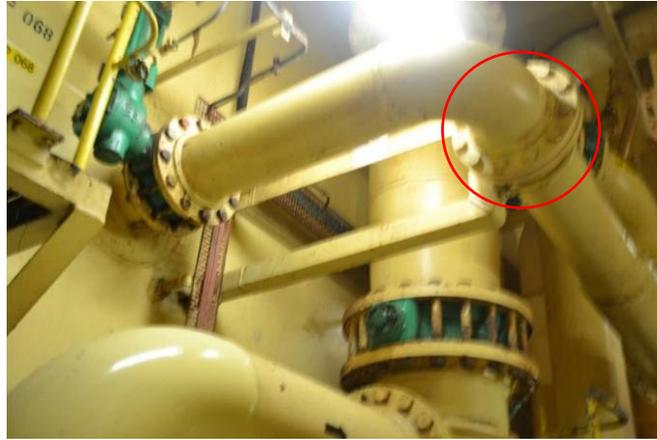
Figure 3 - Photo taken before the crash highlighting the flange where the leak occurred

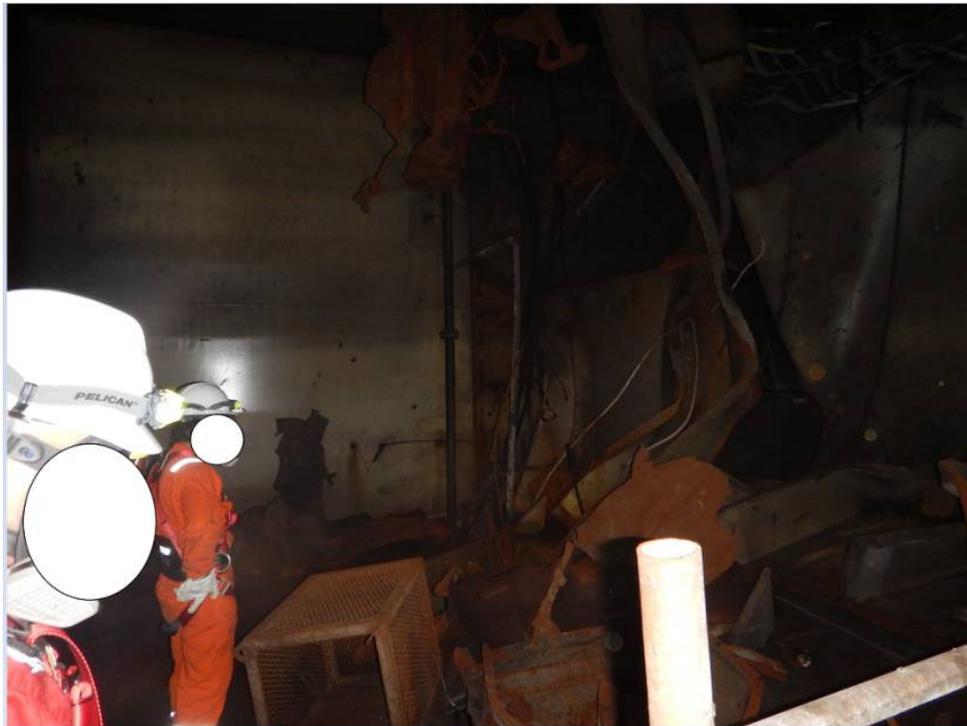
In the back of the pumps room, the pressure caused by the explosion broke the bulkhead between the pumps room and the engine room, causing destruction in this environment. The following figures show the damage caused to this area by the explosion.

Figure 5 - broken bulkhead between pumps room and engine room

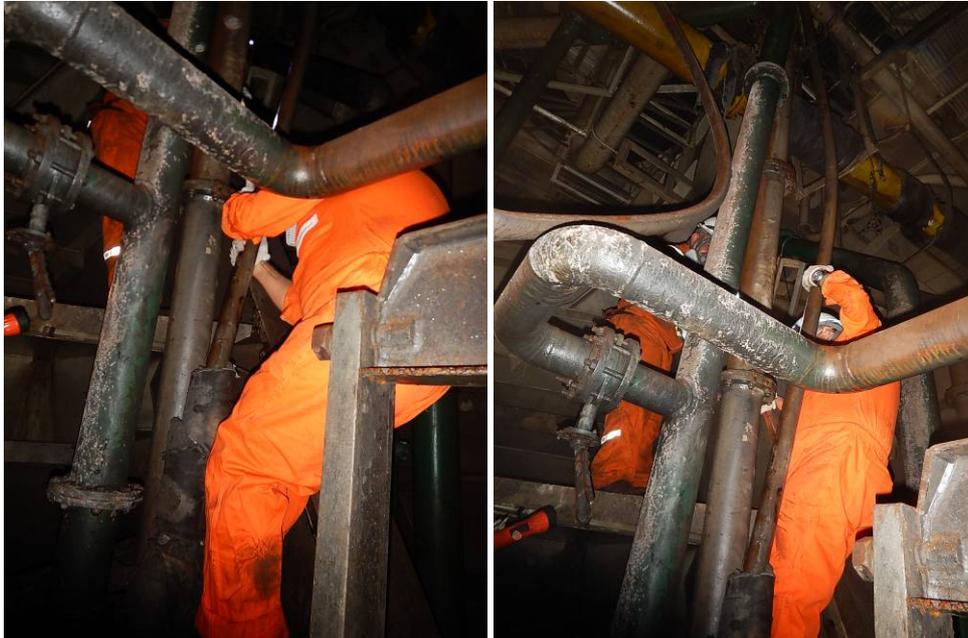
Figure 6 - Access to the area where, due to the explosion, there was communication between the engine room and the pumps room

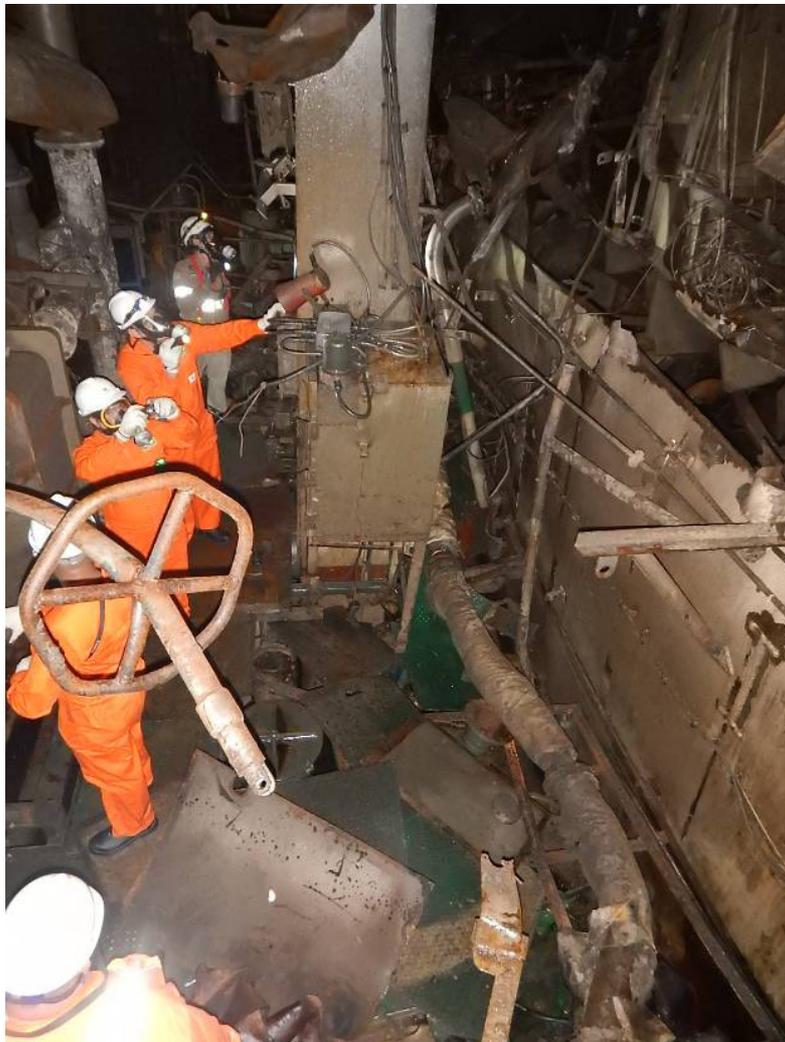
Figure 9 - Destruction caused by explosion

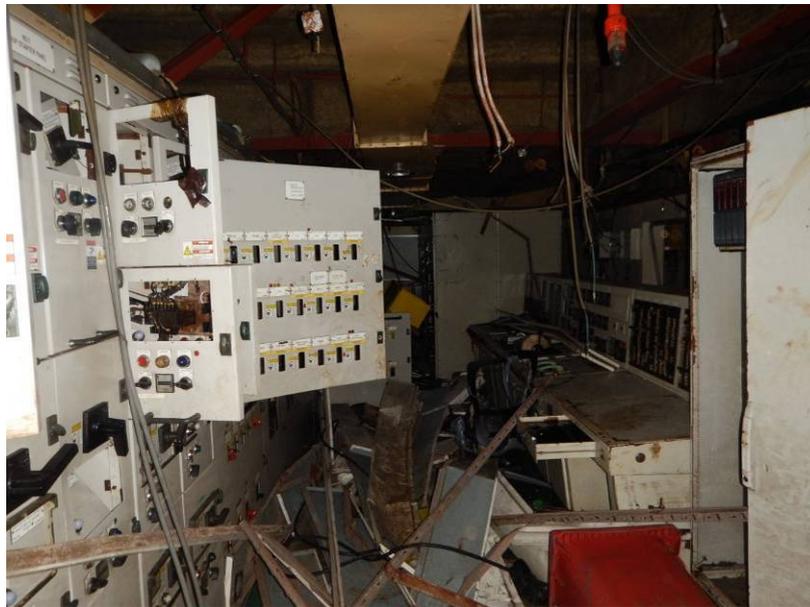
The pressure in the engine room caused the death of an operator of utilities which was located in the muster point in the engine control room (ECR). His body was only accessed and rescued around 0:00 on the day of 12.02.2015, shortly after the arrival of rescuers of the Body of Military FireFighters of Espírito Santo (CBMES). The following figures show the status of the engine room after the explosion.

Figure 10 - engine room control room (ECR) after explosion

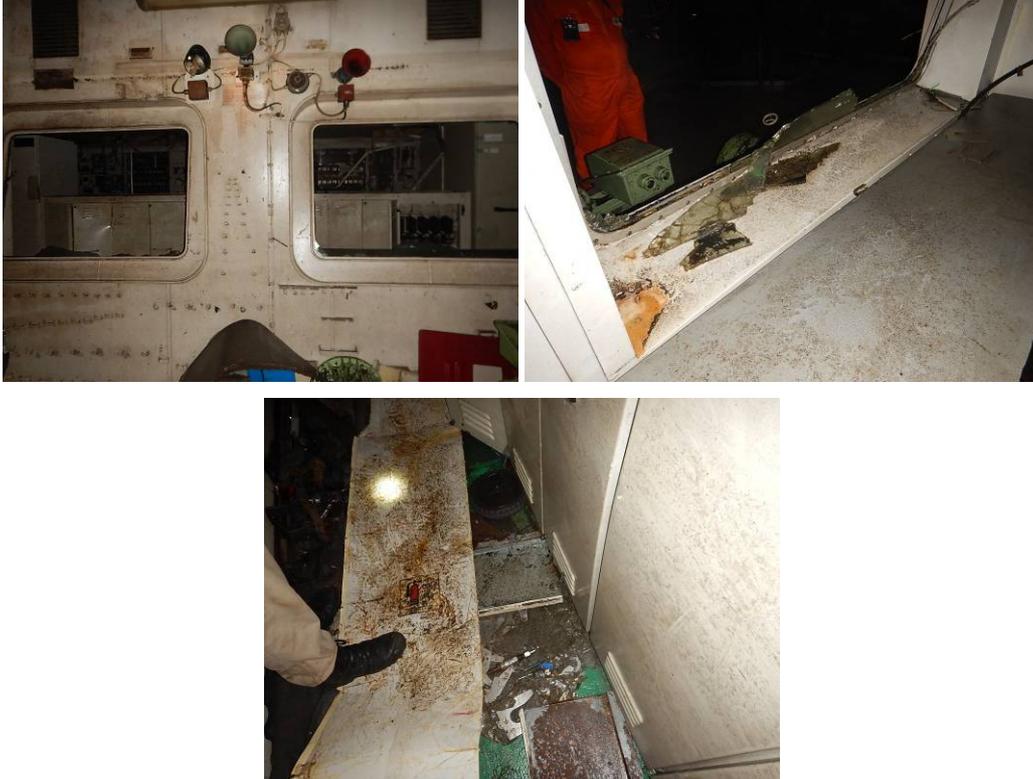
Figure 12 - ECR Windows (broken glass and shrapnel inside the room)

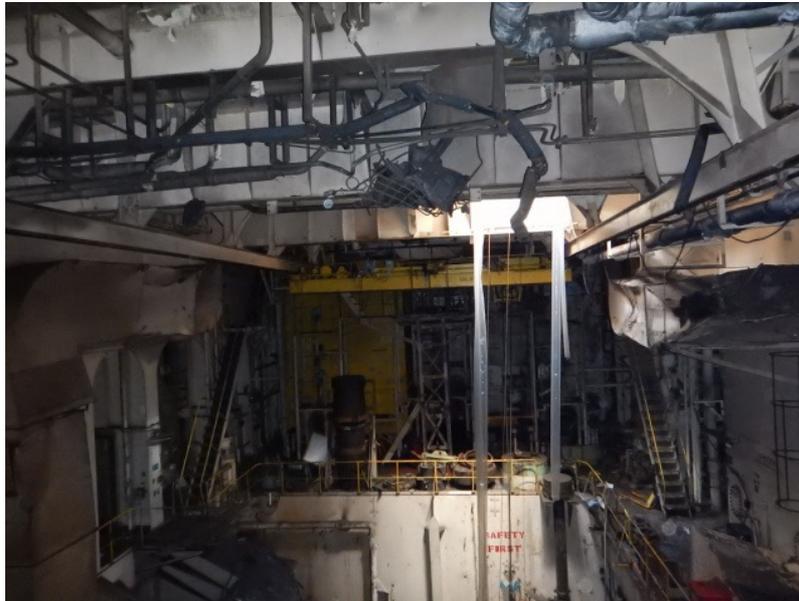
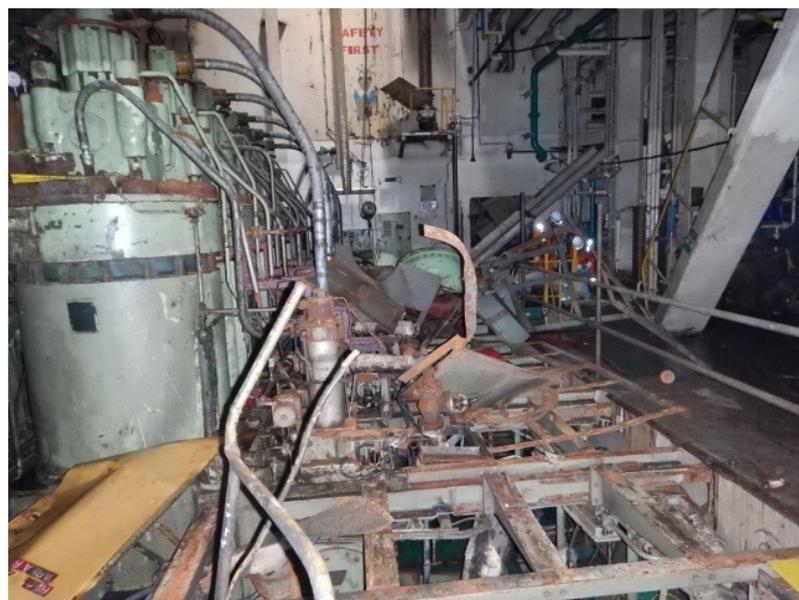
After the explosion, the unit incurred in blackout, and both the main power generation system and the emergency generator were affected. This fact can be attributed to the lack of protection forecast for this area of the unit.

Figure 13 – Machine rooms after the explosion

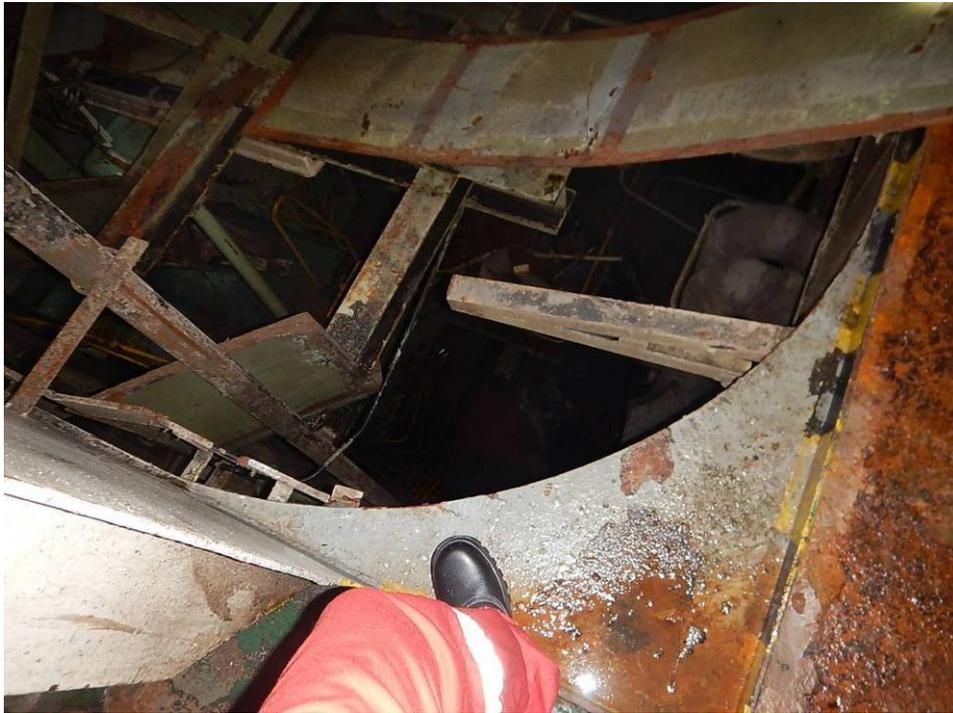
Figure 15 - Floor Part missing from in the outside of a room

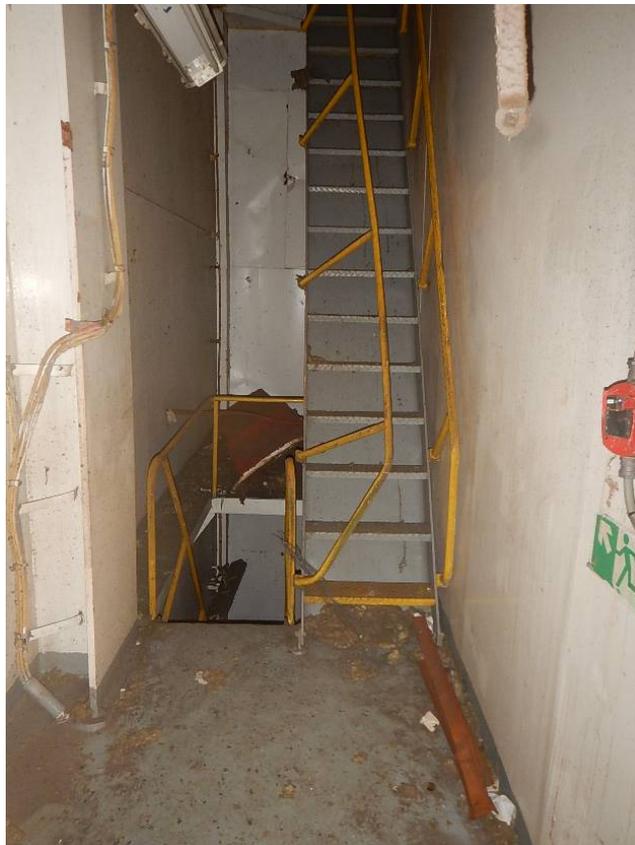
Figure 16 - area of the door adjacent to the maintenance workshop thrown back the stair in distance

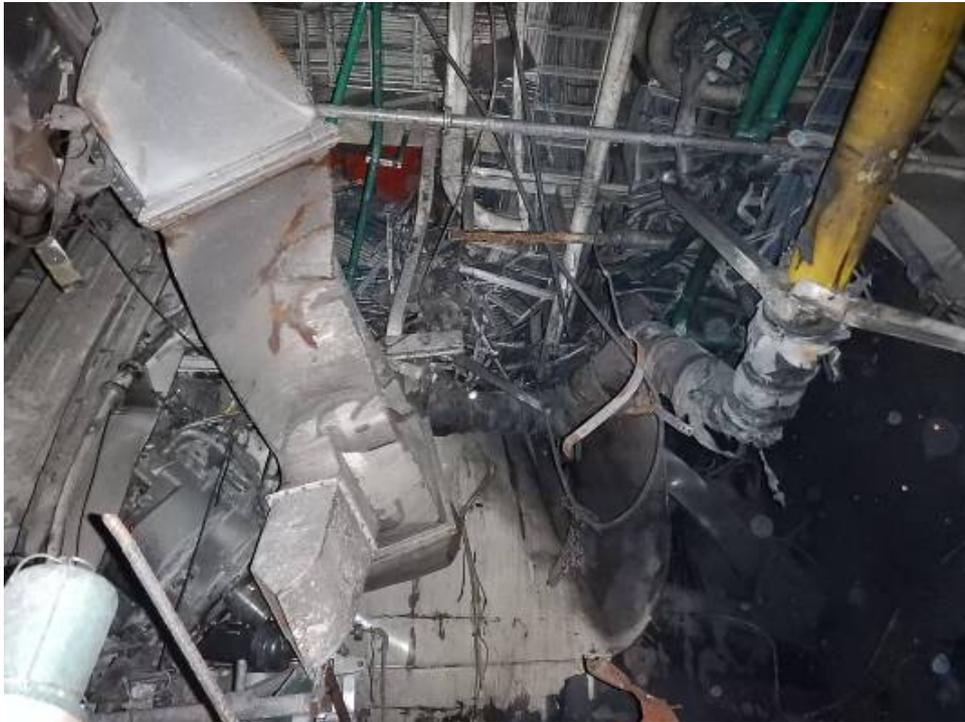
Figure 19 - hanging objects

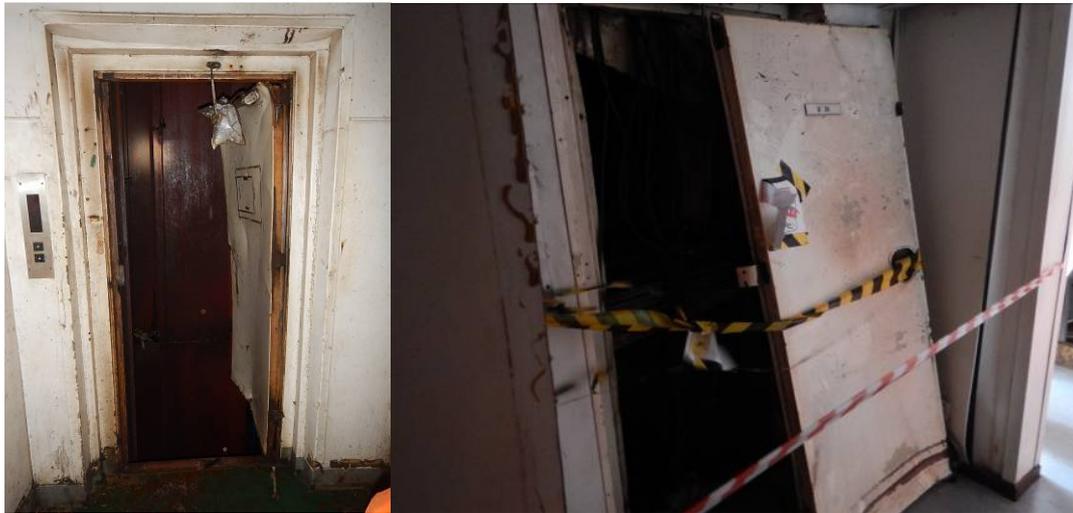
At the FPSO CDSM, the elevator linked decks between the engine room and the “D” level and it was thrown against the ceiling of the last ward on the top floor. It can be seen from Figure 20 that the square of the level of the elevator door machinery moved into the elevator shaft, unlike the other levels, in which the door moved out of the elevator.

Figure 20 - Elevator door in the engine room level (Left) and "D" level (right) after the explosion

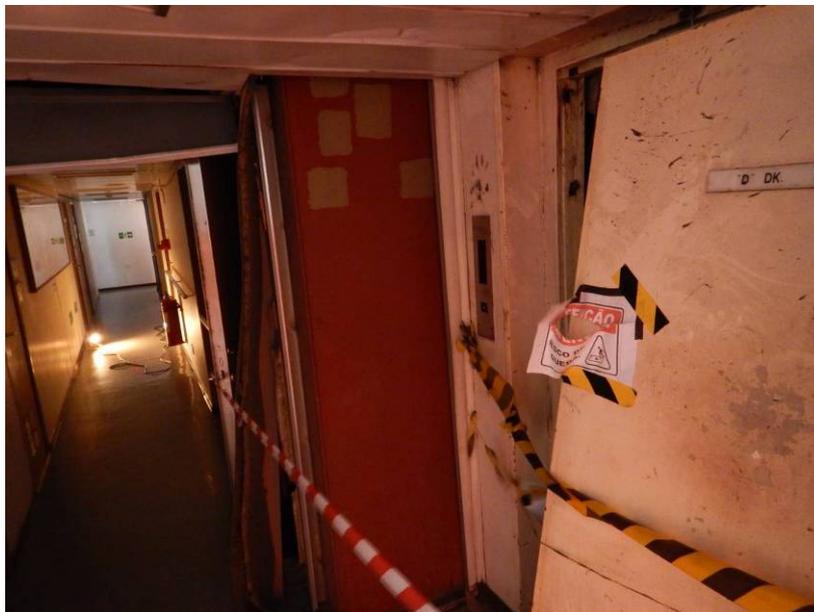
Figure 22 - Elevator door at the "D" deck after the explosion

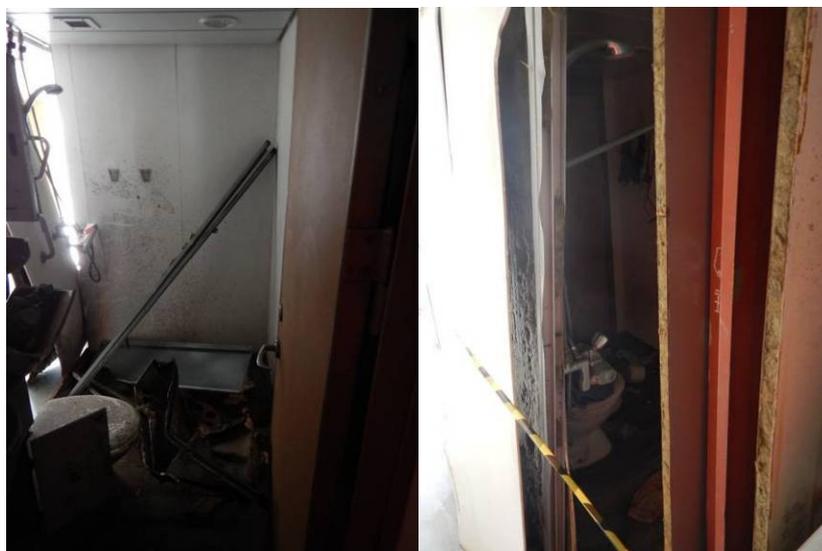
The region near the elevators also suffered damages in the explosion. Figure 23 shows damage to a box in level "D" of the unit.

Figure 23 - Cabin in front of the elevator door after the explosion

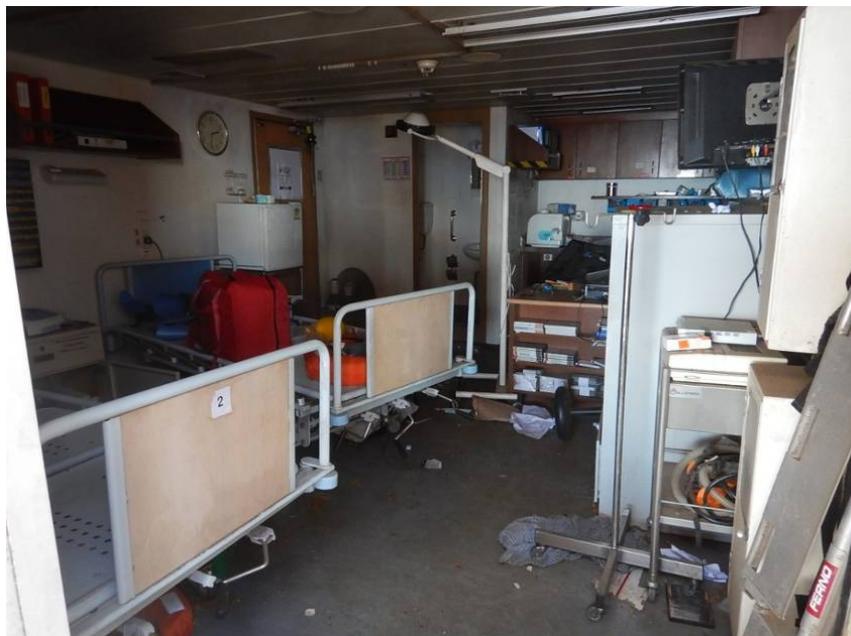
According to testimonies, the explosion damage on the nursery ward had left this environment unable to provide any care to the injured ones. The first aid supplies were contaminated by residues of the explosion and the glass wool which came off of the lining of the accommodations partitions. The ward stretcher was designed to service in the deck of the explosion and it was found without the head protector. Figure 24 shows how the ward was found twenty and two days after the explosion.

Figure 24 – Nursery ward (22 days after the explosion)

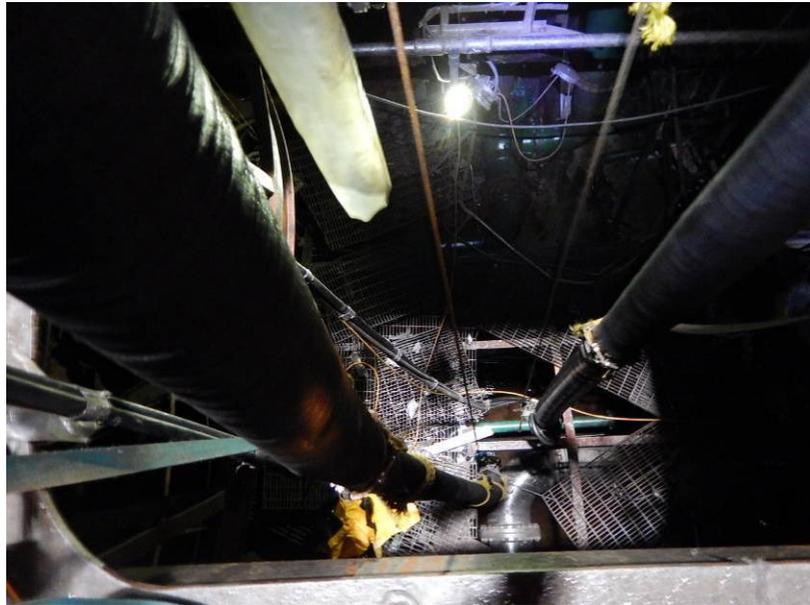
Figure 25 - Floor of the pumps room

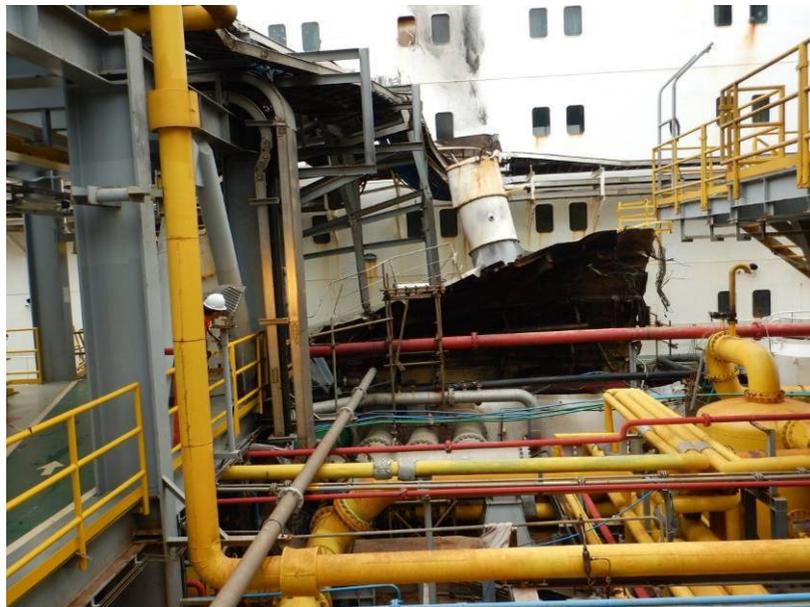
Part of the main deck floor was broken and moved up, as can be seen in Figure 26.

Figure 26 – Pumps room entrance after the explosion.

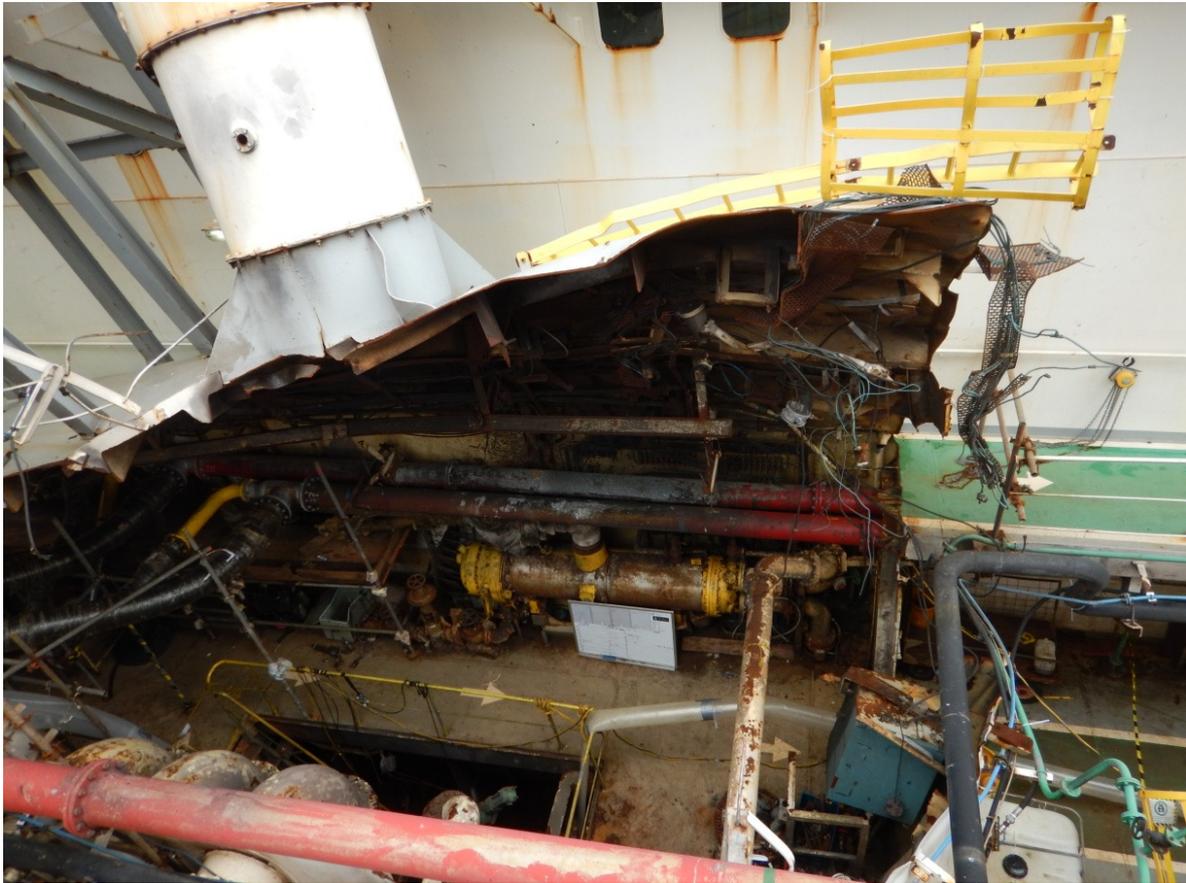
Figure 27 shows the damage occurred in line pipes of fire after the crash. Damaged and blended lines with flexible lines as well as other equipment affected by the explosion can be observed.

Figure 27 - The status of fire line pipe from the input of the pumps room after the explosion

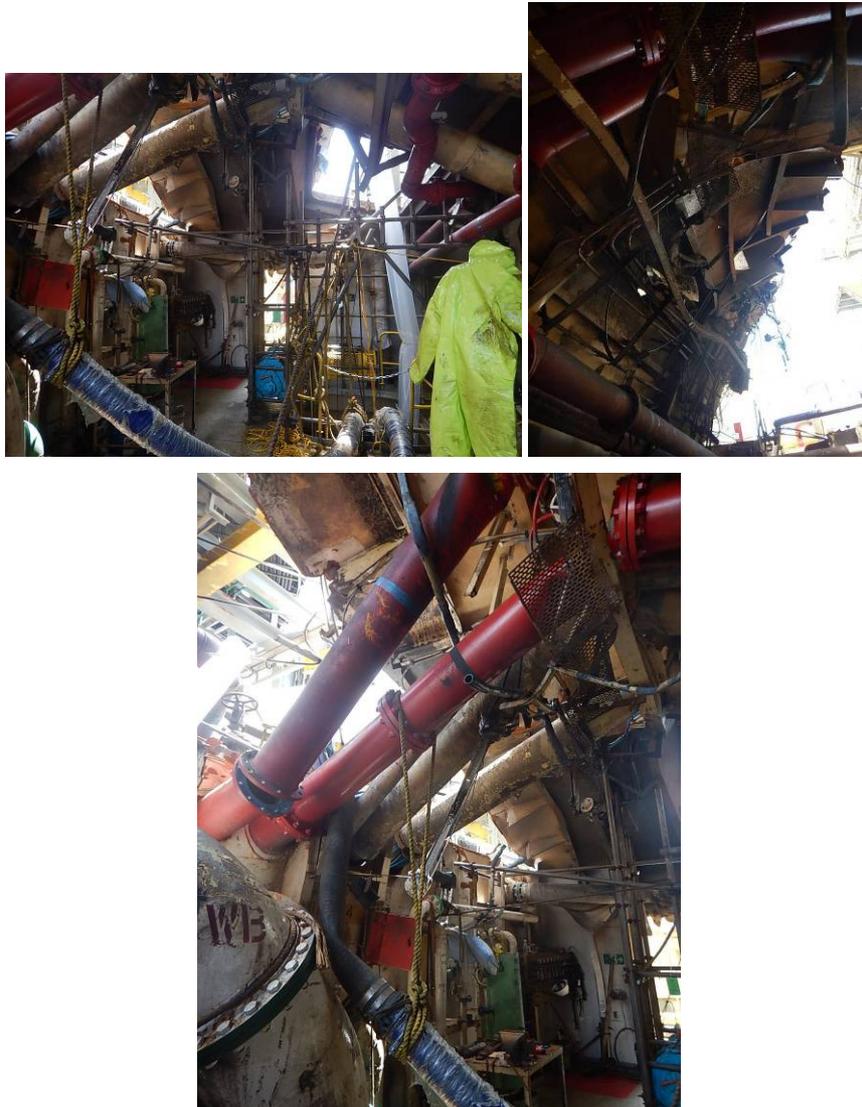
During the inspection activities conducted by the ANP, the floors of the pumps room had low lighting, missing or bulging steps and stairs destroyed replaced by provisional fitted with scaffold pipe. In the described conditions, where the sites were observed steel surface it was raised by the effect of explosion and several destroyed equipment.

Figure 28 - the pumps room entrance with raised roof and pipes

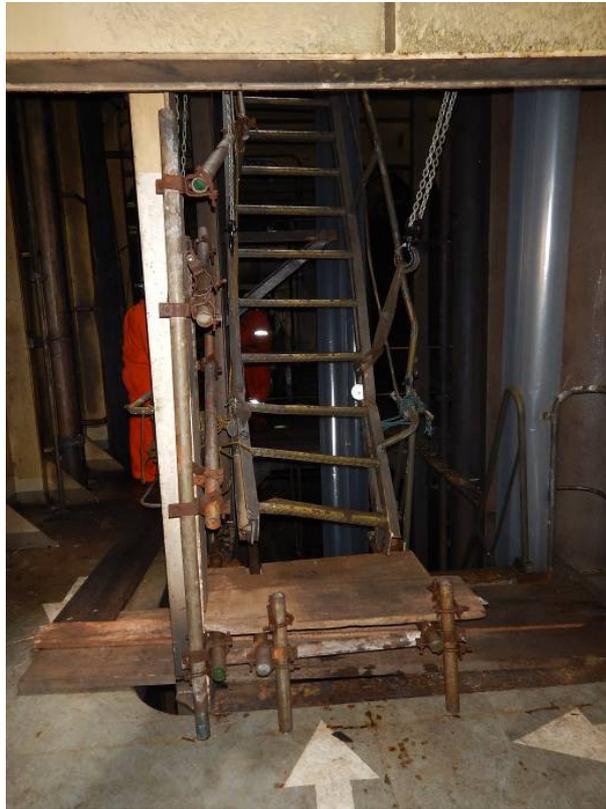
Figure 29 - damaged access and provisionally adapted for people crossing by

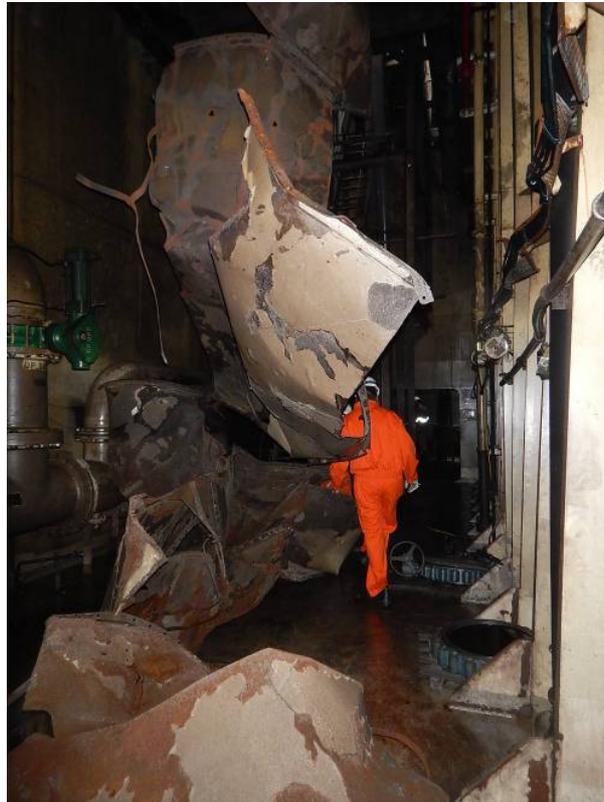
Figure 30 - ventilation system destroyed and hanging

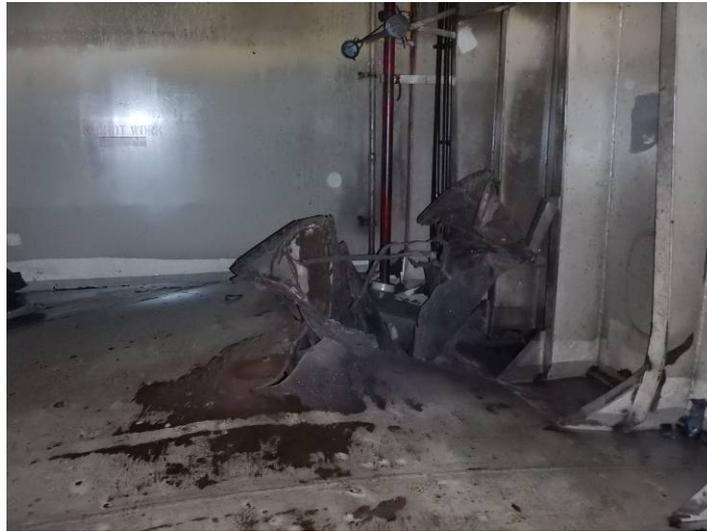
Figure 33 - Ground damaged by explosion

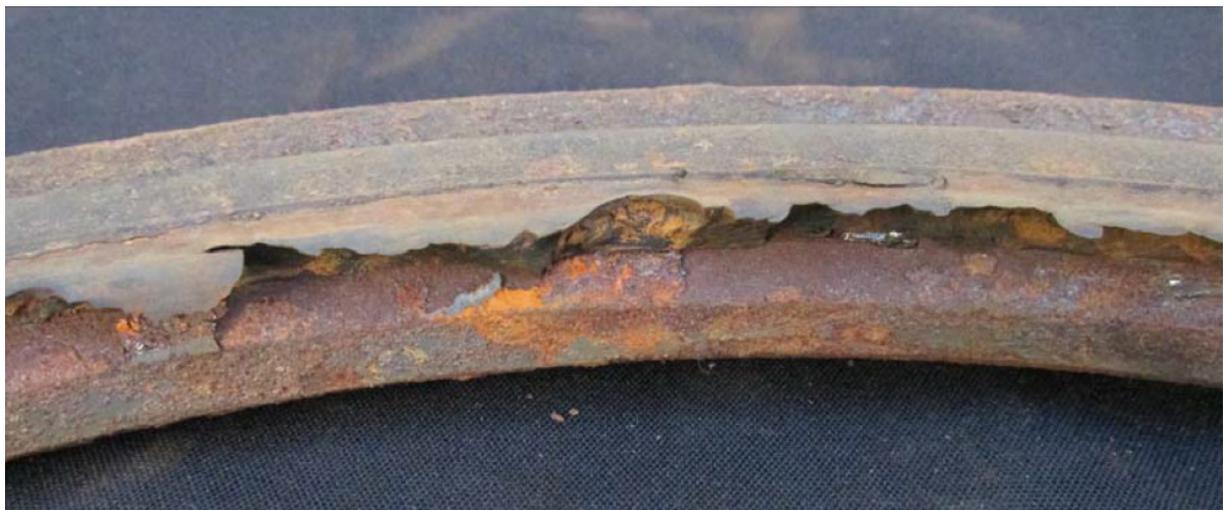
Figure 72 - Macroscopic appearance of a failed gasket seal, showing cracks in the longitudinal direction and next fracture contact transition region with fluid and with the external environment

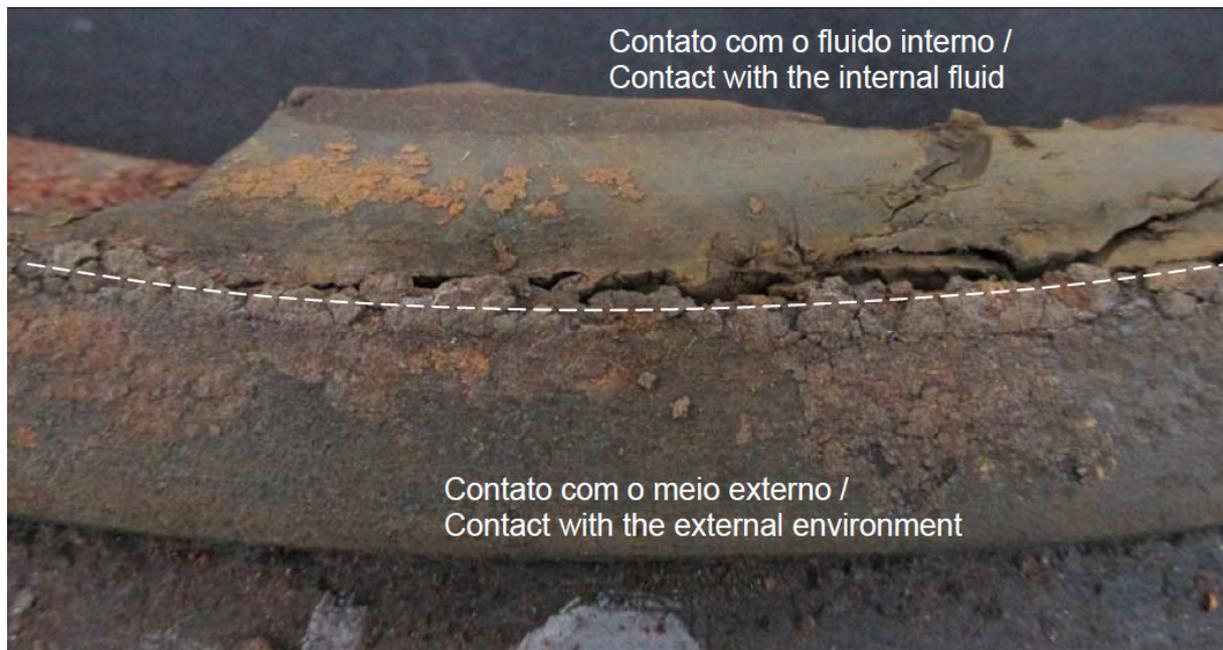
Figure 73 - Macroscopic appearance of a failed gasket seal, showing cracks in the longitudinal and transverse direction and next fracture contact transition region with fluid and with the external environment

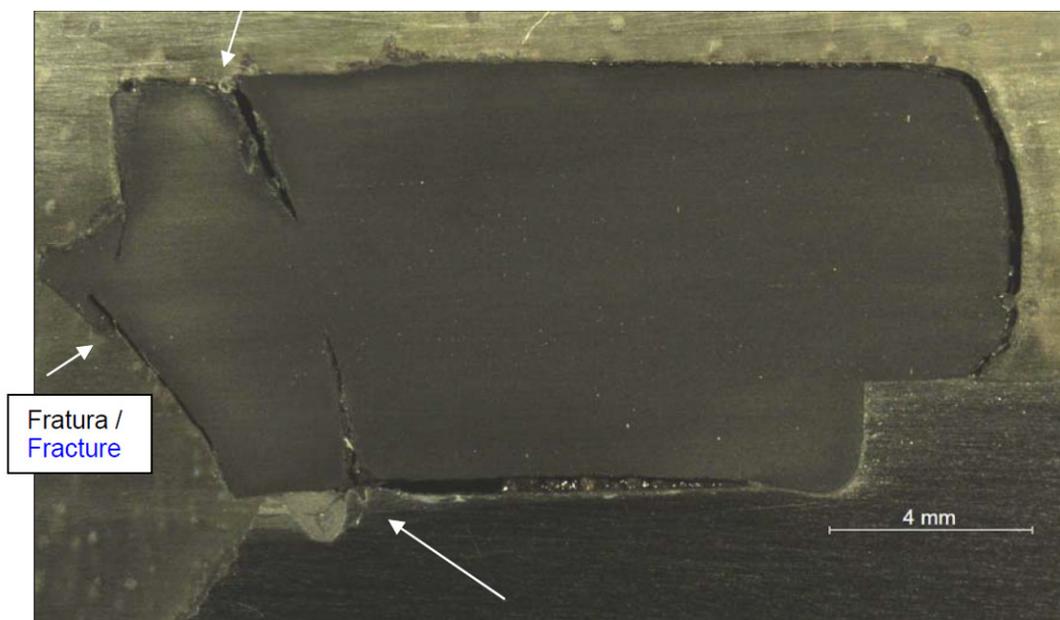
Figure 74 - metallographic appearance of the cross section of the seal, showing internal and surface cracks located in the region of contact with the fluid

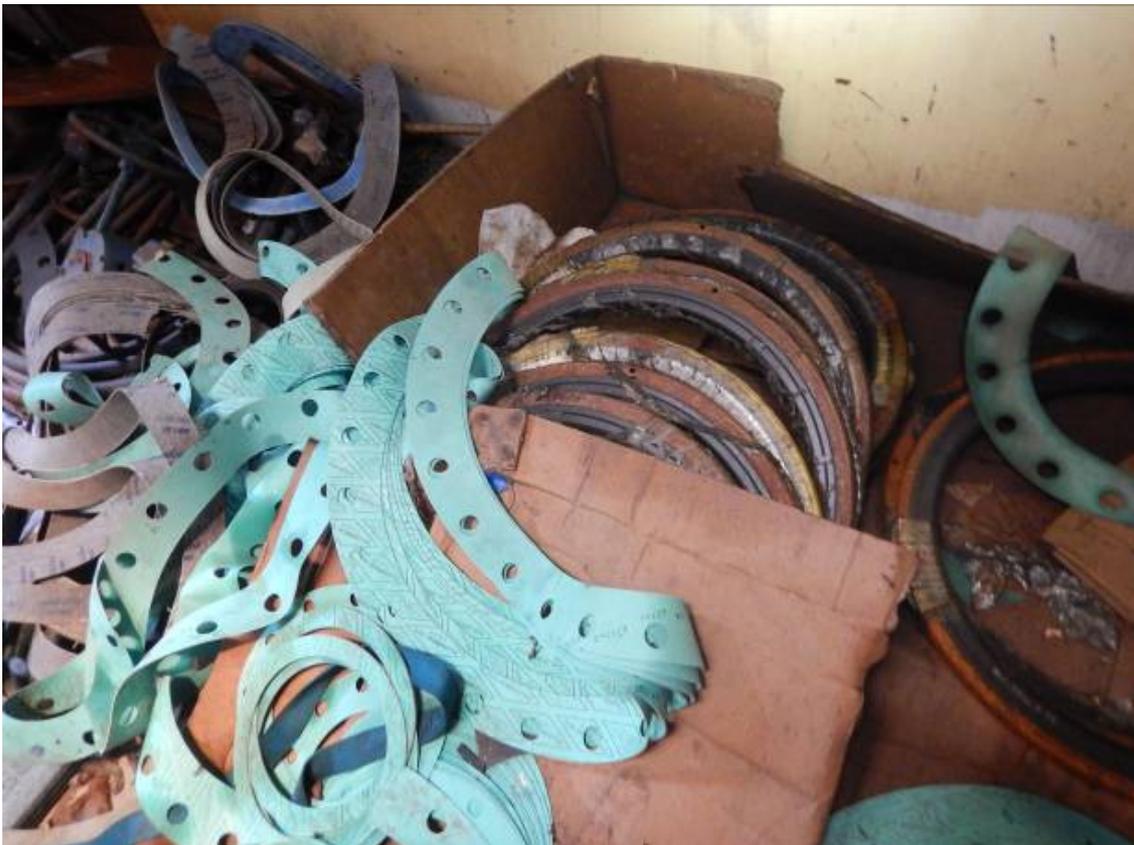
In November 2013⁹⁰ the planning to install two valves was postponed and the first exchanges of system valve seals, being followed by a campaign of exchange of valve seals were made. This campaign was initiated by the interior of the pump house, providing the possibility for the board to create personal routes for condensate flow and isolate parts of the system, making it possible to perform interventions and other regular maintenance activities. Some of shaft seals (seat rings) are replaced shown in Figure 82.

Figure 82 - Some of the shaft seals (seat rings) substituted with the goal of correcting the problems of the charging system valves.

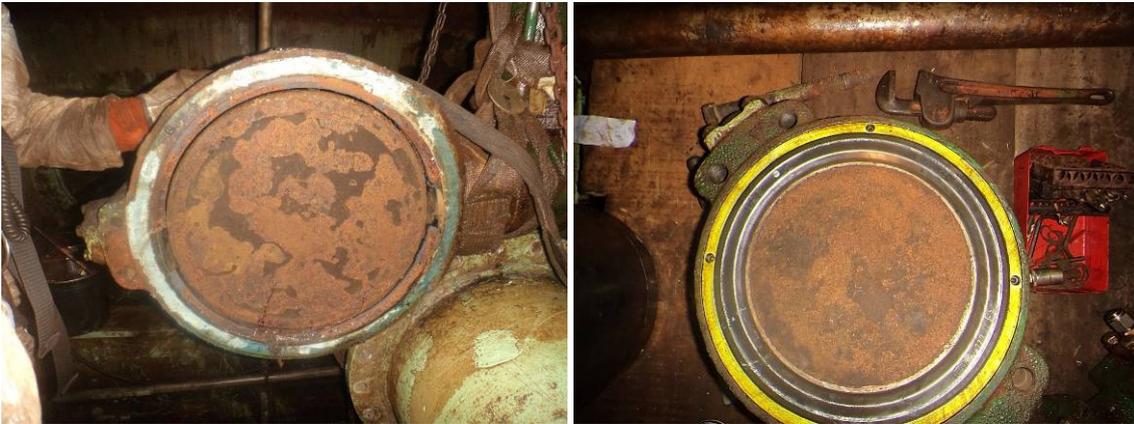
Figure 83 - Left, valve seat ring degraded and right valve seat ring replaced.

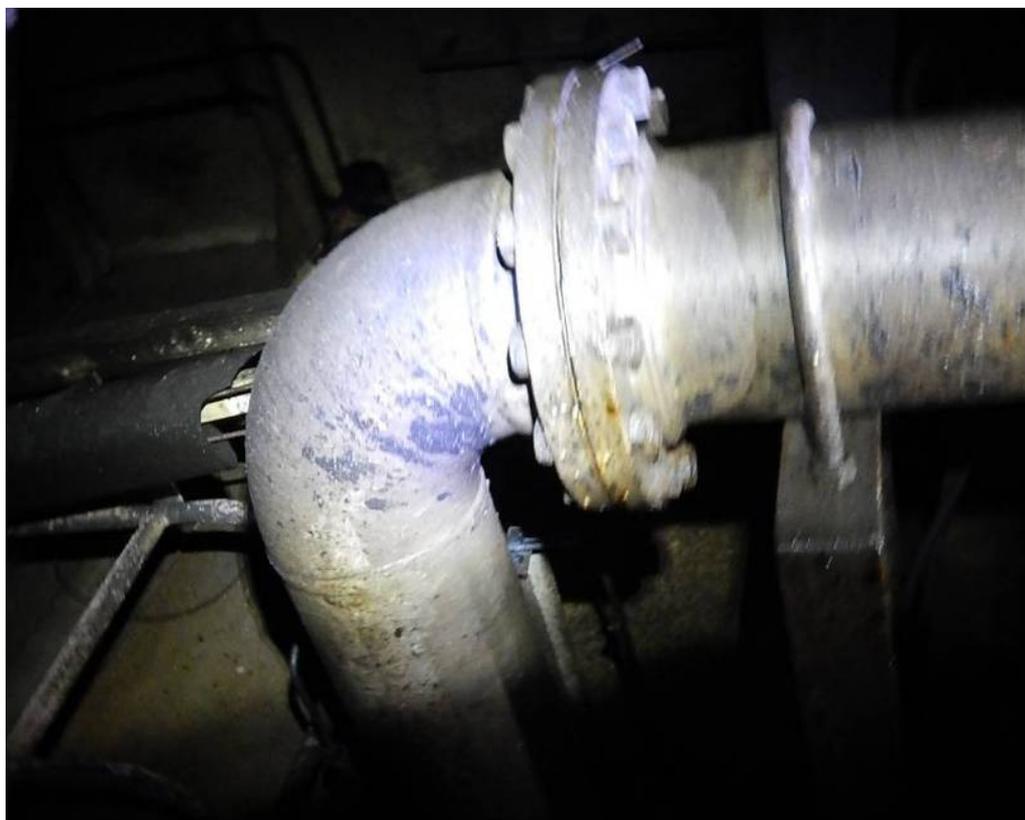
The flange connection in which was installed the spade for the insulation of OP-068 valve was condensed leak point in this accident. During the investigation of the ANP, after the accident, there was high risk of removing such a spade in the situation where the FPSO CDSM was. Thus, the ANP did not have access to the spade and the analysis of the piece in question properties will be made as soon as made available by the companies involved. The outlook for business is that the withdrawal of the spade occurs when the unit is under cross docking, as the situation has not been scheduled to occur.

Figure 84 - Spade installed for valve insulation OP-068

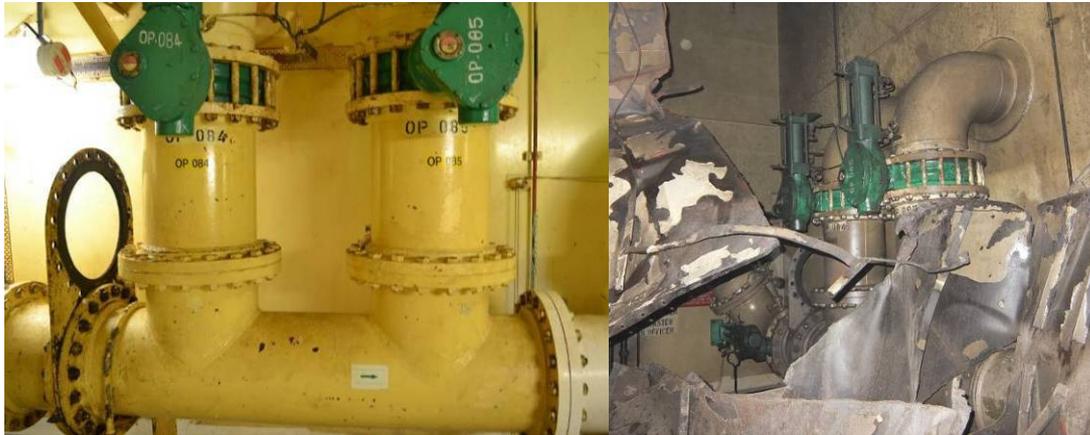
Figure 105 - PB-valve 084 before and after the accident

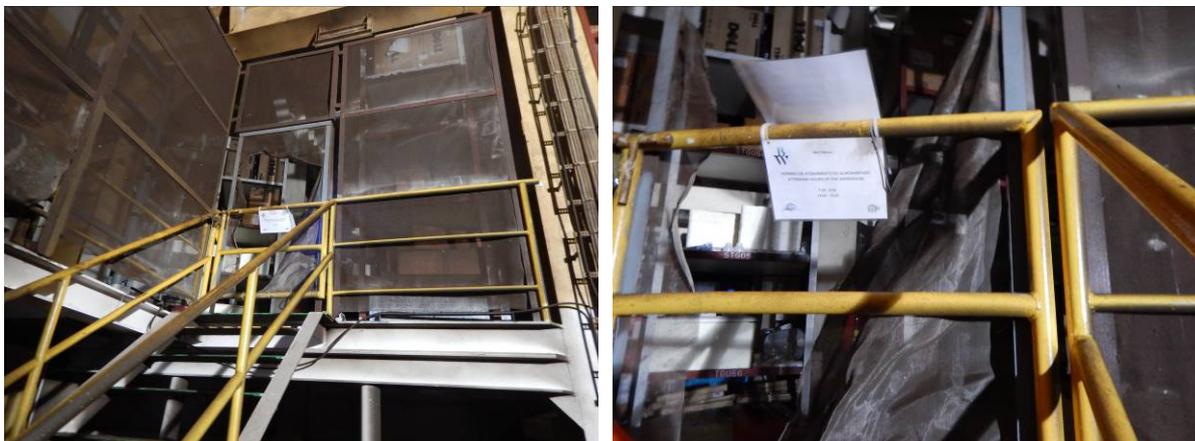
Figure 122 - broken screen on warehouse gateway
