BRAZILIAN NAVY DIRECTORATE OF PORTS AND COASTS

MARITIME ACCIDENT SAFETY INVESTIGATION REPORT

FPSO CIDADE DE SÃO MATEUS

EXPLOSION FOLLOWED BY FLOODING WITH CASUALTIES.

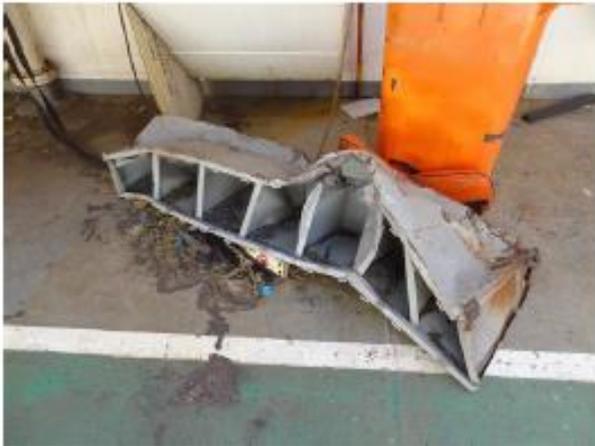
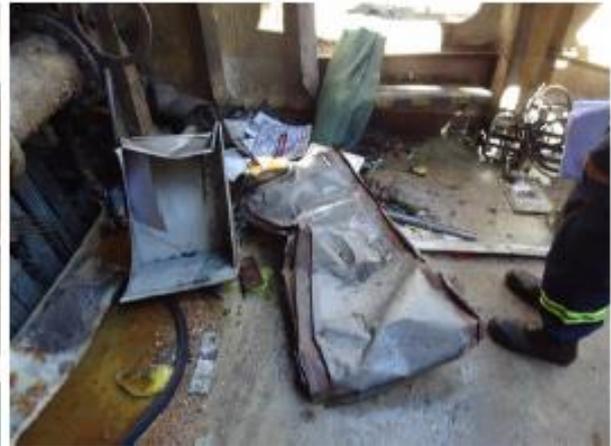
Picture 03

Lockers deformed by the explosions and expelled from the inner quarters of the superstructure.

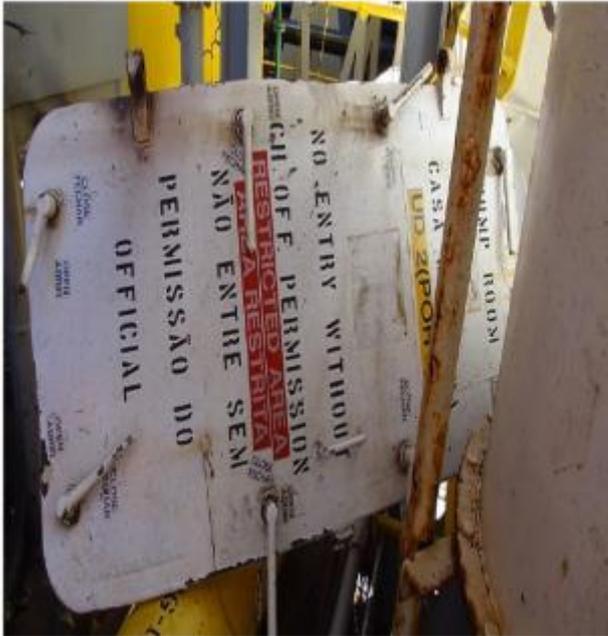
Picture 05 – watertight door to access pump room, portside, destroyed by the explosion.

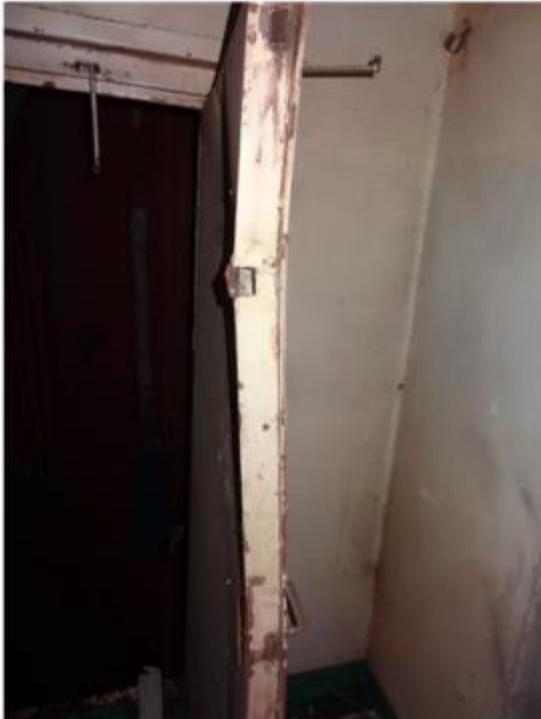
Picture 07 – access door to the elevator in the superstructure deformed by the explosion.

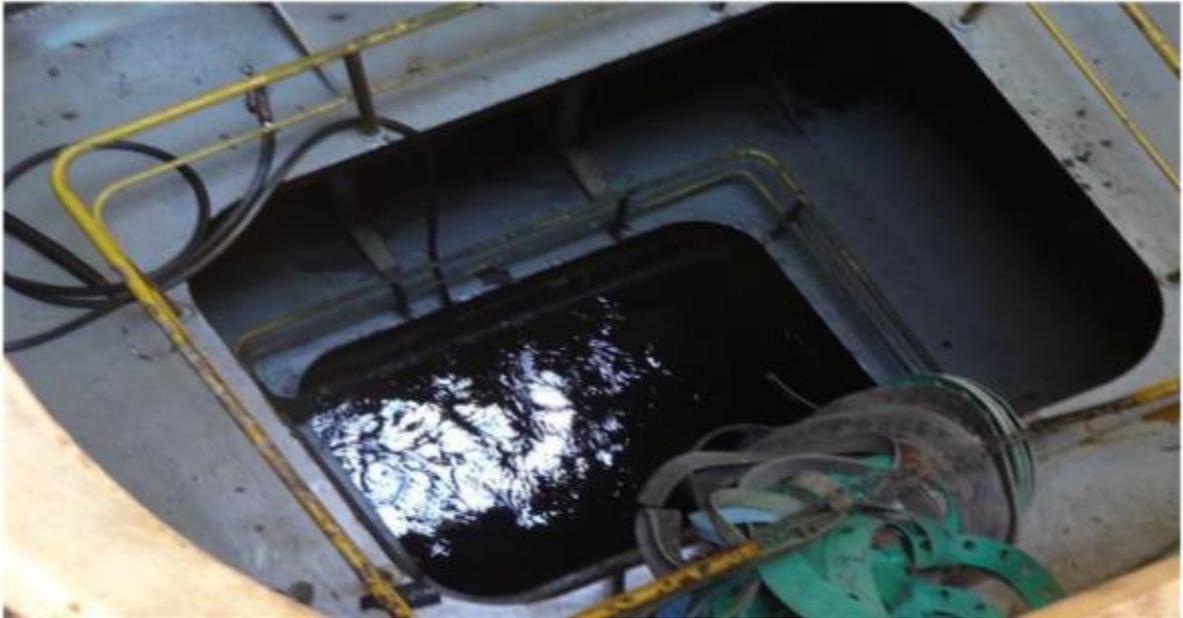
Flooding of the engine room after explosion disabled the Auxiliary Combustion Engines (MCA) and switchboards, including the Main Switchboard. Structural reinforcing elements and the network system running through the room were severely damaged by the explosion. The Engine Control Center (CCM) was destroyed by the pressure wave caused by the explosion, which was originated in the Pump Room.

Picture 09 – Flooding in the engine room seen by the hatch on the main deck, aft

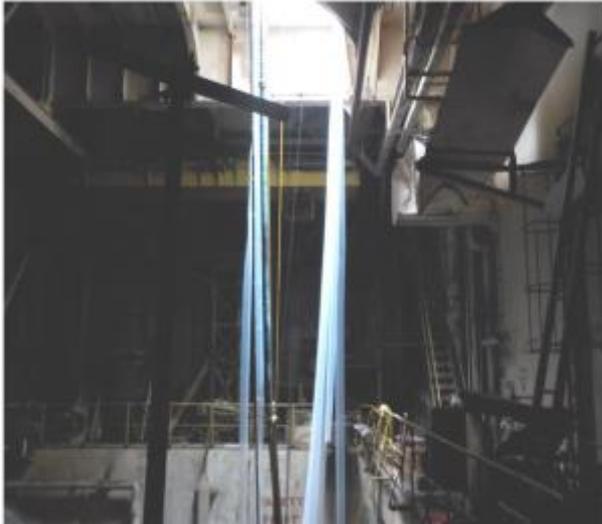
Picture 10 – Upper portion of the Engine Room partially destroyed.

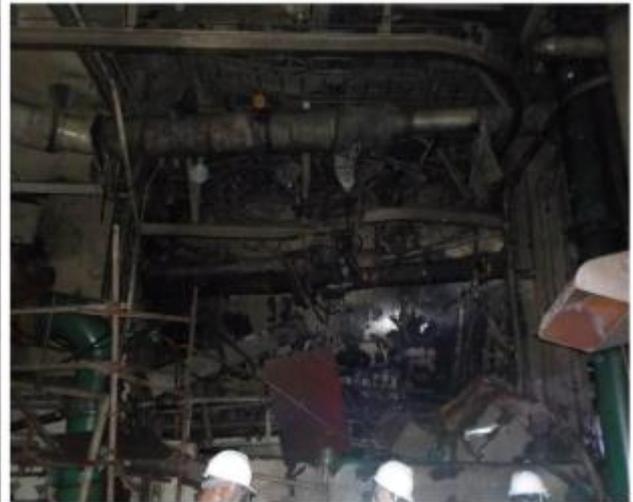
Picture 11 – Engine Room next to the starboard broadside presented signs of destruction in network and structural elements.

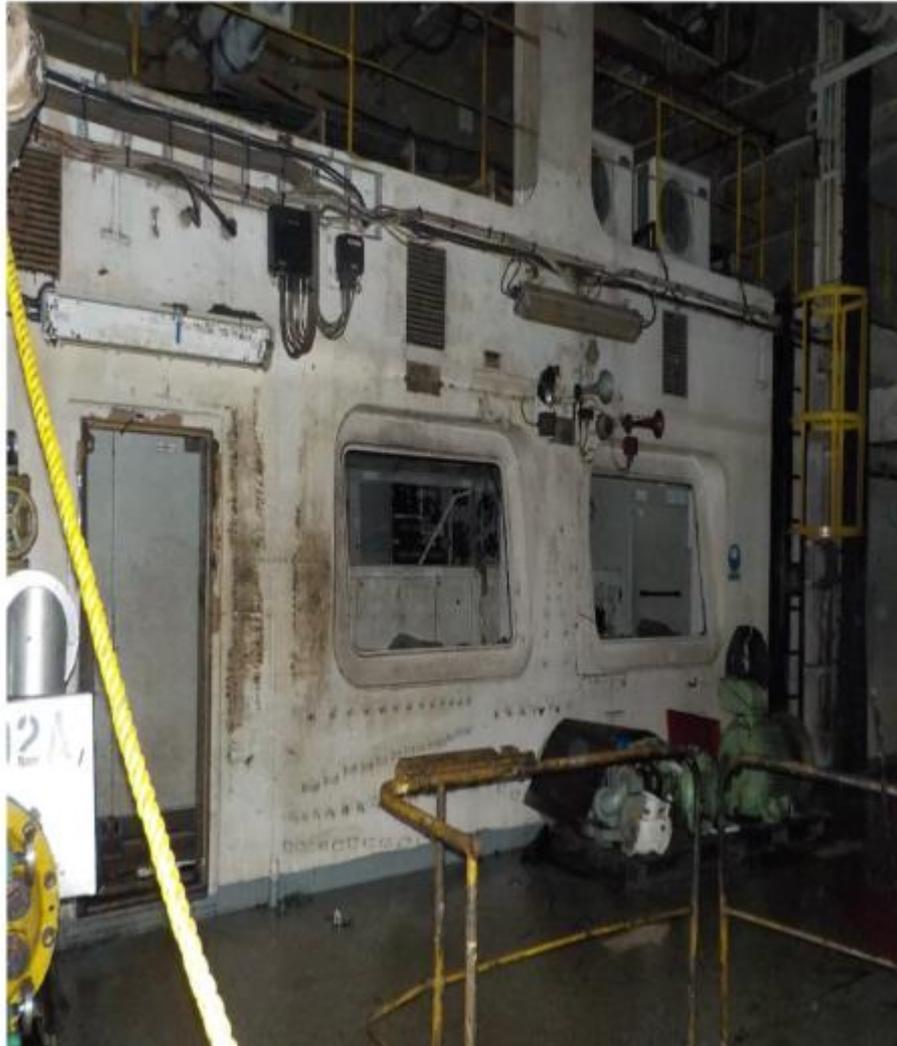
Picture 12 - CCM in the Engine Room destroyed by the effects of the explosion.

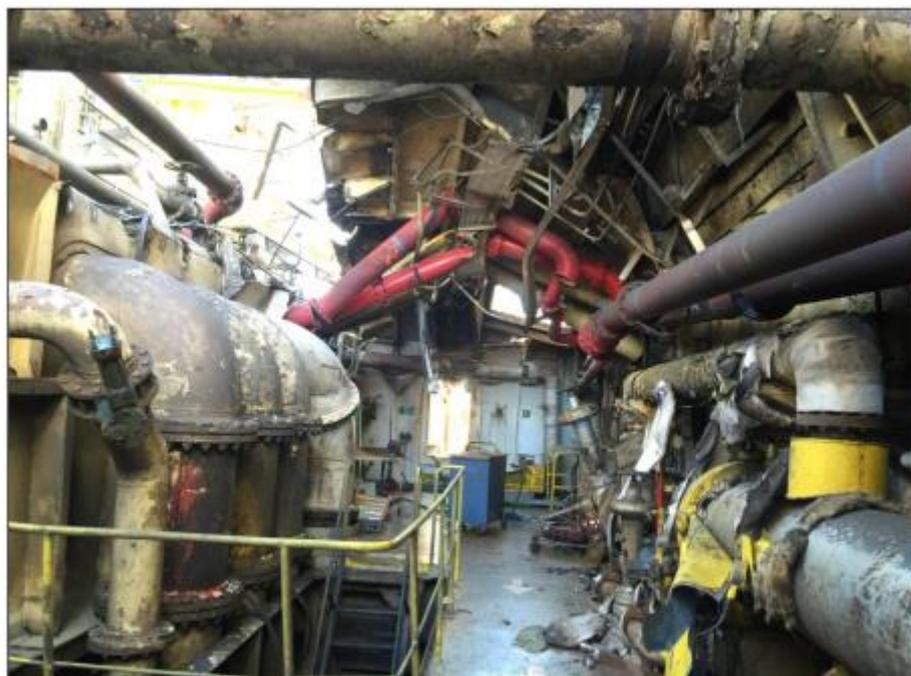
Ceiling of the pump room: located above the main deck, it was displaced and severely damaged by the explosion. Right under the 1st level the vertical plumb reinforcements of the aft bulkhead that isolates the Pump Room from the Engine Room were severely kinked and unable to perform their role of increasing the rigidity of the panel formed by the bulkhead.

Picture 15 – Pump Room Ceiling in the main deck
Fire network damaged by the explosion, which contributed to the flooding of the compartment as it was kept pressurized

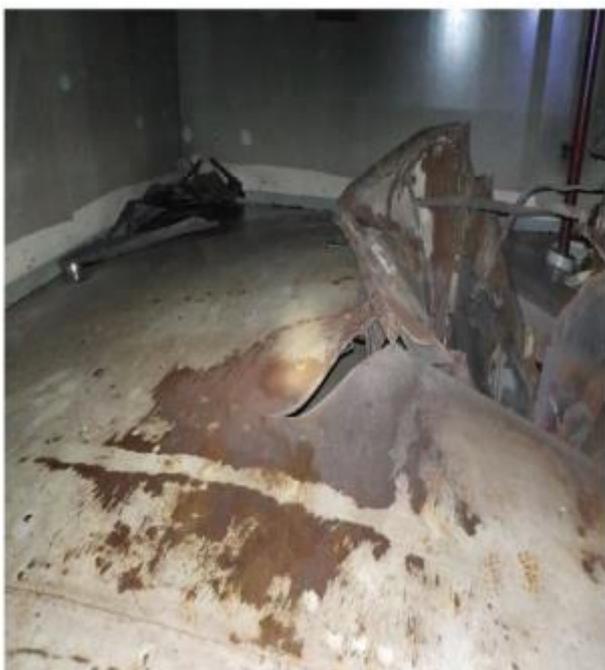
2nd level of the Pump Room: damaged floor near the starboard air extraction pipeline.

Picture 16 – Floor located at the 2nd level presenting severe deformation

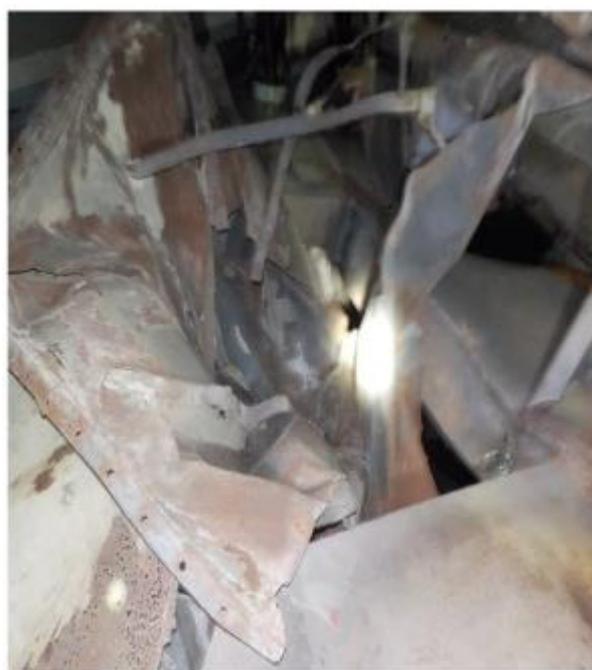
Picture 17 – Vertical air vent totally destroyed by the explosion pressure wave

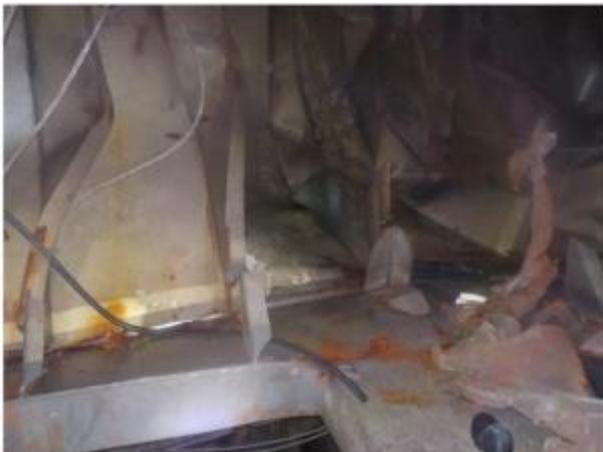
3rd level of the Pump Room: air extraction pipes were destroyed by the pressure caused by the explosion. Access stairs were also destroyed. Access to the lower levels of the Pump Room was only possible after installation of scaffolds by the crew. Bulkhead that separates the Pump and Engine Rooms were deformed and tumbled to aft, opening sections bordering both rooms. Bulkhead was separated in its upper welded joint with the unit structure due to the ascending pressure caused by the explosion at the lower part of the compartment.

Picture 18 – Tumbled aft bulkhead between the Pump and Engine Rooms was tumbled

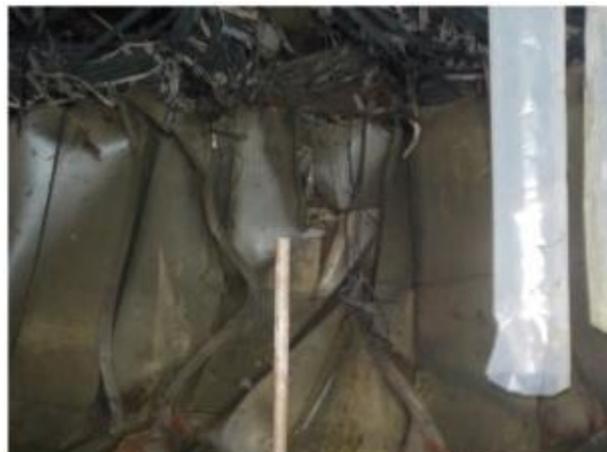
Picture 19 – Collapsed bulkhead between the Pump and Engine Rooms

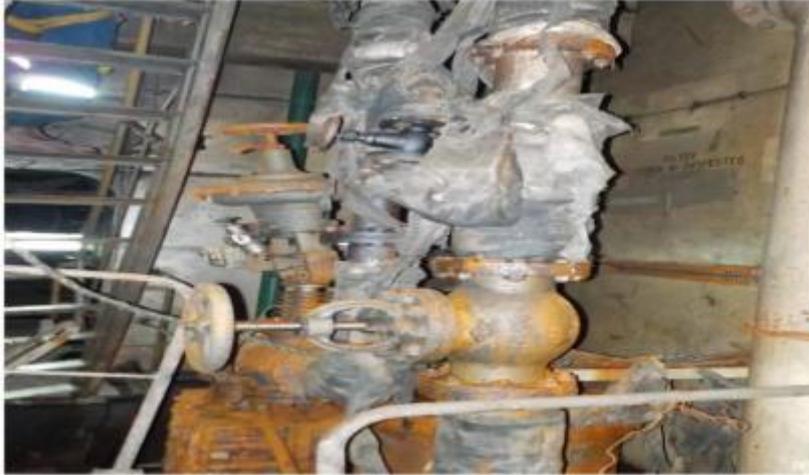
5th level of the Pump Room: the lower level of the Pump Room is divided by an intermediate floor formed by skids that allow access to equipment such as the stripping pump. Such skids were severely affected by the explosion. The stripping pump presented superficial damages on the thermal isolation of the housing and of the draining system manifold.

Picture 20 – Stripping pump presented superficial damages

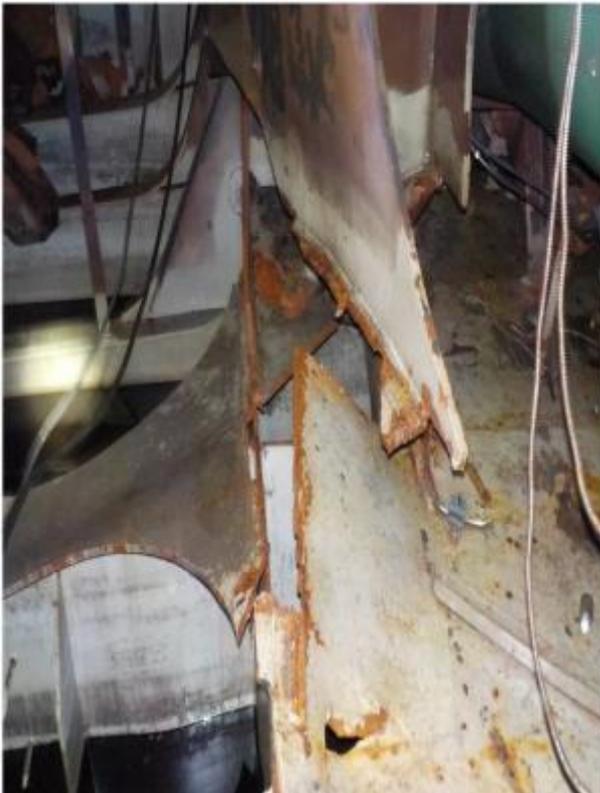
At the Pump Room floor it was noticed a strong deformation at the junction of the sixth girder (longitudinal structural reinforcement of the bottom plating) from the starboard bulkhead with a Samson post (vertical beam that supports the ceiling at the lower panel).

Picture 21 – Severely damaged 6th bottom plating reinforcement girder of the Pump Room

The shape of the deformation on these structural reinforcements means that the pressure caused by the explosion was concentrated at the compartment bottom near the condensate leak and then expanded vertically upwards, which explains the deformations found in the structure and bulkhead of Pump Room upper levels. The compartment also presented oily water at the bottom between the structural reinforcements of the compartment's bottom plating.

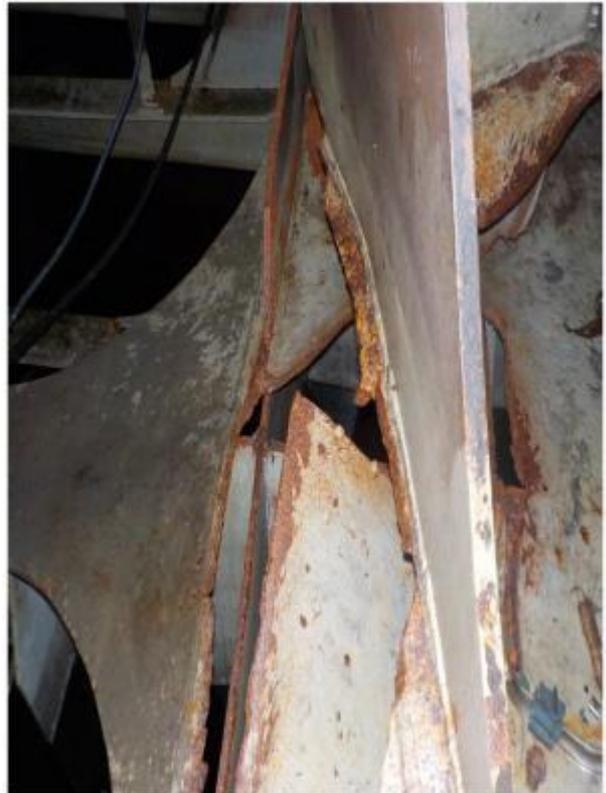
Picture 22 – Vertical detail of the collapsed and deformed structure

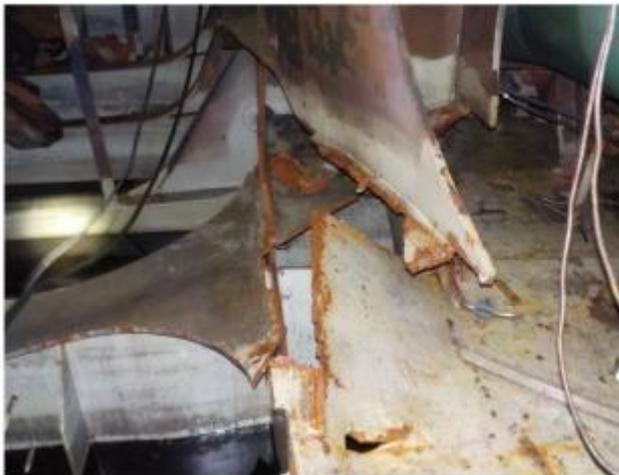
Picture 23 – Severely damaged 6th bottom plating reinforcement girder of the Pump Room

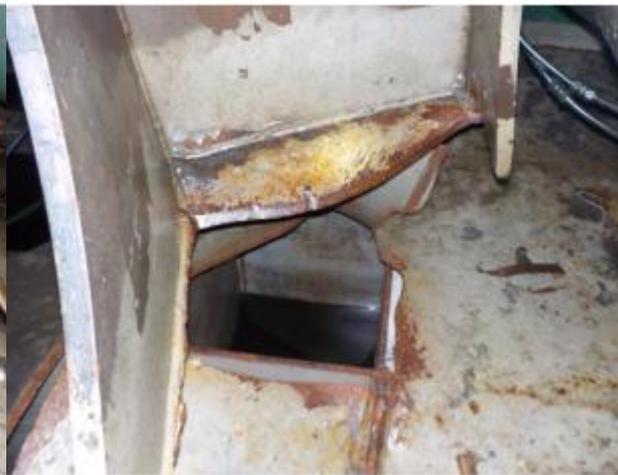
Picture 24 – Under the damaged structure there are remnants of oily mixture

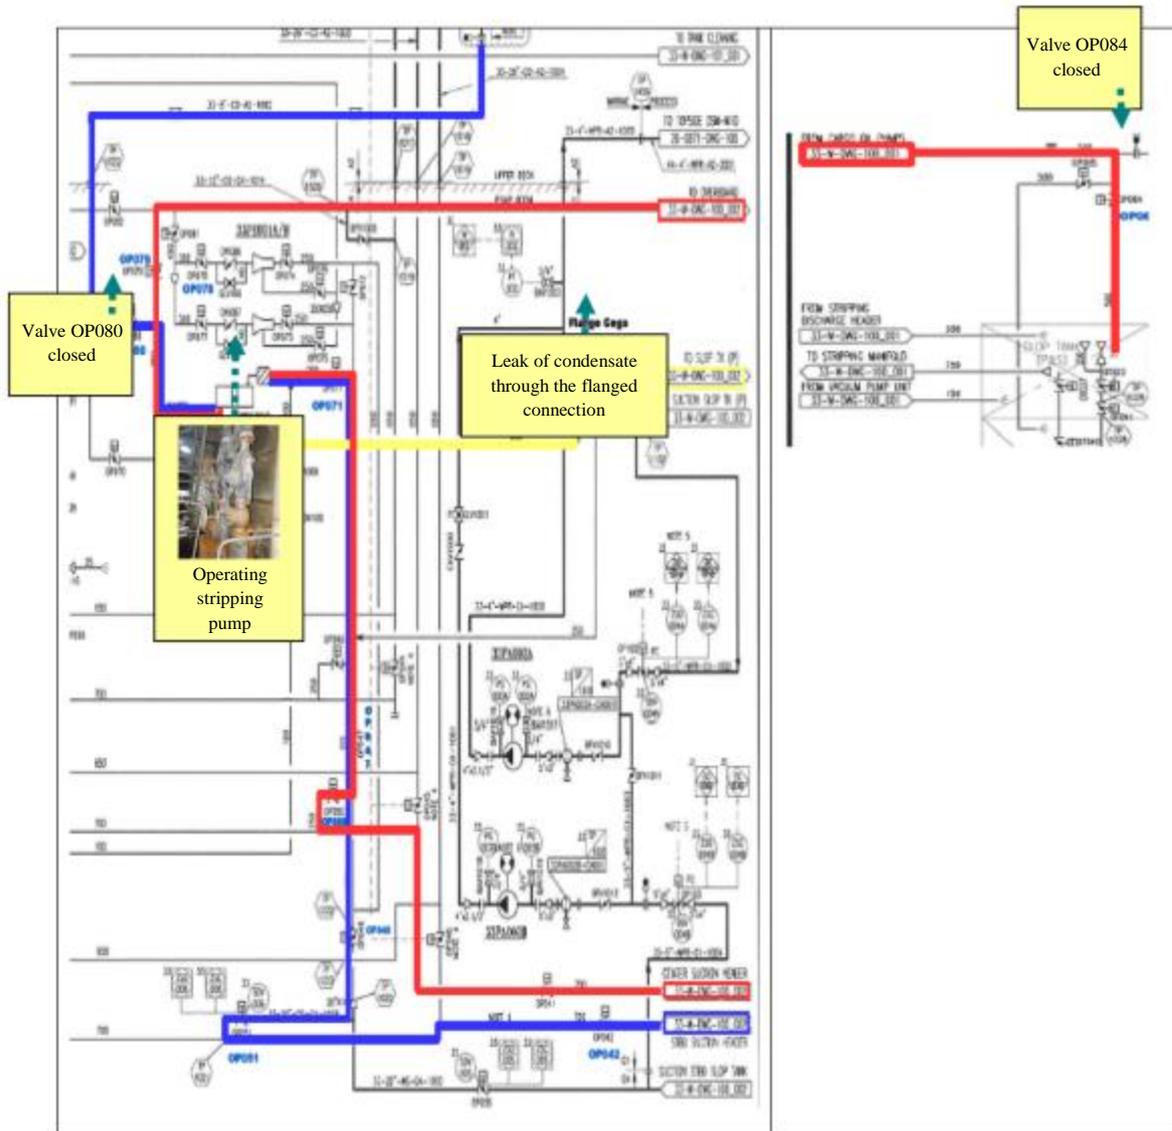
Drawing 2 – network diagram indicating closed valves during operation of the stripping pump.

As the stripping pump is of the positive displacement type³, its operation for more than two minutes with both valves OP-080 and OP-084 closed, caused the pressure to build up inside the discharge network provoking the leak of condensate by the flanged connection joint at upstream of valve OP-068. This arrangement is marked in blue color on Drawing 2 below.

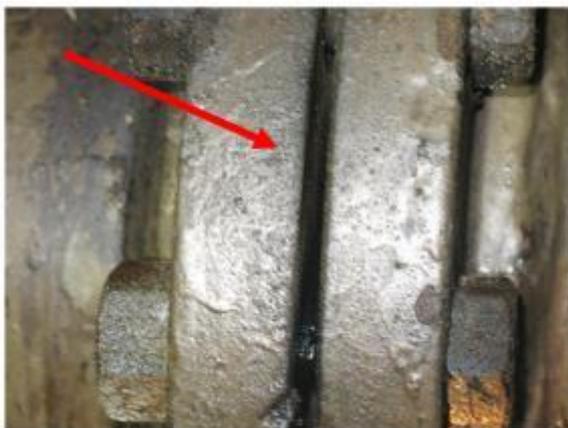
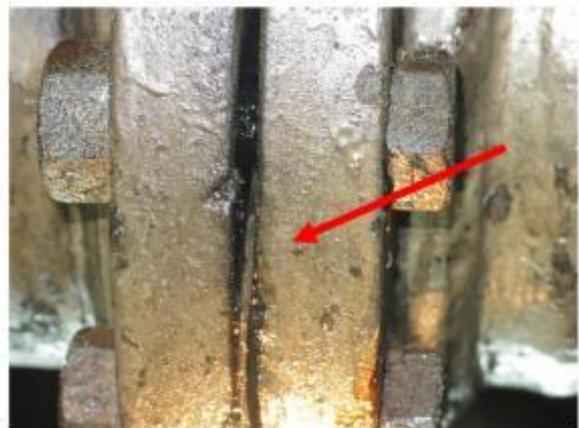
Picture 31

Considering the operational error of closing valve OP-084 while the pump was still running, this action alone would not cause the leak of condensate if the integrity of the flanged connection (obstructed by the racket) had been kept. It is worth emphasizing that the pump worked at 8% of its working capacity, its hydrostatic pressure was of 30kg/cm² and it had a safety system that would relief the pressure after reaching 16.5 Kg/cm², in addition to the whole cargo network being tested after manufacturing and installation with 1.5 times the working pressure (item 4.6.2 – 7.3 and 4.6.2 – 7.3.3 of ABS’ Rules).

Details of the flange joint wearing
(Images obtained after leak – source PETROBRAS)

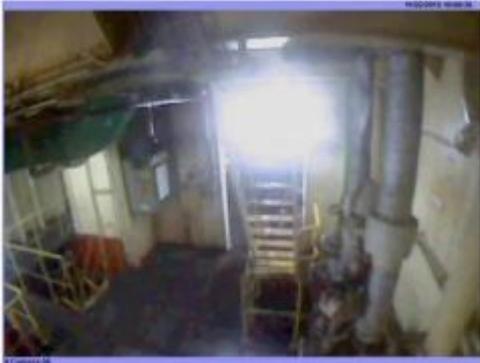
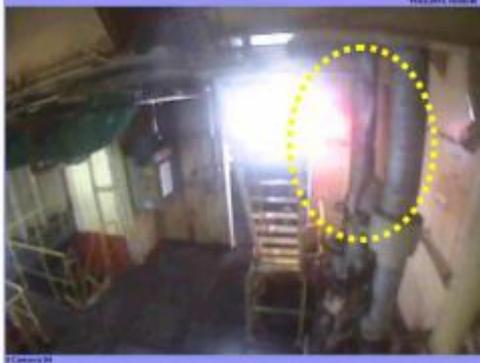
<p>Picture 33 Camera 04 - local time 11h31m52s. Camera is positioned to visualize the red signaling light that is triggered when the gas alarm is sounded as shown in the following image.</p>	<p>Picture 34 Camera 04 - local time 11h31m56s Red signaling light was turned on when the gas sensor TAG 73AB370 was activated with HIHI (11h31min18s) – delay of 18 seconds.</p>

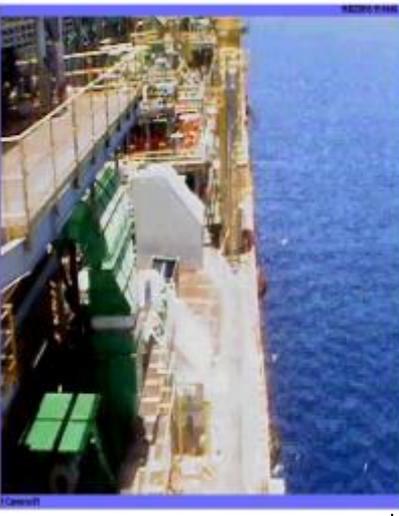
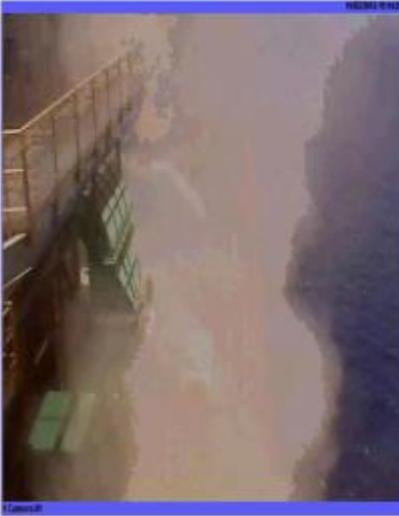
Hydrocarbon cloud remained at the lower portion of the compartment as only the gas sensors installed at the bottom of the pump room were triggered, thus evidencing the presence of flammable gas (fuel) and oxygen (combustible). The source of the ignition that led to the explosion is still unknown, it could have occurred by a spark following the use of tools by the crew in the attempt to contain the leak, generation of static electricity following the use of fire hose during cleaning, or even utilization of handheld VHF radios, or also by the natural heating the compartment was submitted to after exhaustion stoppage, or an unknown cause. The CCTV images below show the exact moment of the explosion.

Picture 35 Camera 01 – local time 12h38m01s	Picture 36 Camera 01 – local time 12h38m03s	Picture 37 Camera 01 – local time 12h38m09s
