# Veslefrikk cessation – Permanent P&A

10<sup>th</sup> Plug and Abandonment Seminar

20 10 2022 Stavanger

# Veslefrikk Permanent P&A cessation project

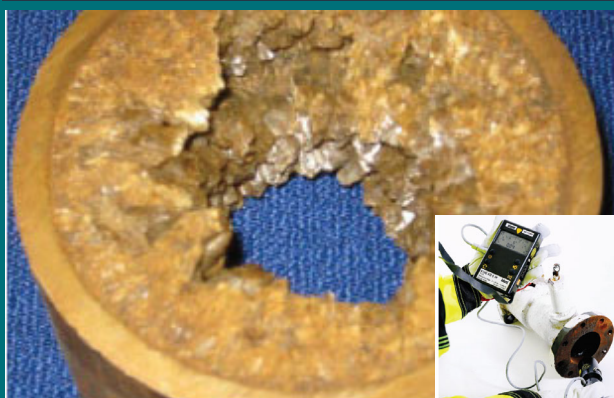
### NORM /LRA /LSA

- Normally Occurring Radioactive Material (NORM)
- Establish procedures for measurements and handling

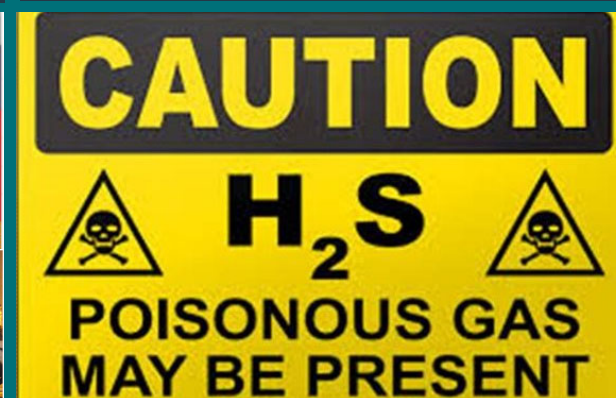
### H<sub>2</sub>S

- H<sub>2</sub>S specialist services

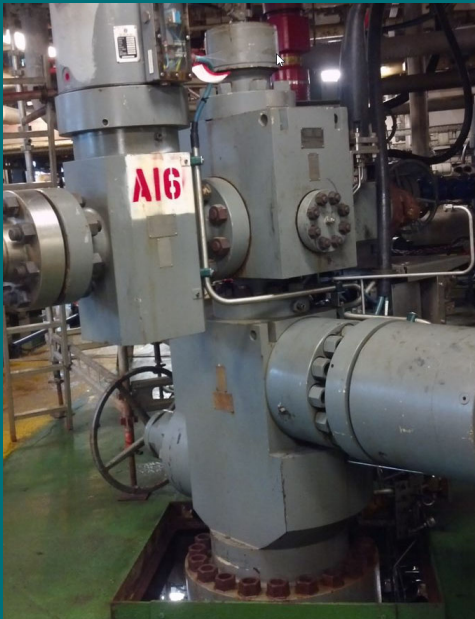
Abrasive water jet  
Cutting of XM T bolts

- ASV removal- Optimized cutting, milling, pulling sequence for each ASV type
- Optimized and removed bottle necks in nipping operations, reduced from almost 4 days to less than 1 day
- Performing majority of operations in TSW to minimize mud handling cost and optimize cement quality
- Cutting XMT bolts with abrasive water jet cutting and performing WL operations as simultaneous operations
- Improved efficiency by fabrication of prototype 13 3/8" csg cutter technology
- Efficiency in improvements by standardising operational sequences and using dedicated personnel (Cmt, Fishing, WH)

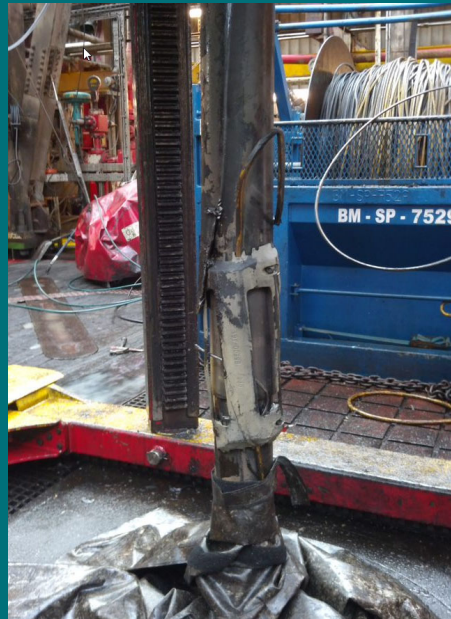
Tubing dropped 5m after  
ASV release and jammed  
on tubing below deep cut.  
Pulled 680 m extra tubing

- Milled ASV in one well
- Completion
  - Tubing dropped after ASV released, and jammed to tubing below at deep cut
- Reduce time for reconfiguring Unitong

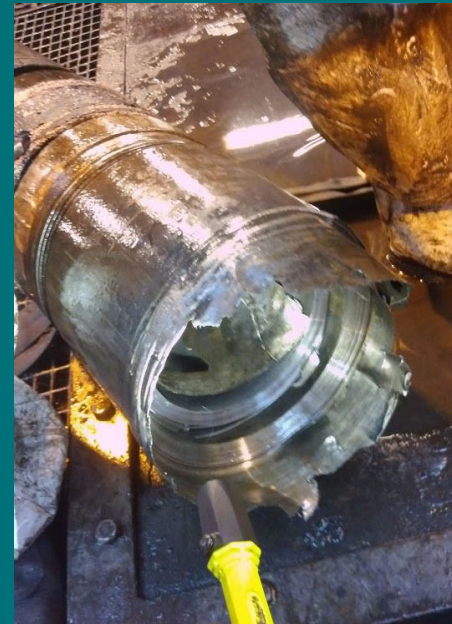
Retrieved ASV after  
milling

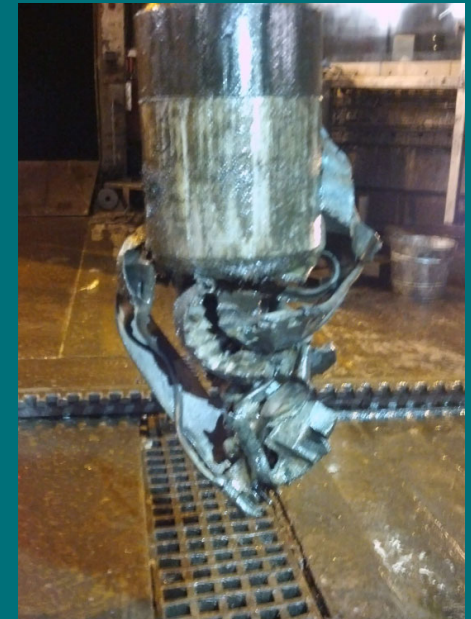
Fished clamps from  
wellhead

- Equipment failures, NPT (Unitong, HTV arm, URA/RA)
- Downhole control line experiences
  - Lines broken in several places and lost in hole
  - Clamps broken off, fished or pushed to bottom

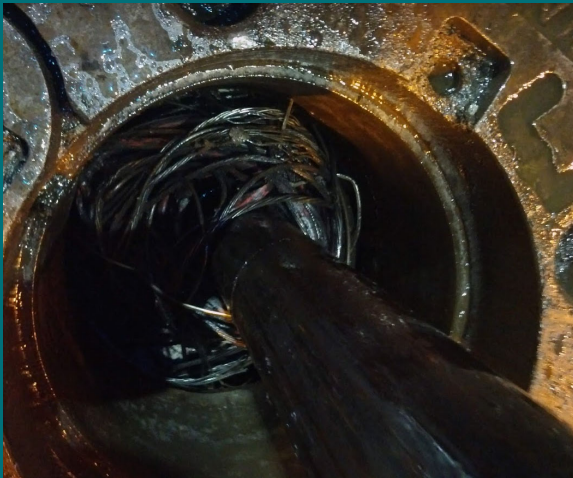
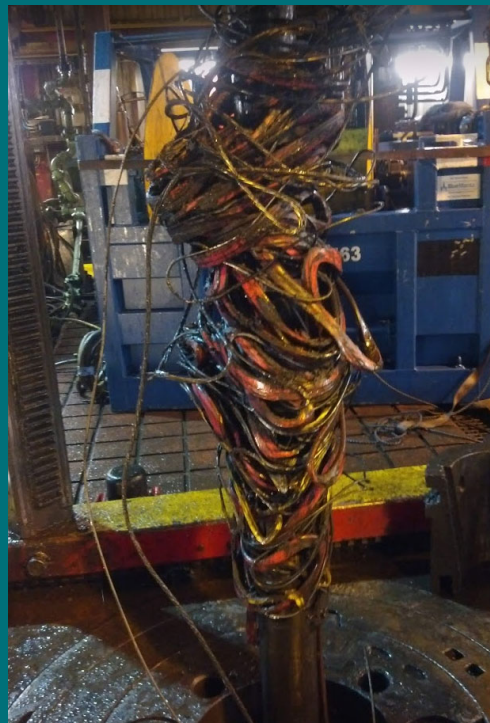
DACS well with 7 control lines and bumper wires  
Control line birds nest pulling tubing

- Use extra drill crew to operate spooling unit
  - Retrieved birds nest on several occasions
- ASV
  - ASV with design flaw
    - Required to cut and pull on DP in several runs

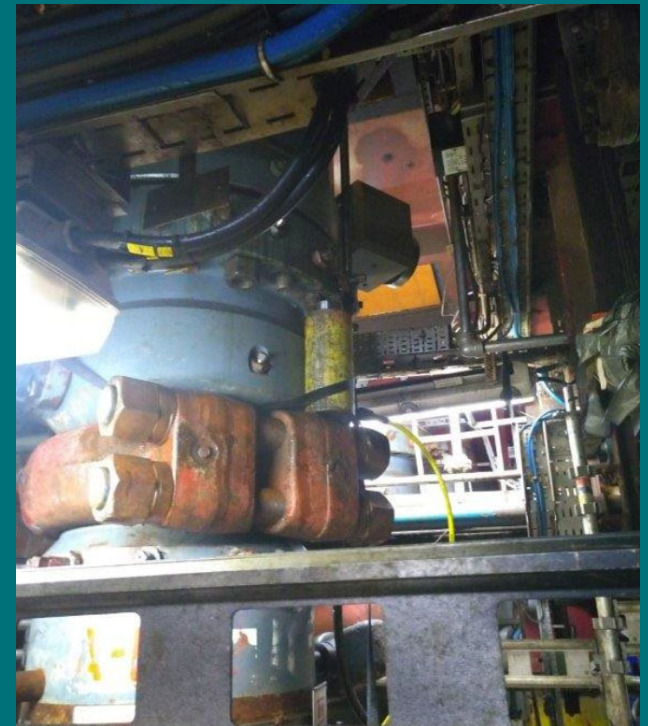
Assisted pulling of C-section  
with hydraulic jacks.

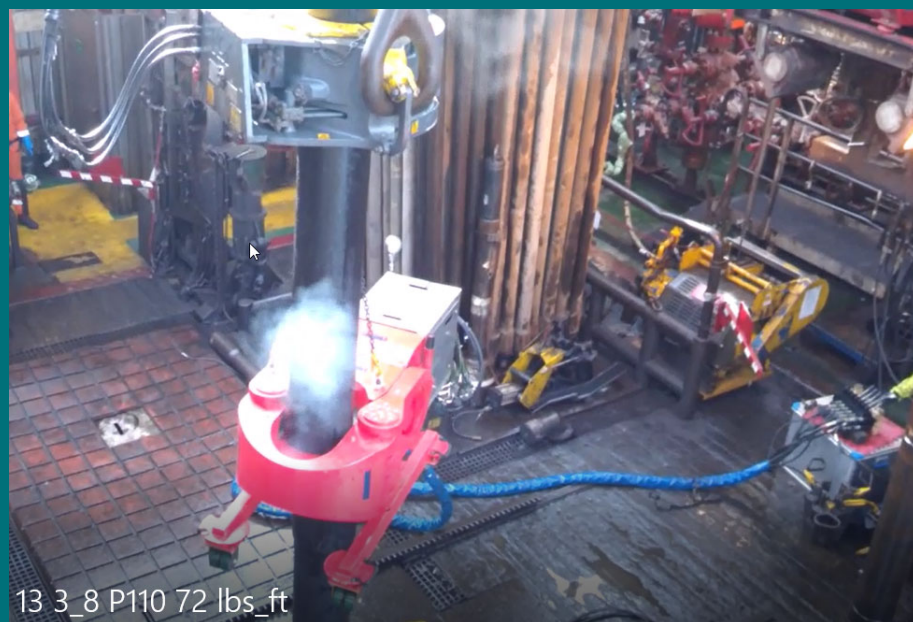
Successful cut of 13 3/8" P-110 # 72 csg

- Fabricated prototype 13 3/8" csg cutter
- Fluid handling
  - Perform operations in SW. Reduced need for mud.
  - Introduced plan for injecting tubing and A-annulus fluid directly into A-11. Reduced risk for gas/musterahm

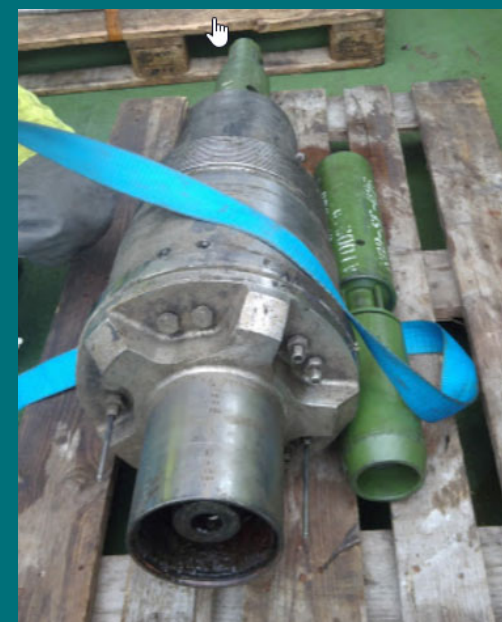
Pulled parted tubing  
Parted during injection below hanger
