**10 YEAR OPERABILITY SURVEY**  
**OF**  
**NORWEGIAN FPSOs**

This report is sponsored by OLF's FPSO network. The primary objective of the network is to gather and transfer lessons learned on Norwegian FPSOs, so that future projects can benefit from the experience gained from earlier projects.

In the period from 1986 to 1999, six FPSOs started operation in the Norwegian sector of the North Sea (Petrojarl1, Varg, Norne, Balder, Jotun and Åsgard). In 2002, a survey was initiated by OLF to assess and record the key project lessons learned on 5 of these projects and this data became the basis for a web accessible database, which has received wide usage throughout the industry. However, most of the lessons learned relate to the project and early start-up phases. The purpose of this survey is to assess the Operating lessons learned over the last 10 years and the extent to which decisions made in the design phase have influenced the overall success of the project.

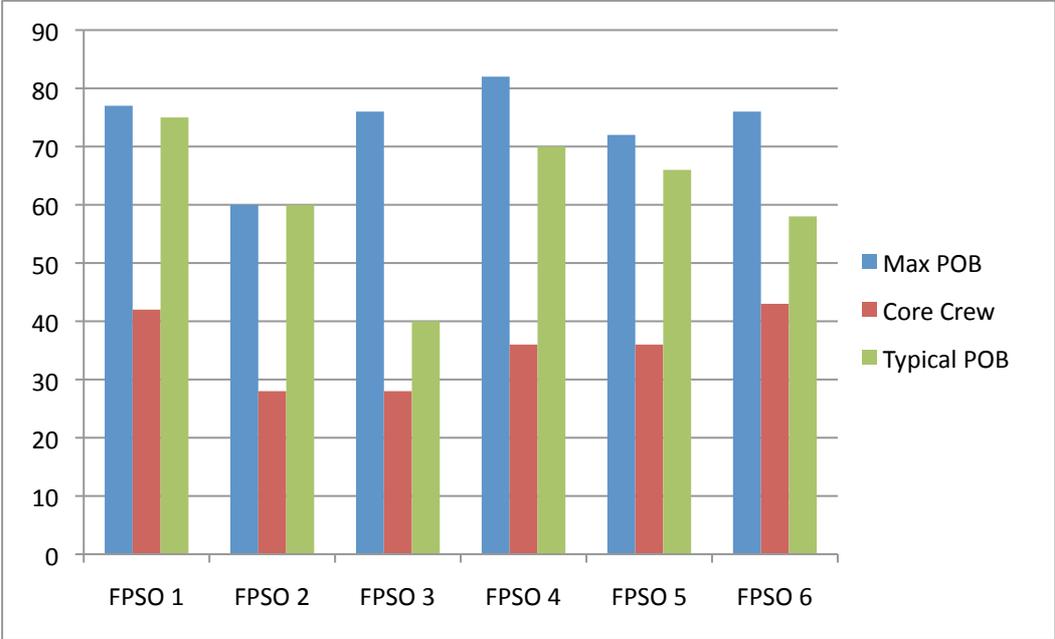
3.3 POB Average chart

provided to the Wellhead platform – which increases the FPSO POBs by 7-10. The figures referred to here are averages. See chart Fig 3.3

**Personnel:** This is driven by offshore crew and onshore staff levels. While some FPSOs have low core crew numbers they also have higher maintenance crews. Five FPSOs have average POBs between 55 and 75 but only one has POBs as low as 40.

As reported in the 2002 Survey ref 1, on 5 of 6 FPSOs the accommodation is considered too small. On several FPSOs, some additional cabins have been added or split where this is possible. These 5 FPSOs are almost always close to full (Fig 3.3). In some cases there are more beds available, but are unused because of the Norwegian union agreement for a single sleeper per cabin. This therefore requires some support staff to work nights to make best use of the cabins. The lack of beds causes problems with maintenance and repairs and subsequent production efficiency, and in one case, makes providing staff for the WHP much more challenging. The only FPSO not suffering POB problems also benefits from low levels of equipment breakdown and required maintenance.
