Norsk olje&gass

"Sharing To Be Better"*

Critical (red) well control incident –
Well displaced to gas after unintentional cycling of deep valves

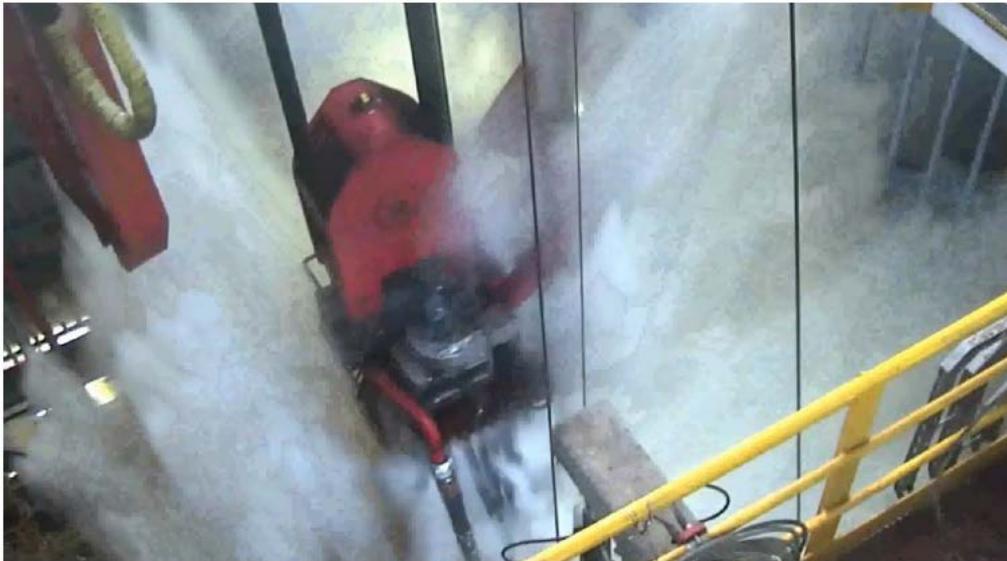
Gas flowed out of well and partly emptied the water filled marine-riser. (picture to the left taken from fingerboard level; the hydraulic slips (2 1/2 ton) and the two bushings (1 ton each) were lifted by the flow and landed several meters away on the drill floor)

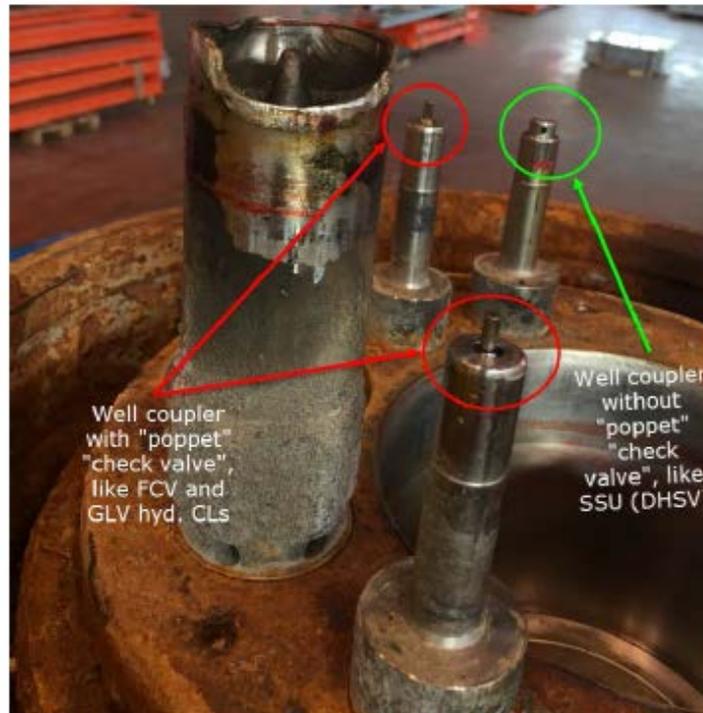
Tubing Hanger for Vertical systems

Poppet valve for FCV/GLV control line

Tubing hanger lock sleeve

Well coupler with "poppet" "check valve", like FCV and GLV hyd. CLs

Well coupler without "poppet" "check valve", like SSU (DHSV)

Check valves for control lines to the GLV and FCV circled in red
Seen from the top of the tubing hanger
