Offshore Platform Well Control Incident

Well incident in 8 1/2" hole section

Kick in 8 1/2" hole section

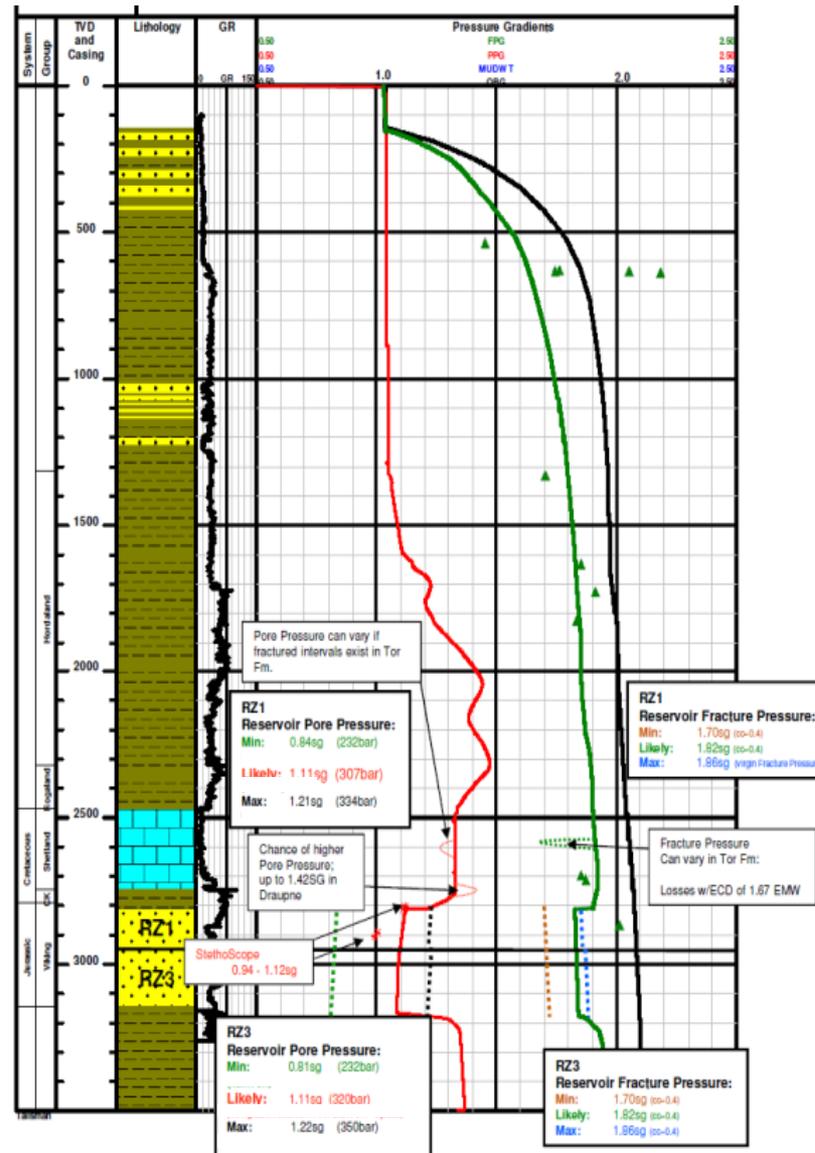
- Made up and ran in hole with 8 1/2" rotary steerable drilling BHA with solid float
- Drilled shoe track and displaced to 1.25 sg Low Solid Oil Based Mud.
- Drilled the RZ1 sand reservoir according to subsurface instructions
- Geosteered and drilled RZ1 sand to stay within the reservoir. Recorded pressure points in RZ1 reservoir to 1.13 sg during drilling: 33 bar static overbalance exerted by the drilling fluid

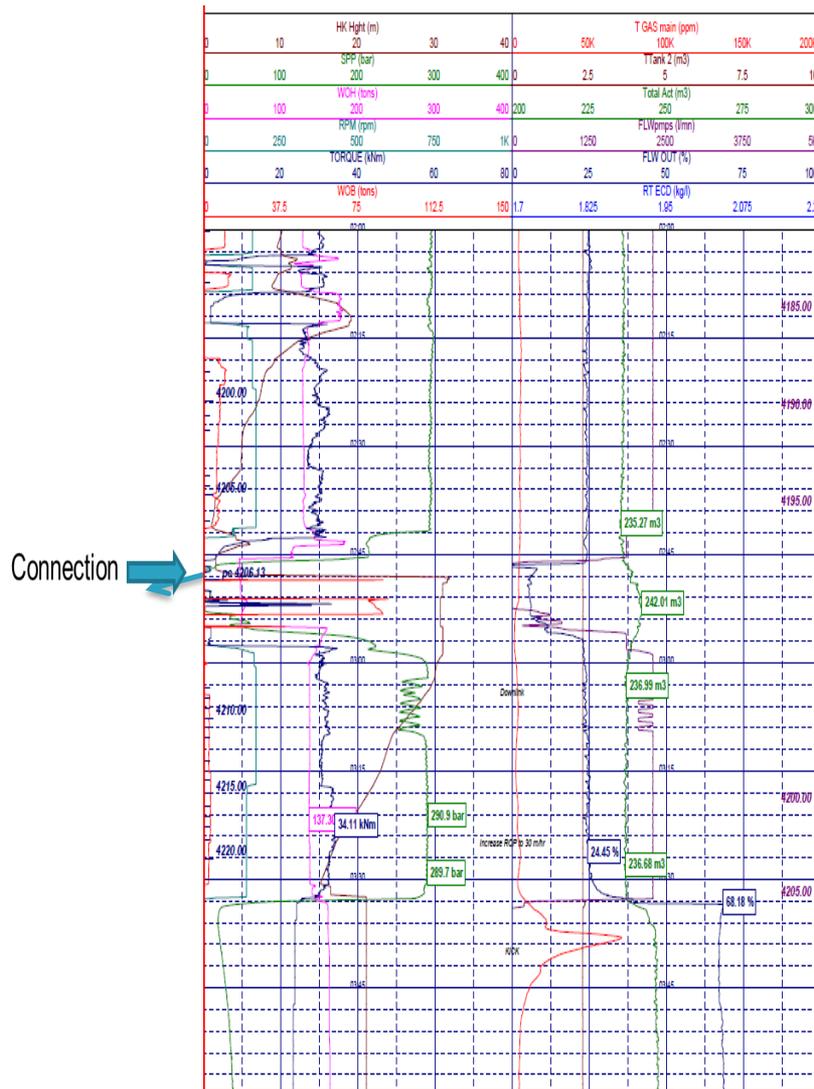
What happened?

- Experienced positive drill break when drilling in to RZ3 reservoir sand
 - Did not carry out a flow check
- Had connection at 4206 m MD
 - took kick, but it was not observed
- Continued drilling 8 ½" hole to 4221 m MD using 1.25 SG Low Solid Oil Based Mud
 - Note that the driller was relieved by the tool pusher after the connection.
- Observed sudden increase in return flow
 - Mudlogging return flow increased from 24 % to 68 %
 - Shut in well on annular
 - Gas in mud increased from 0.5 % to 7 % in
 - Observed pressures increase

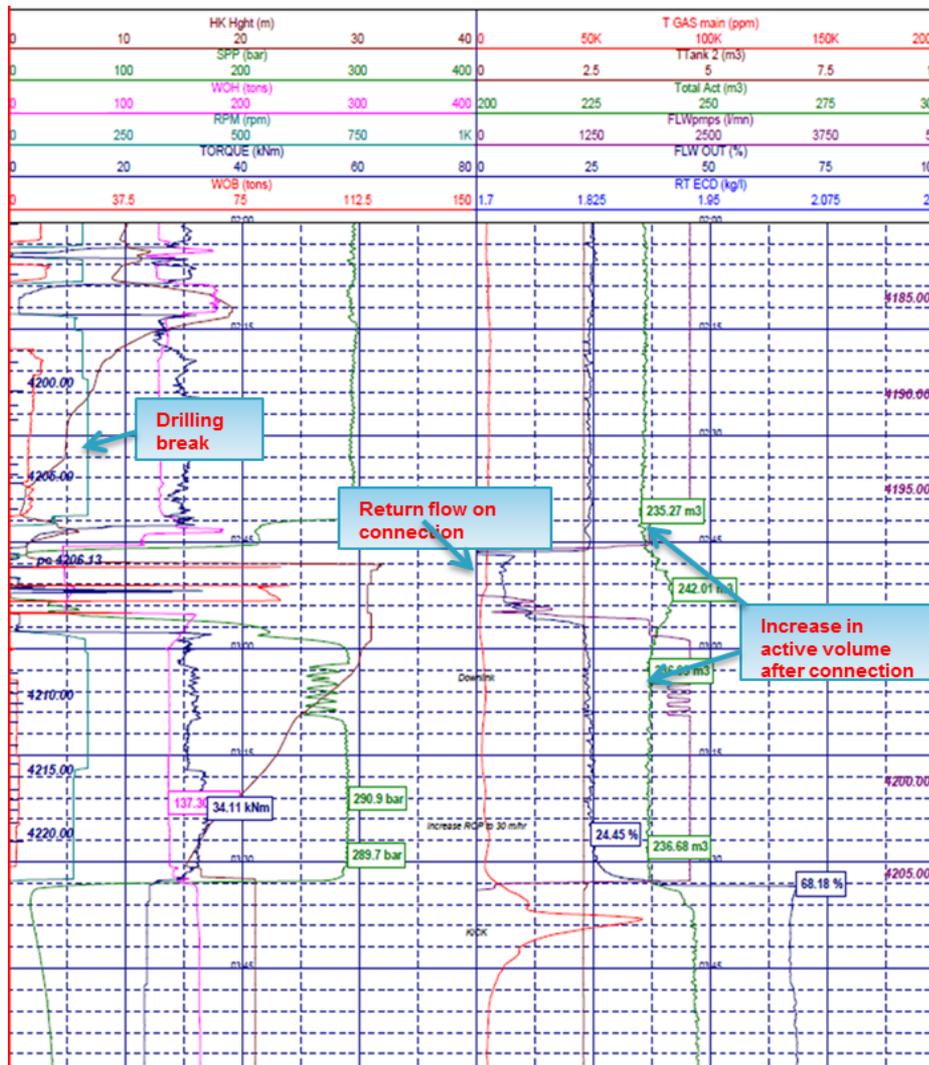
What happened?

- Flow check?
- Alarms?
- Camera picture not changed back from derrick to flow line.
- Data engineers focus?

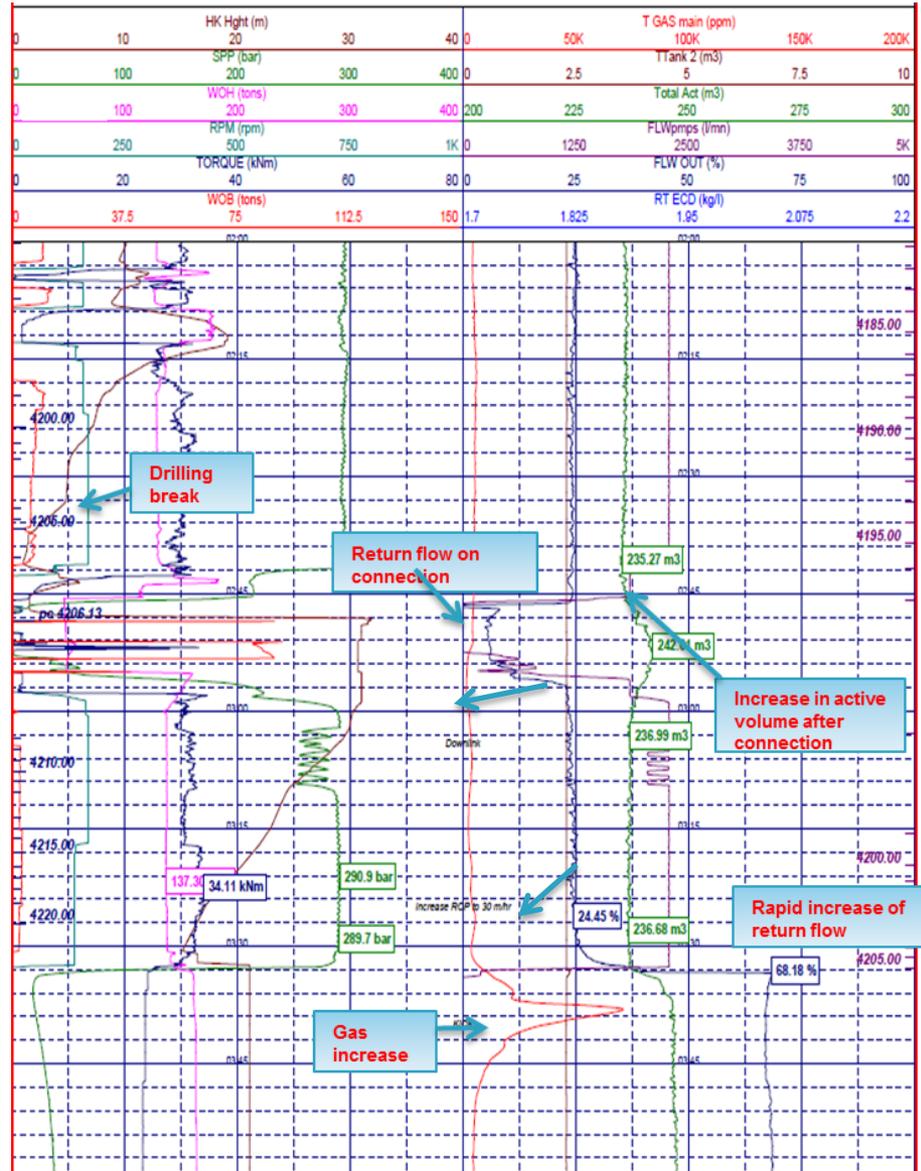
- Rapid return flow due to gas expansion in annulus
- Shut in BOP
- Gas circulated through poor boy
- Kick in 8 1/2" hole
