**INVESTIGATION REPORT OF THE
EXPLOSION INCIDENT OCCURRED ON
11/02/2015 IN THE FPSO CIDADE DE SÃO
MATEUS**

**SUPERINTENDENCE OF
OPERATIONAL SAFETY AND THE
ENVIRONMENT (SSM)**

AUGUST/2015

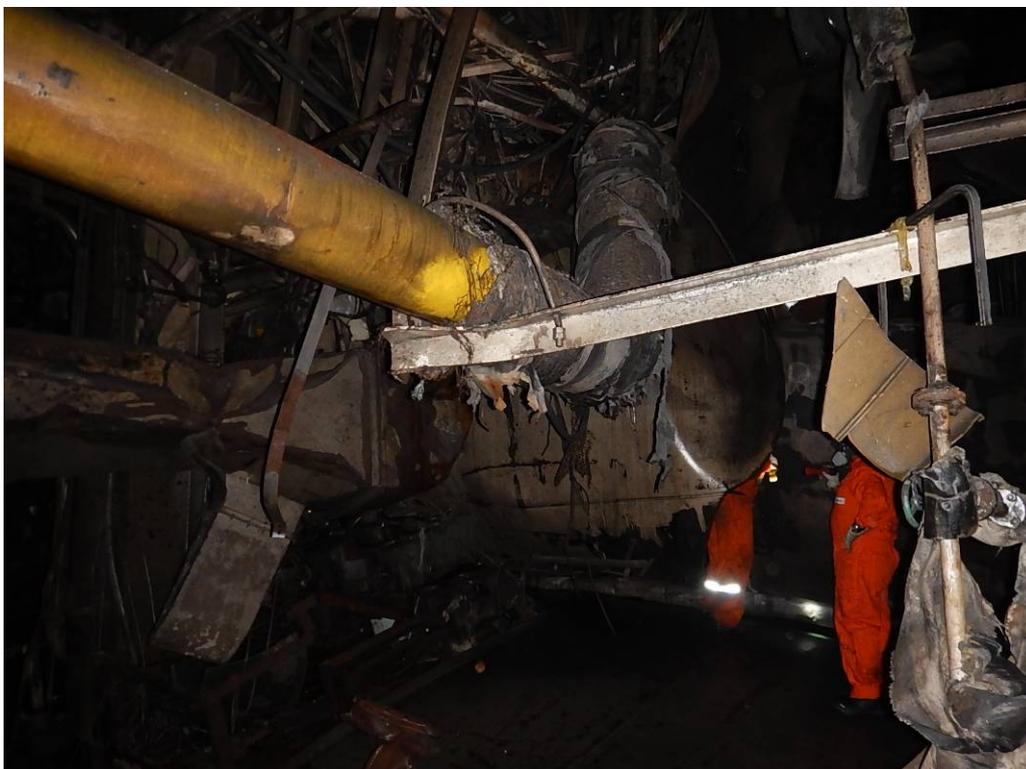
Figure 7 - Area where, due to the explosion, there was communication between the engine room and the pumps room

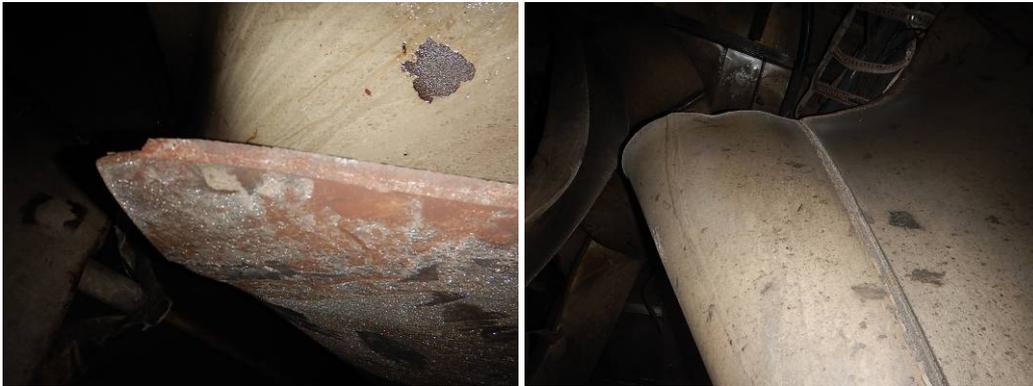
Figure 8 - bulkhead between the pumps room the folded engine room

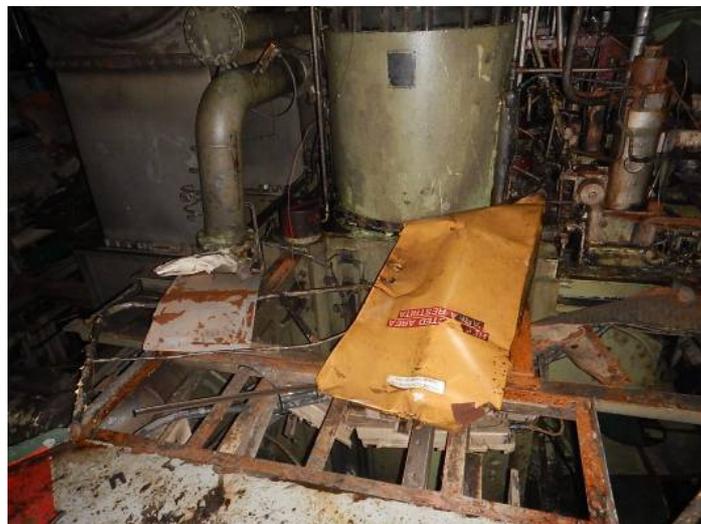
Figure 11 - Port from the other control room entrance to the engine room which was located outside the room

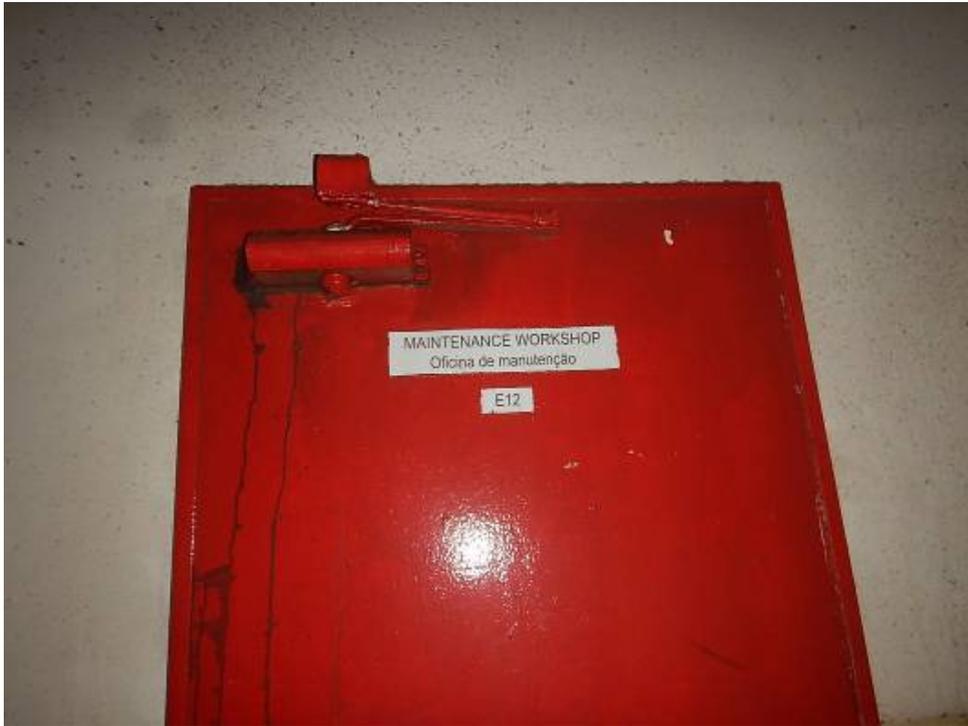
Figure 17 - vapored door maintenance workshop

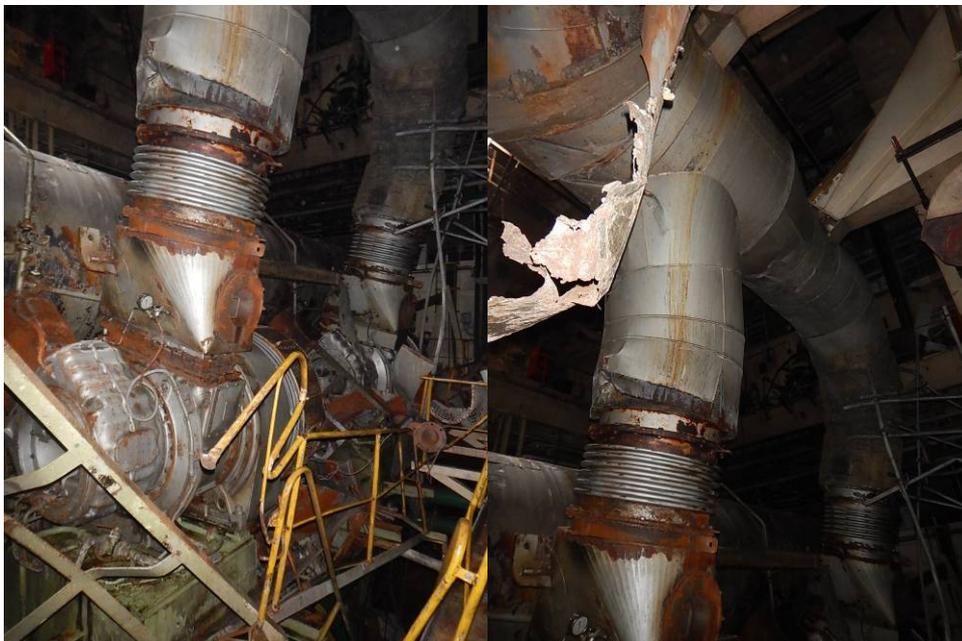
Figure 18 - Other systems destroyed in the engine room

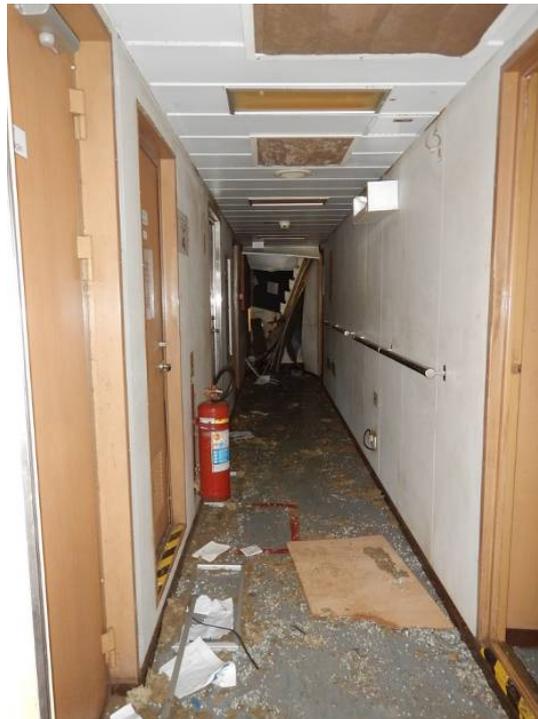
This situation is considered critical, given that the houses should be the safest place the unit, providing for the gathering of people for normal operation and for emergency situations. The houses was where the greatest number of people would be during the emergency, as people focused points against the CCR, ward and temporary refuge (cafeteria). However, the houses proved to be vulnerable to the scene of the accident. Figure 21 shows the state of one of the corridors of the houses after the explosion.

Figure 21 – house ward corridor in level "A" of the unit after the explosion.

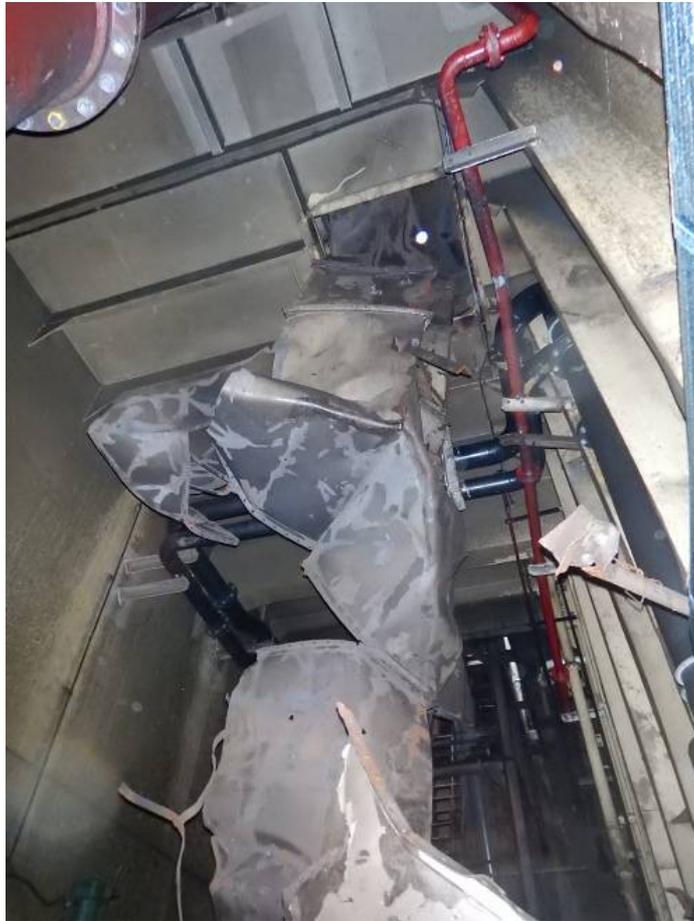
Figure 31 - ventilation ducts hanging

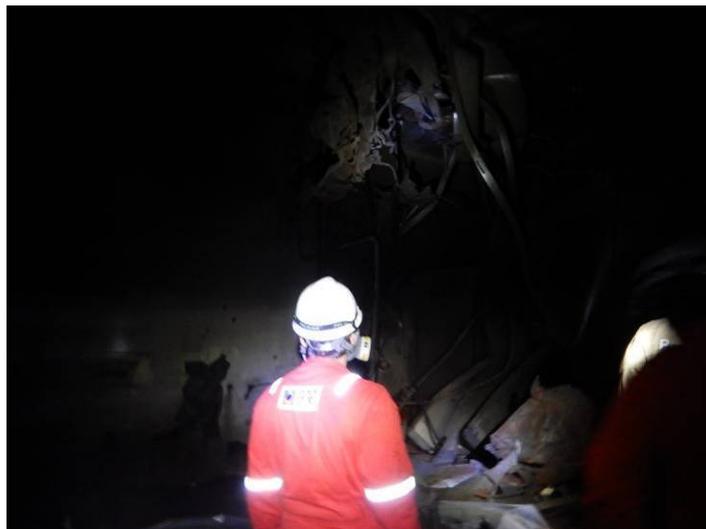
Figure 32 - Low luminosity in the pumps room

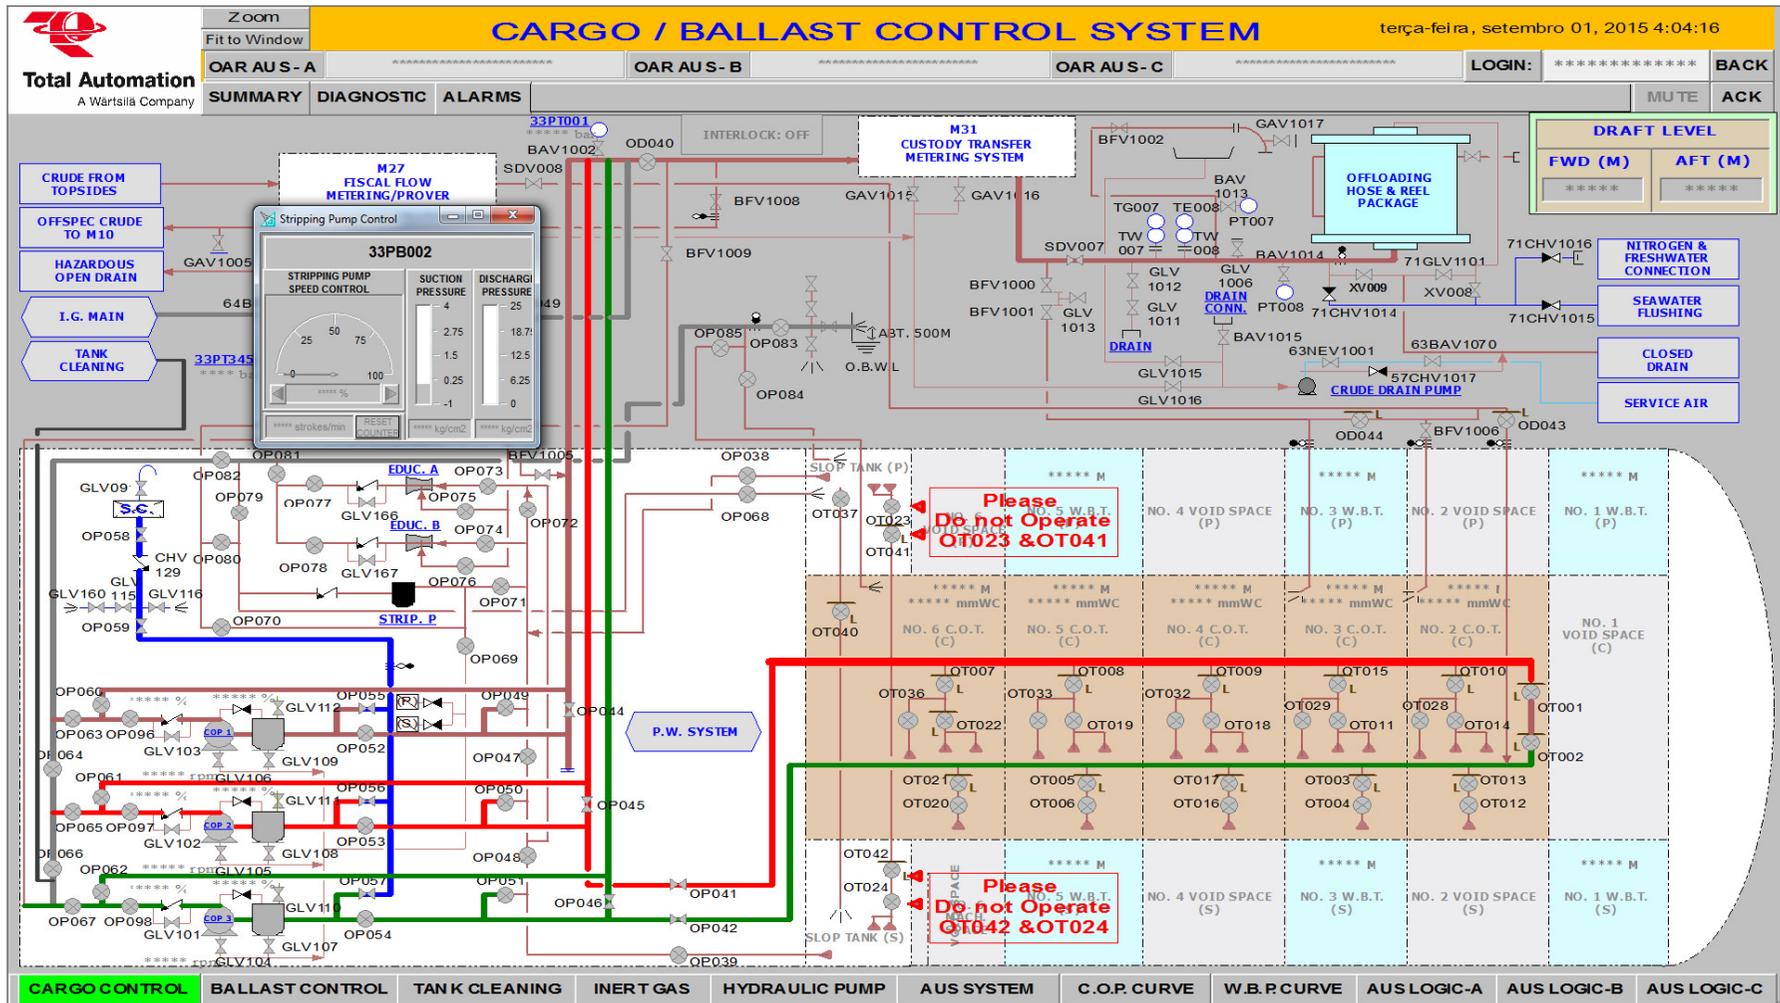
Figure 64 - Screen control and monitoring of stripping pump

The information available in CCRM for marine operator were: (i) the percentage of opening of the vapor control valve, (ii) suction pressure and (iii) the offload pressure. The stripping pump was endowed with by minute strokes counter (strokes / min) as its datasheet, and had the foresight to display the amount of strokes per minute (strokes / min) of the stripping pump on screen HMI, but this information was not available to the marine operator.

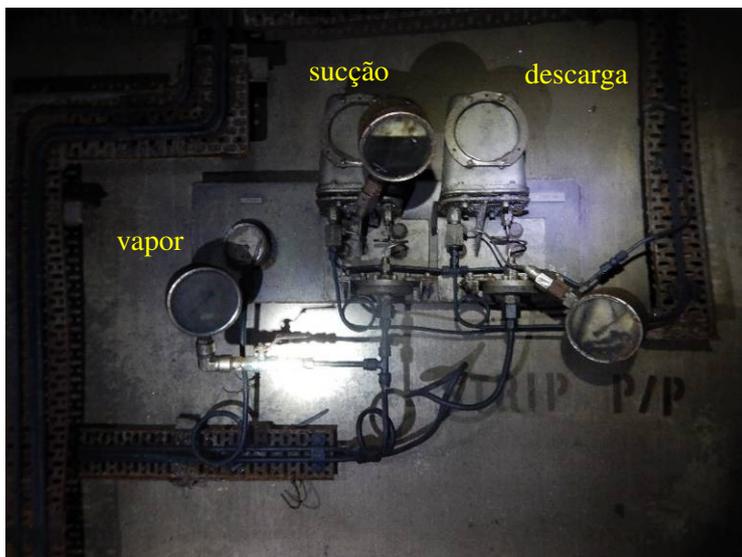
In the meantime the pump operator was in the pumps room, he had the access to the vapor pressure information, pump suction pressure and offload pressure of the pump through local indicators, as shown in Figure 65.

Figure 65 - Pressure Gauges vapor, suction and offload stripping pump at the pumps room

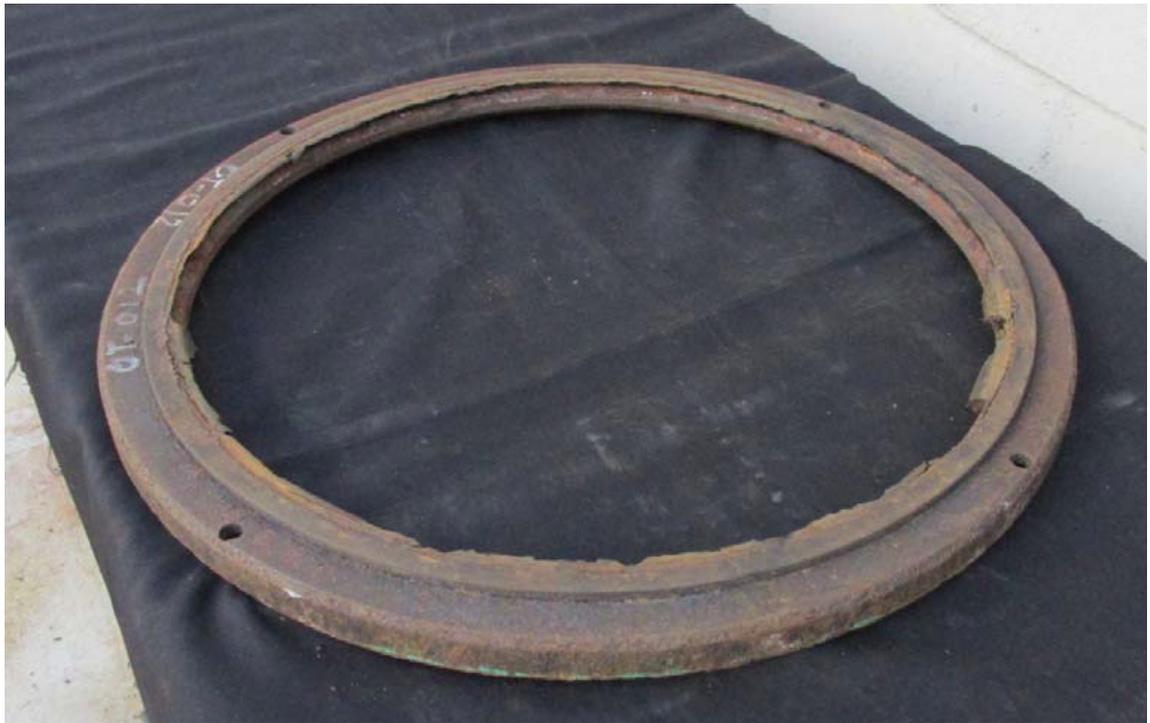
Tests performed in the rubber seal where the failure occurred showed that it was made of elastomeric material with absorption characteristics of a Nitrile Rubber (NBR), being a remarkable

fact from its composition with 9.8% of volatile materials. The report indicates this is a relatively high amount of volatile materials which can be associated with the condensate absorbed by the elastomer.

Figure 71 - Seal assembly Aspect received for analysis - photo contained in the report

The results presented in this report showed that the seal failed due to the presence of longitudinal and transverse cracks caused probably by a chemical attack of the internal fluid to the ring associated with operating voltages, generating the loss of system sealing.

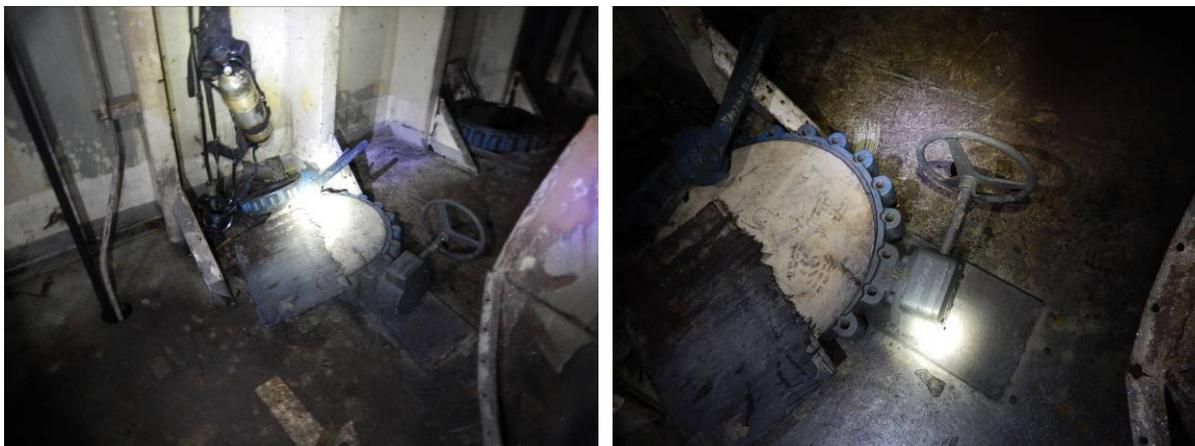
The change request for the installation of five manual valves (on the suction of the slop tanks, and between the port slop tank and 6C tank) was approved by the Operations Manager in February 2012 and evaluated by the engineering sector of BW Offshore. The valves were purchased in 09/10/2012⁸⁴ and embedded in the unit, but by the time of the accident it had not been installed, as shown in Figure 75.

Figure 75 - Manual valves not installed inside the pump house

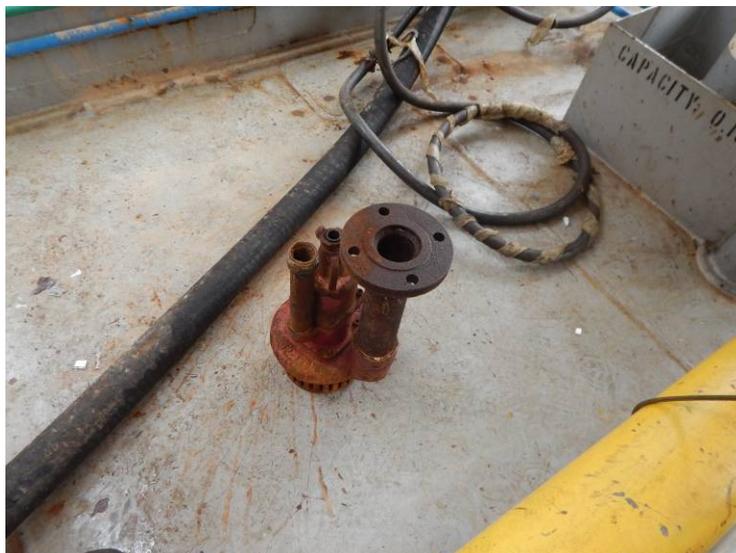
Figure 76 - Submerged pump used for load transfer between tanks during temporary change

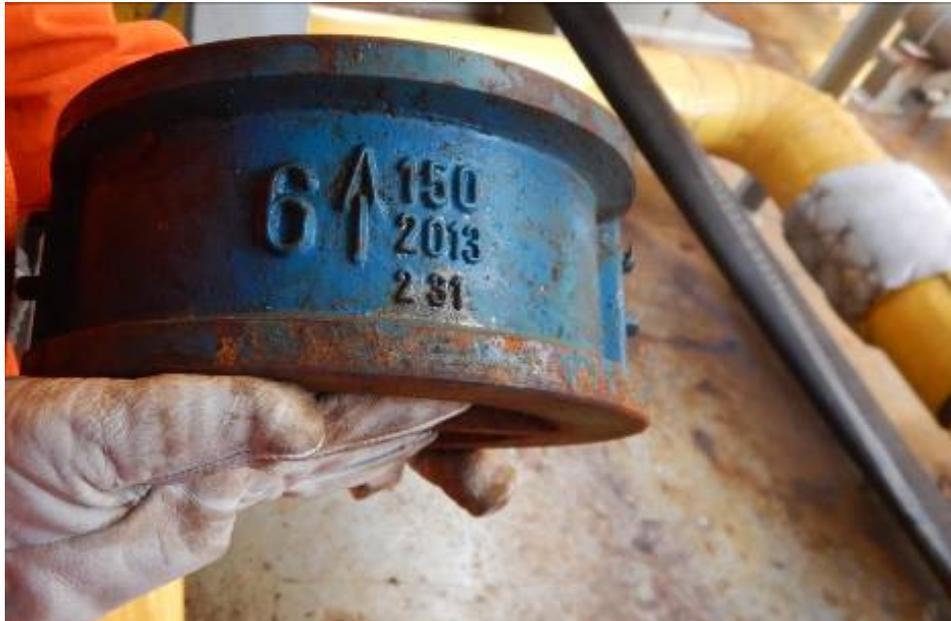
Figure 79 - Check valve which was installed (the line removed after the accident)

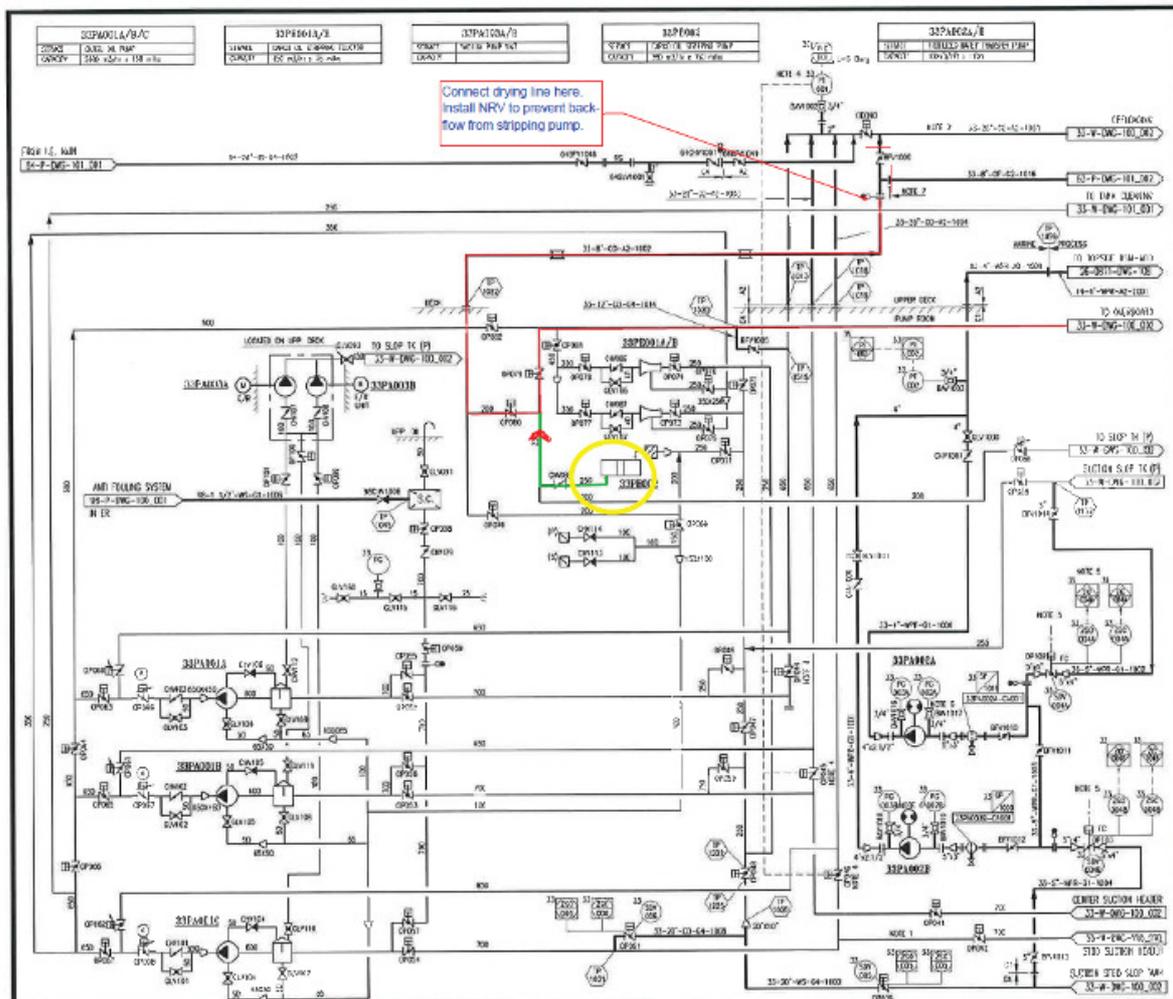
Figure 80 - indication of the need for the check valve installation ⁸⁸

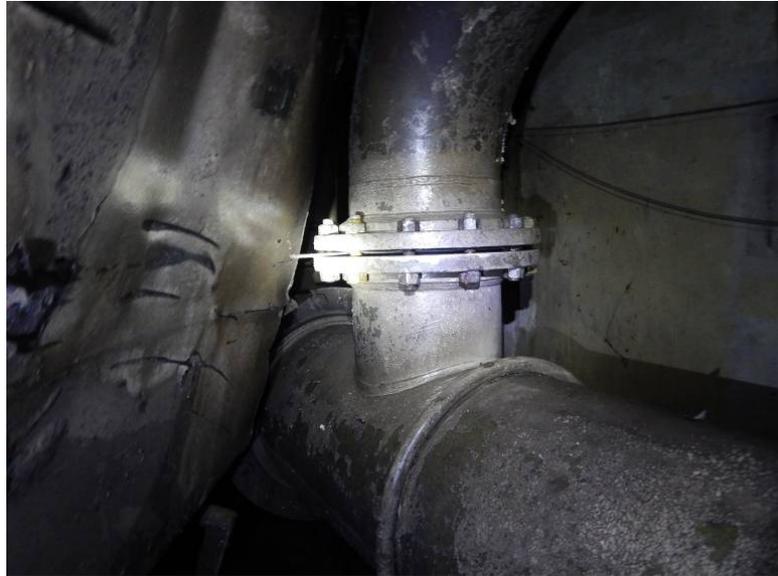
Figure 85 - Spade installed for valve insulation BFV-1005

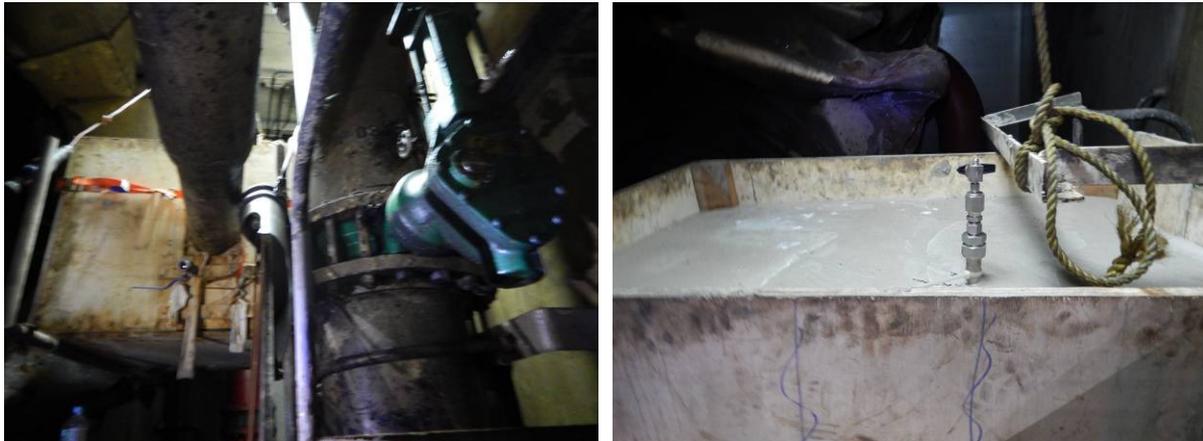
Figure 86 - Insulation (post-accident) in concrete box around the spade to installed valve insulation OP-068

It adds that, although the installation of spades for insulation of OP-068 and BFV1005 valves were registered in the drawing to change management MOC-CSM-091, such insulations were recorded in long-term insulation of control⁹⁴. It is analyzed below in detail as were the controls and the procedures set out guidelines for insulation systems and insulation control long-term FPSO CDSM.

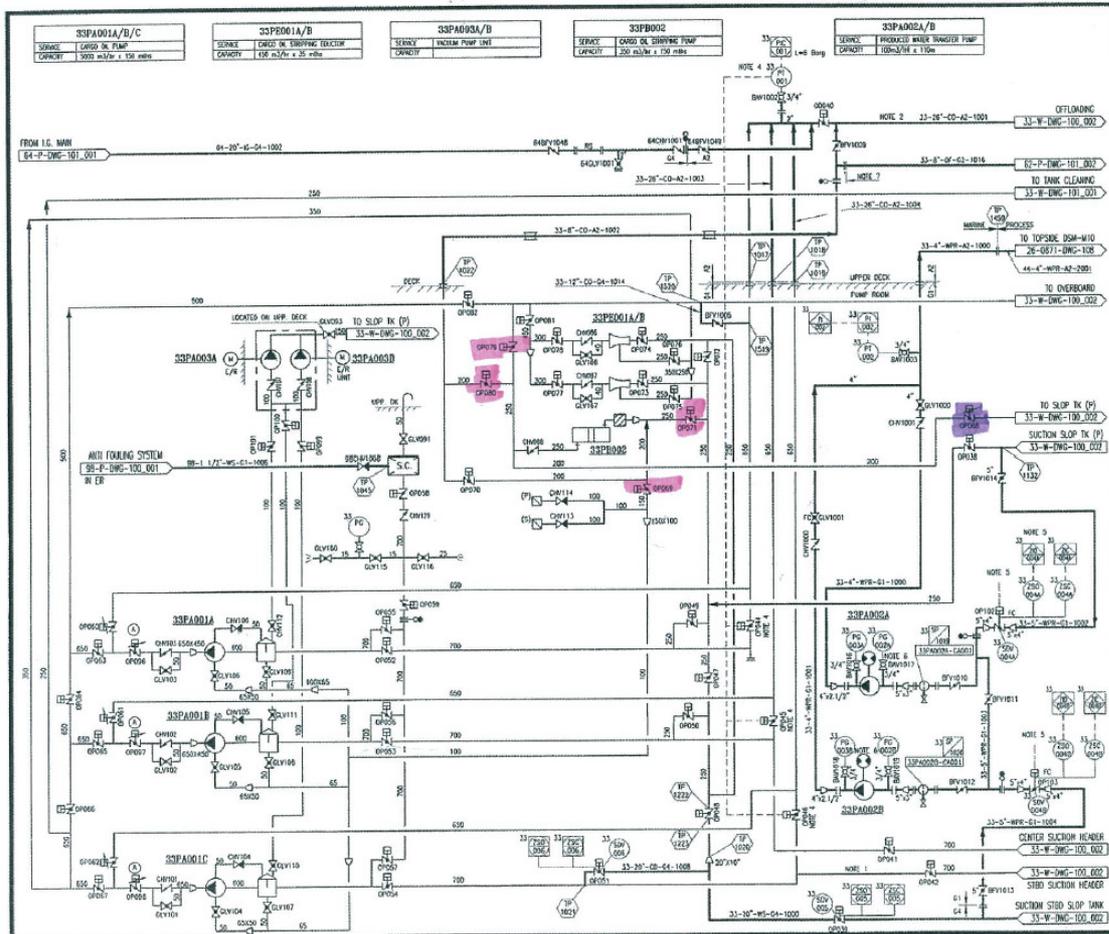
The P&ID¹⁰⁰ accompanying mechanical insulation enhancement certificate contained in said valve, but not the racquet indicated position, upstream or downstream of OP-valve 068, as shown in Figure 87.

Figure 87 - P & ID marked, but without the spade identify the amount of OP-068

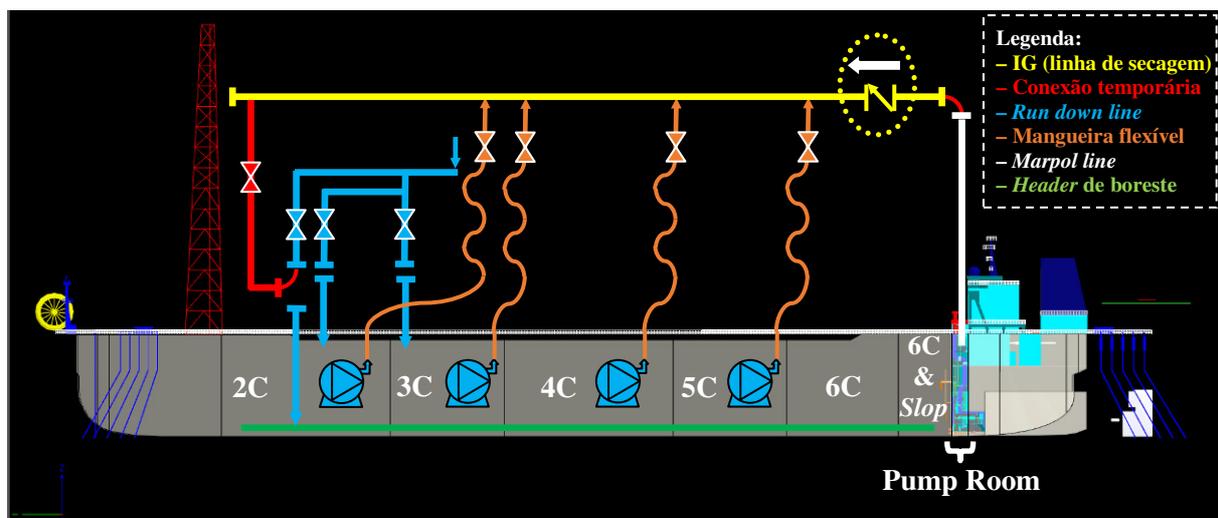
On 13/09/2014 the check valve installed in the inert gas drying line is reversed by setting a modification in relation to the MOC-CSM-091. In the marine superintendent of the Service Form November 2014¹⁰⁵ was recorded 6C that the tank had to be loaded (condensate production), then the line check valve MOC-091 should be inverted. Since then, the flow direction changed to the opposite in inert gas drying line, that is, through the course of the pump house to the cargo tanks, as illustrated in Figure 89. This change to the management MOC-CSM-091 change was made without hazard assessment and the overall impact on activities before implementation. The operation performed on this day was the use of stripping pump for transferring the contents of the slop tank port to 3C tank, by opening the valve in the OD-043 line run down.

Additionally, it was found that, during and after repair of the valves of the tanks 2C to 5C and slop tank port, activities were carried unplanned changes that used in relation to own MOC-CSM-091¹⁰⁶, distorting the originally intended use of the alternative alignment installed.

Figure 89 - Change in the MOC-CSM-091

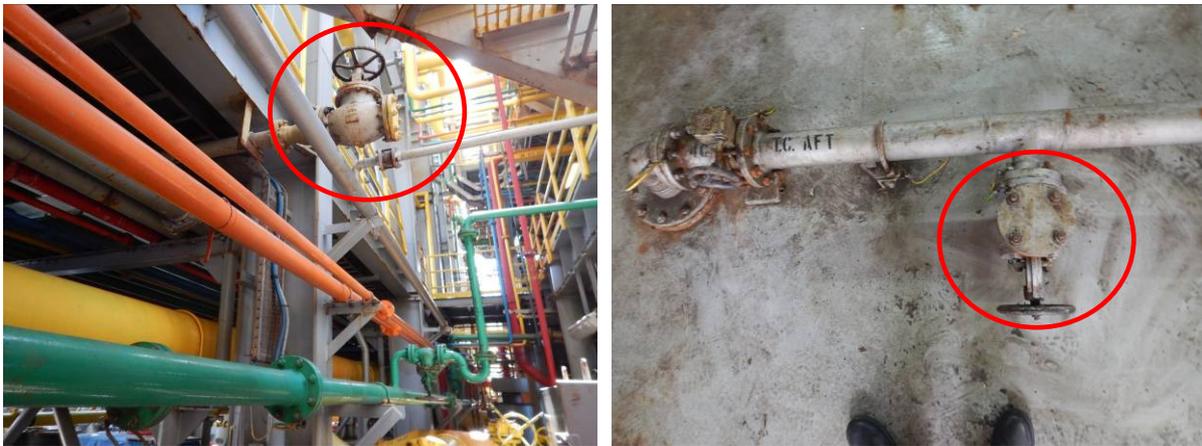
The contents of the port side slop tank was being directed to the tank 4C using the stripping pump and, therefore, it was necessary to use the washing line 4C tank (4C aft COW line). This alignment with COW line with installing insulation to isolate the 4C of other tanks, shown in the following figures, is yet another modification that occurred without prior assessment of the dangers and the overall impact on the activities, i.e., without using the tool change management.

Figure 90 - Flexible hose connection points between closed drain and 4C aft COW line

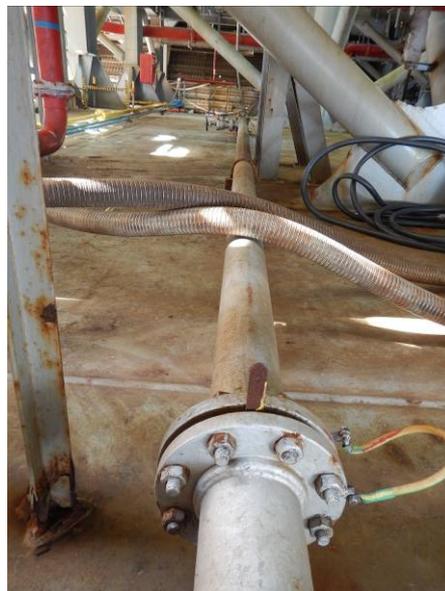
Figure 10 – Insulation of 4C aft COW line

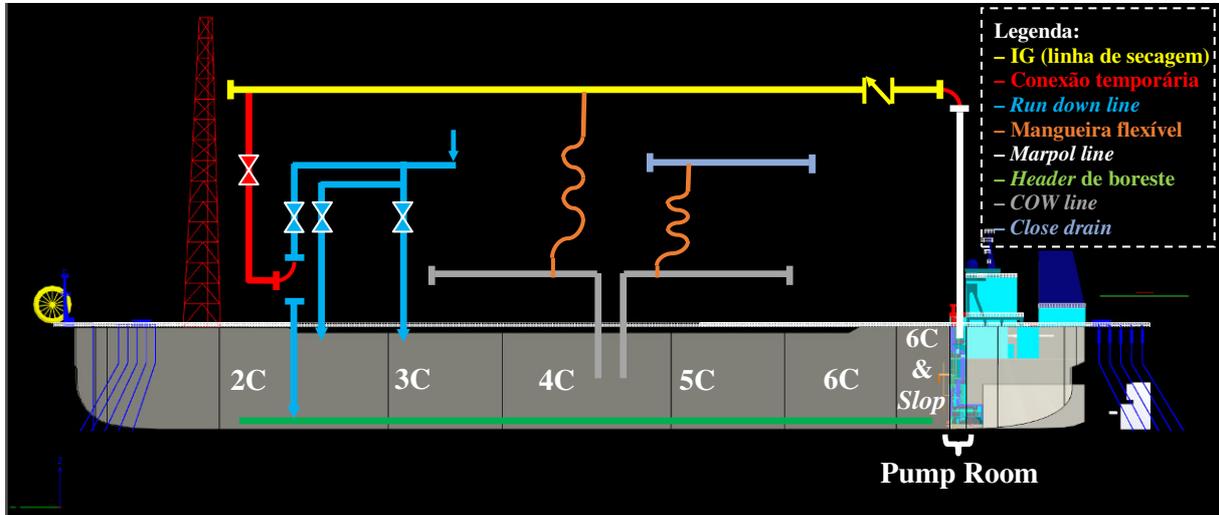
Figure 92 - Wiring diagram of flexible hoses to the tank 4C

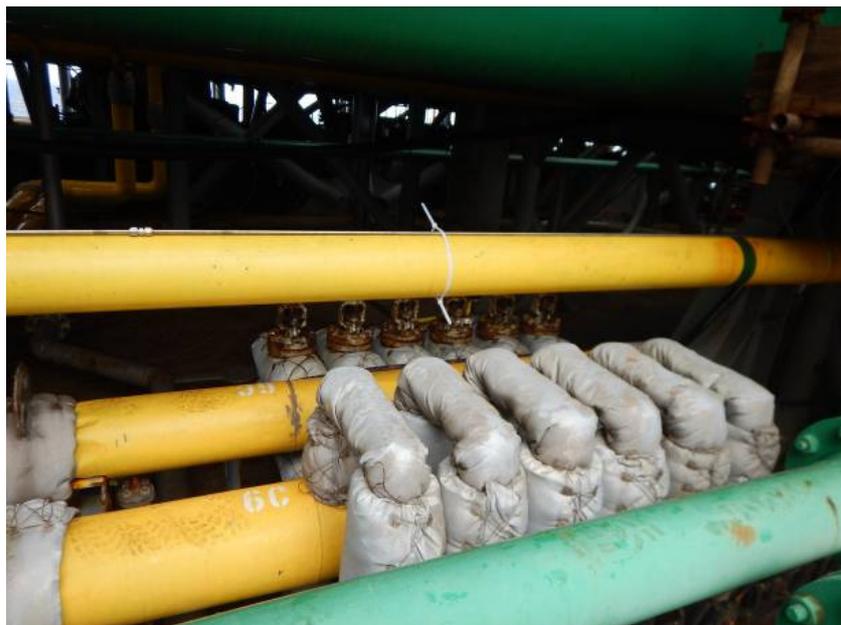
As evidenced in audit, on 17/01/2015 it was started this a try operation 6C empty the tank through the condensate vaporization. This shutdown was initiated due to the difficulty to empty the tank with the stripping pump. The objective was to heat the water inside the tank 6C utilizing the existing steam line within the tank. This operation was evidenced by the early 6C tank temperature record in office log book to book, which so far contained no temperature record in this tank.

Figure 93 - Valves in the upper deck of the heating line (steam) of 6C tank

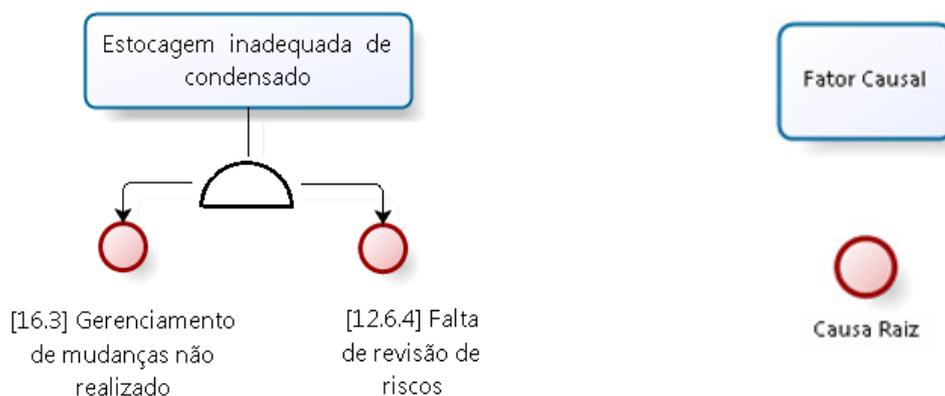
Figure 98 - Causal Factor # 1: Inadequate Condensate Storage

Despite this, there is another opportunity to correct such deviation, since there was a requirement that risks were reviewed at the beginning of the production phase. This review could not be evidenced during this investigation, since the safety studies issued at the design stage were still in force on the date of the accident, also considering the initial specification of not stock condensed without being mixed with oil.

Hence, it is found that, due to the lack of a change management process before the unit operation and lack of risk review at the beginning of unit operation as described in the following sub-items, was stocking inadequate condensate on the platform..

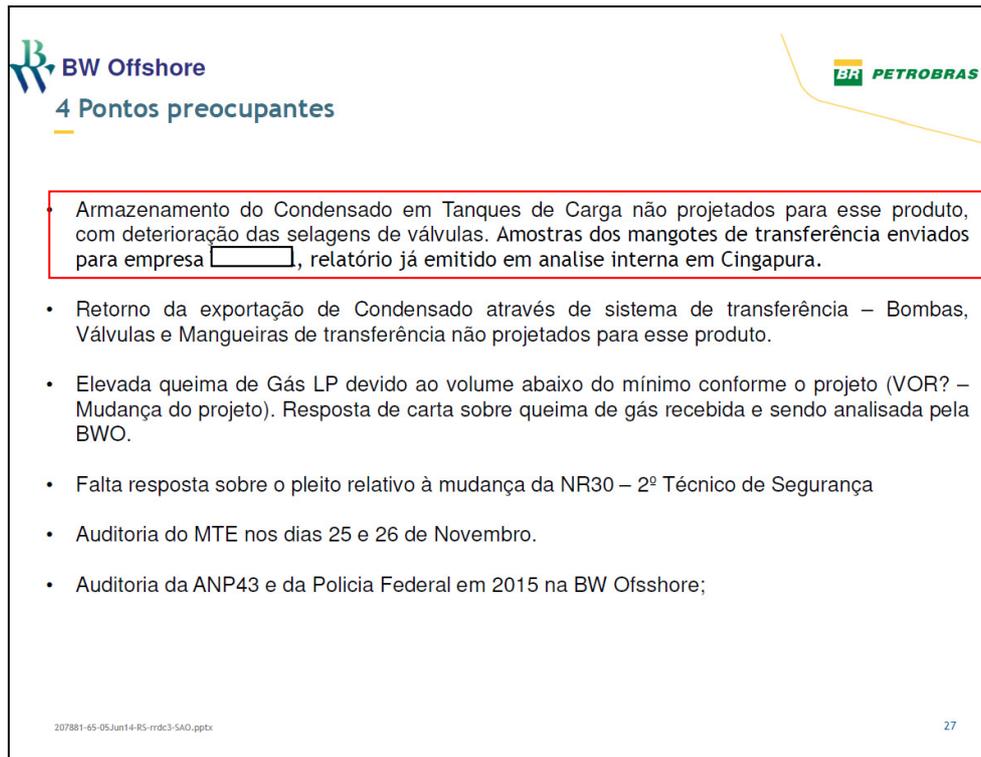
Figure 100 - BW indication Petrobras that the condensate storage in the FPSO CDSM was done improperly

It was evident during the investigation that the improper storage of condensate was known both as BW Offshore Petrobras, as it indicates presentation by BW Petrobras Operational Meeting Monitoring (ROA) of 01.26.2015. Figure 100 shows the slide with pain points indicated by BW.

- Armazenamento do Condensado em Tanques de Carga não projetados para esse produto, com deterioração das selagens de válvulas. Amostras dos mangotes de transferência enviados para empresa [redacted], relatório já emitido em análise interna em Cingapura.
- Retorno da exportação de Condensado através de sistema de transferência – Bombas, Válvulas e Mangueiras de transferência não projetados para esse produto.
- Elevada queima de Gás LP devido ao volume abaixo do mínimo conforme o projeto (VOR? – Mudança do projeto). Resposta de carta sobre queima de gás recebida e sendo analisada pela BWO.
- Falta resposta sobre o pleito relativo à mudança da NR30 – 2º Técnico de Segurança
- Auditoria do MTE nos dias 25 e 26 de Novembro.
- Auditoria da ANP43 e da Polícia Federal em 2015 na BW Ofsshore;

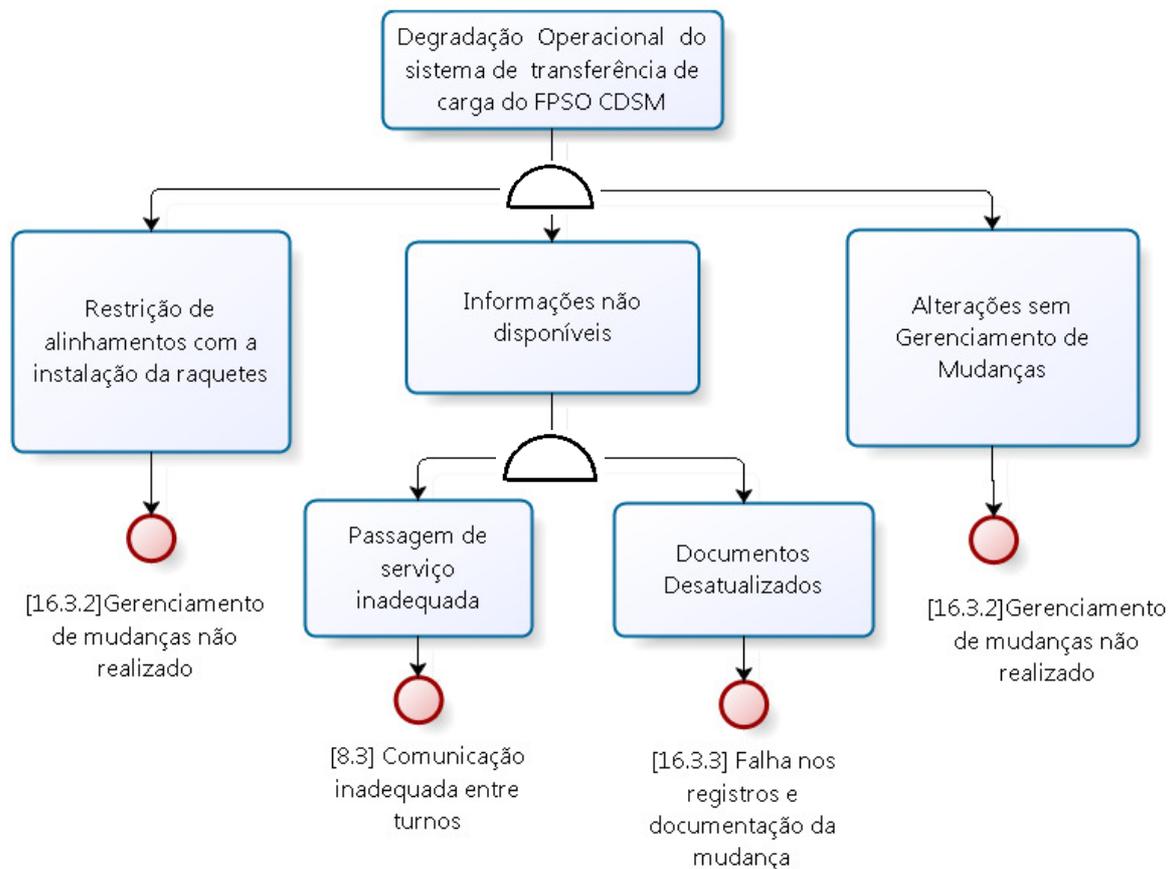
Figure 104 - Causal Factor # 2: storage system degradation FPSO CDSM

In this way, by storing different fluid other than that for which it was designed without there being previous change management to identify and mitigate the impacts, the FPSO storage system was to be degraded over time in relation to its design condition.

The degraded state of the charge transfer system restricted common transfer operations between tanks and drainage tanks, so that means were used that introduced risk and some unfit for operations as inadequate spades and the use of a pipe for condensate which had been designed to conduct inert gas.

The actions taken to try to correct the degradation of cargo transfer system without the machine operator was paralyzed were sometimes made without risk analysis or any evaluation of hazards and the global impact on activities before the change implementation. In addition, some of the changes to the project were not adequately documented and relevant information for operating the system have not been reported in the service passage. These factors contributed to the accident and their causal factors are described below.

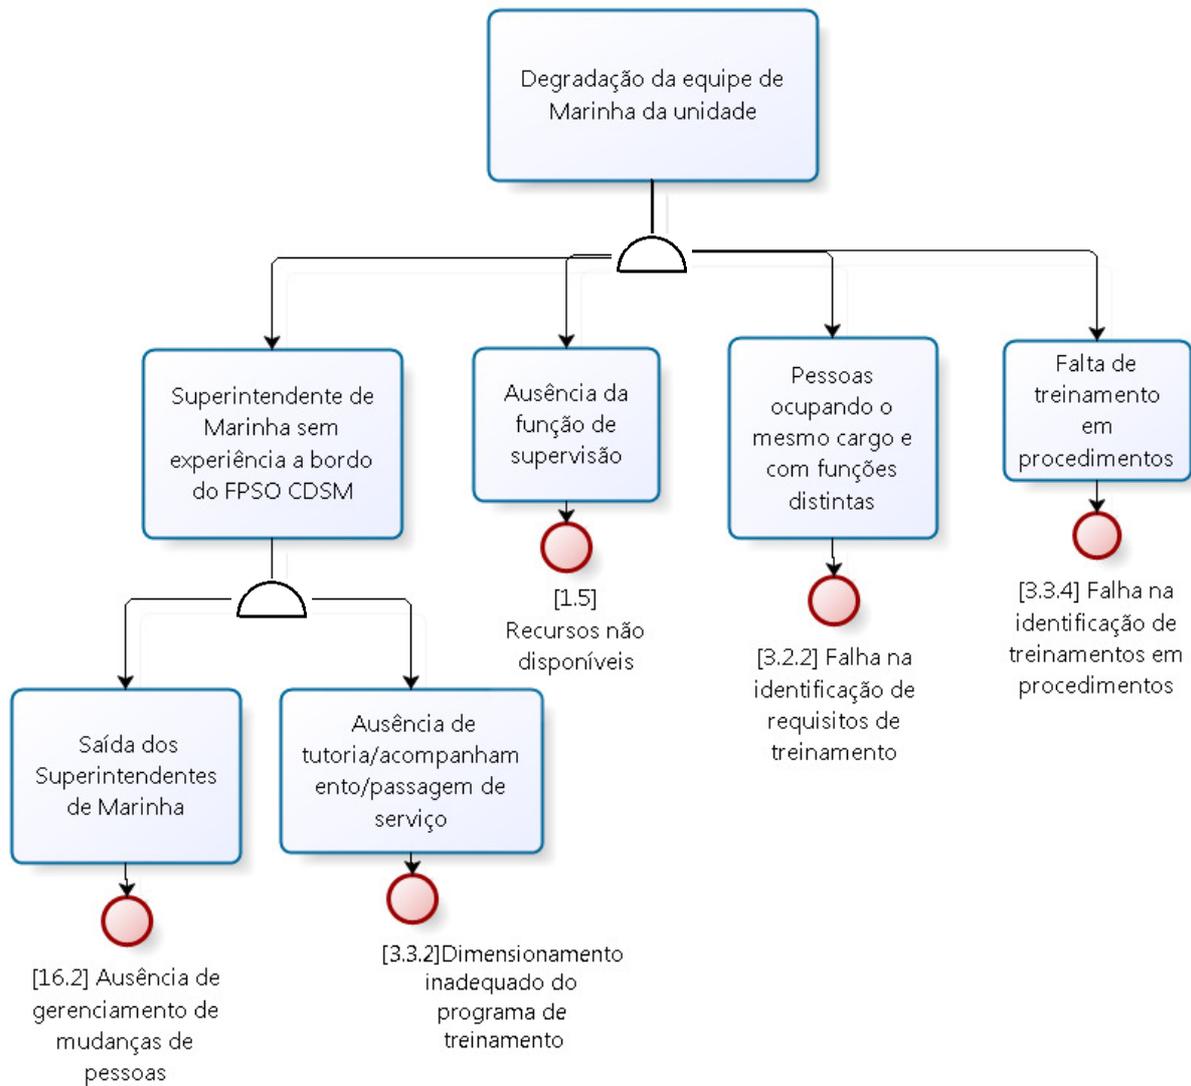
Figure 106 - Causal Factor 3: Marine team degradation of FPSO CDSM

The moment degraded systems are operated by a degraded staff, without proper management of people, there is increased probability of failure. Thus, the accumulation of functions, the loss of knowledge about the current system status, lack of updated procedures and training existing mechanisms, the overload caused by systemic problems and failure in training contributed to the occurrence of contention loss.

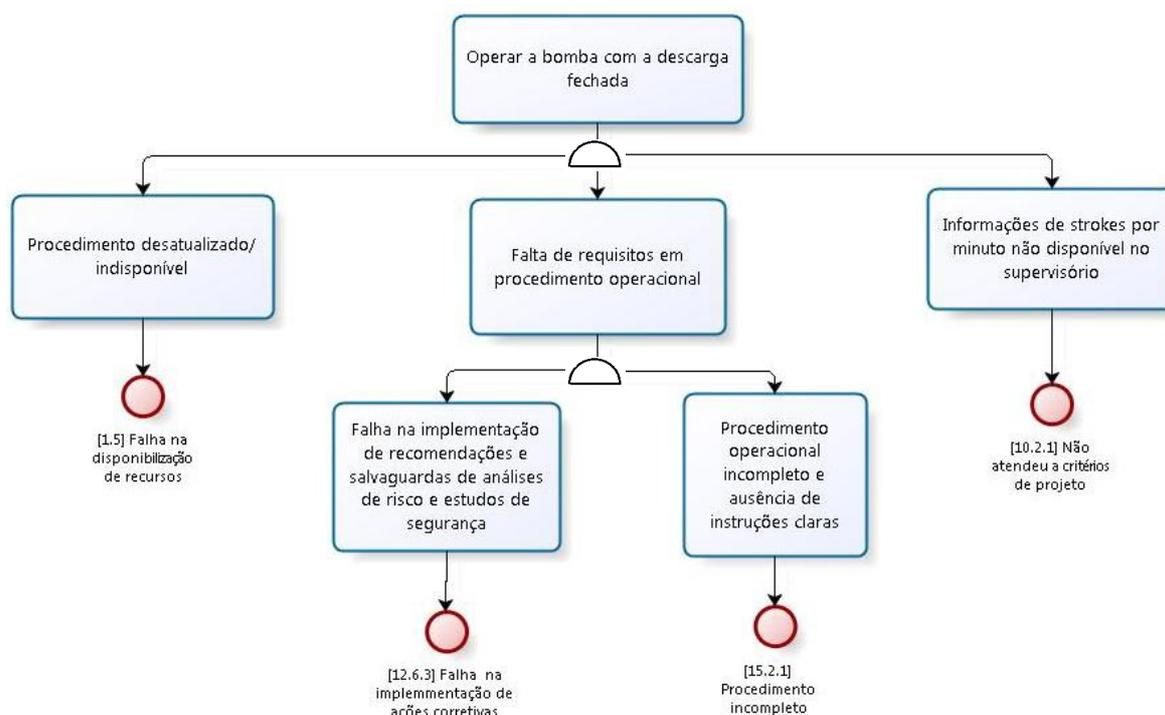
Figure 12 – Causal Factor n° 4: Operating the stripping pump with the offload sealed

There are differences in the testimonies of those who in fact, are the marine operator or marine superintendent, attended the maneuver valves which shut the pump offload. However, when evaluating system operation data, it was found the pump operation with closed offload occurred in other situations days preceding the accident.

Such associated facts led to the situation where it is allowed to operate a reciprocating pump with its offload lines closed, a fact crucial to the accident. This causal factor and their causes, which are described below, are indicated in Figure 111.

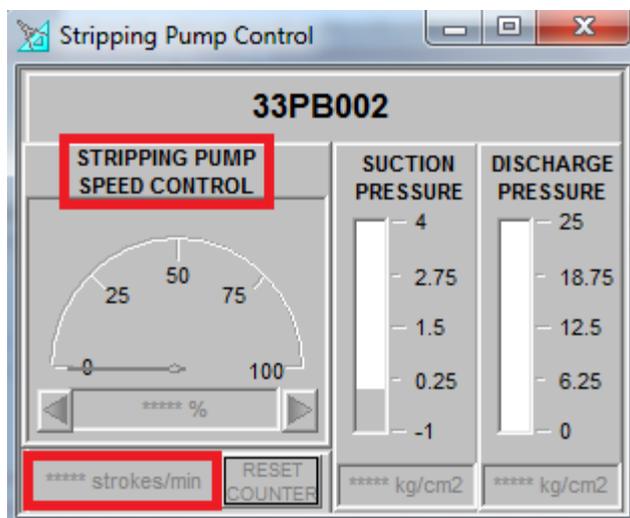
Figure 119 - supervisory system of the window where stated field to pump reading speed in strokes / minute

The strokes counter was not available to the marine operator since the commissioning of the unit, as (i) information provided by the plant operator¹⁷⁸, (ii) audit evidence and (iii) change management on incomplete commissioning of the charging system and ballast control system and (iv) evidence obtained through hearings.
