**INVESTIGATION REPORT OF THE
EXPLOSION INCIDENT OCCURRED ON
11/02/2015 IN THE FPSO CIDADE DE SÃO
MATEUS**

**SUPERINTENDENCE OF
OPERATIONAL SAFETY AND THE
ENVIRONMENT (SSM)**

AUGUST/2015

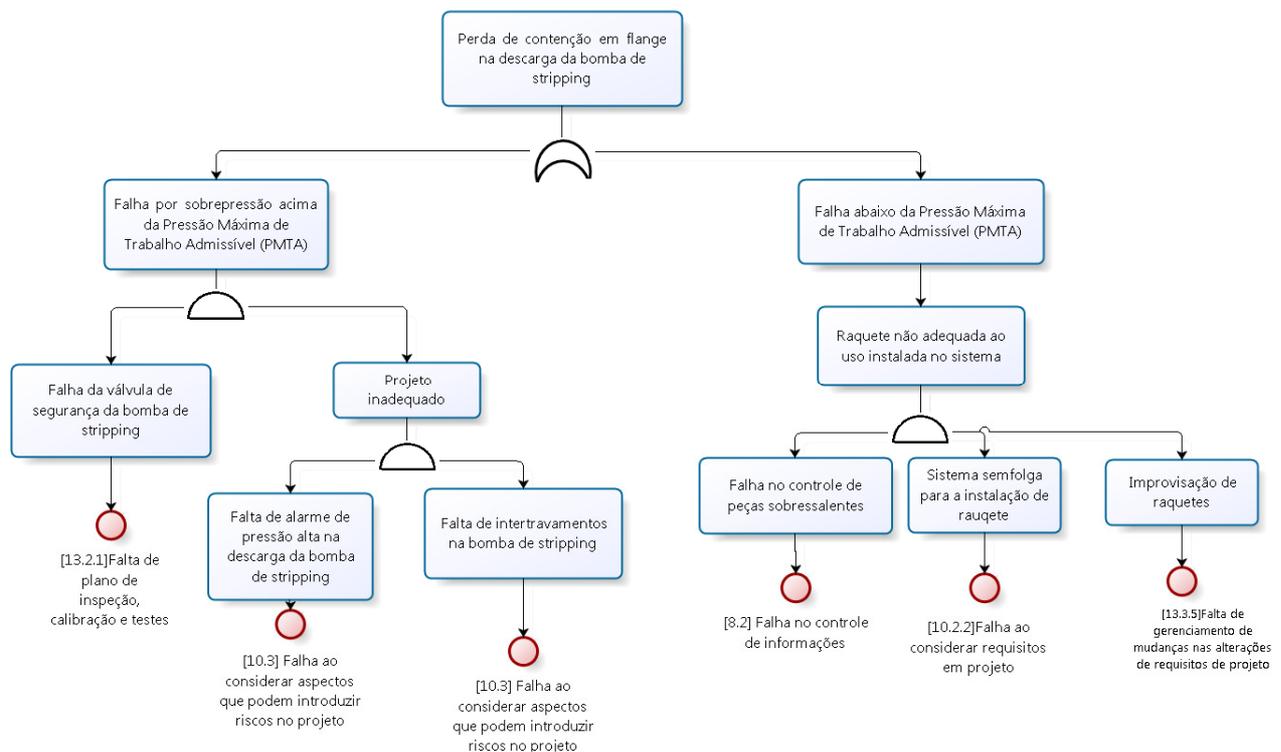
Figure 120 - causal factor 5: primary containment loss condensed material

Above the MAWP, considers the absence of PSV calibration routine (critical system) and no alarms and interlocks as possible causes. Below the MAWP, it was found that the unavailability of type JIS spades (Japanese standard), the lack of space (allowance) for the installation of pressure class spades appropriate to the system, the lack of spades installation control procedures and improvisation spades are possible causes. These causes are detailed as below.

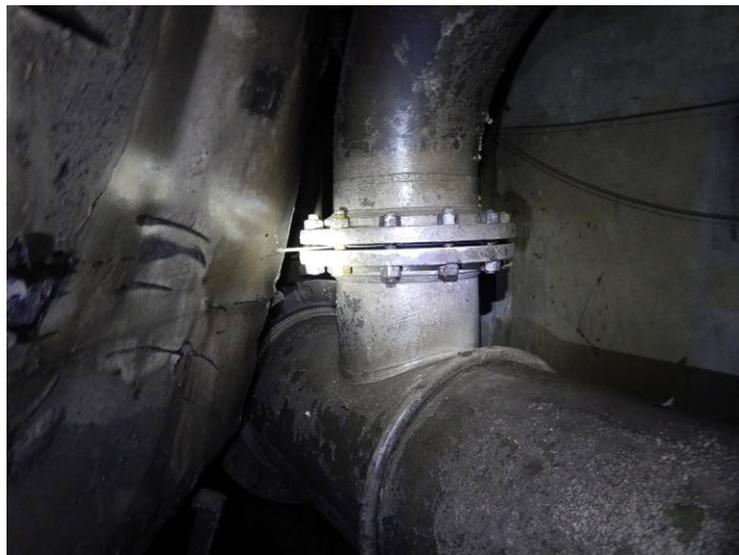
The Figure 123 shows an example spade installed in-line load transfer system. You can see that its thickness is notably much lower than the flanges, showing that it is probably spade not specified for the line pressure class.

Figure 123 - Example of installed spade Online load transfer system

Failure to apply for the pump house the same engineering standards used for the process plant for the conversion project prevented the installation of proper spade, contributing to the insertion in line with a permissible pressure element probably below the MAWP system. Such failure is considered one of the root causes Causal Factor "primary containment loss condensed material" and contravenes the provisions of section 10.2.2 of SGSO.

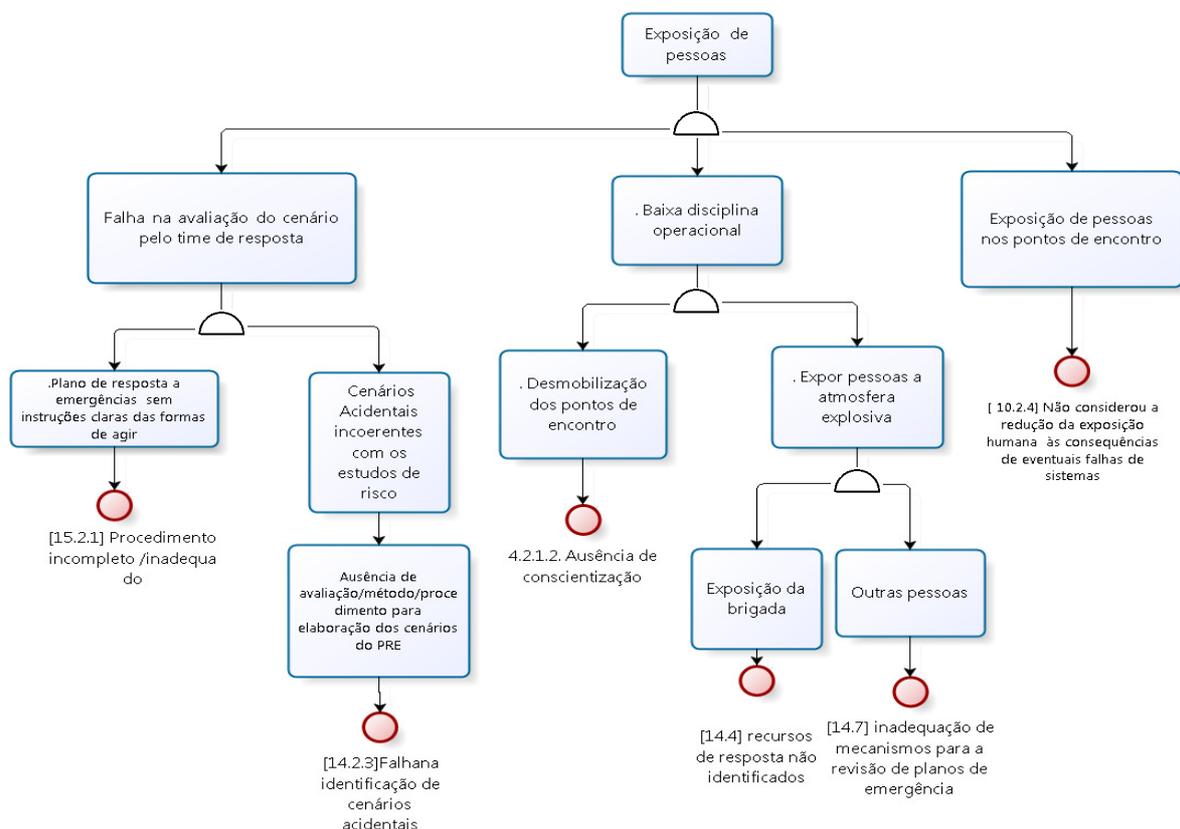
Figure 126 - Causal Factor 6: Exposure to Personnel

Another cause of the danger people from exposure due to the setting of the meeting points for people with response function to the emergency, made without being considered safety studies of FPSO CDSM therefore without proper assessment of the effects of a possible explosion scenario in the pump house (or staggering) about the points against. It is noteworthy that one person was killed and others were injured as they stood in their respective meeting points.

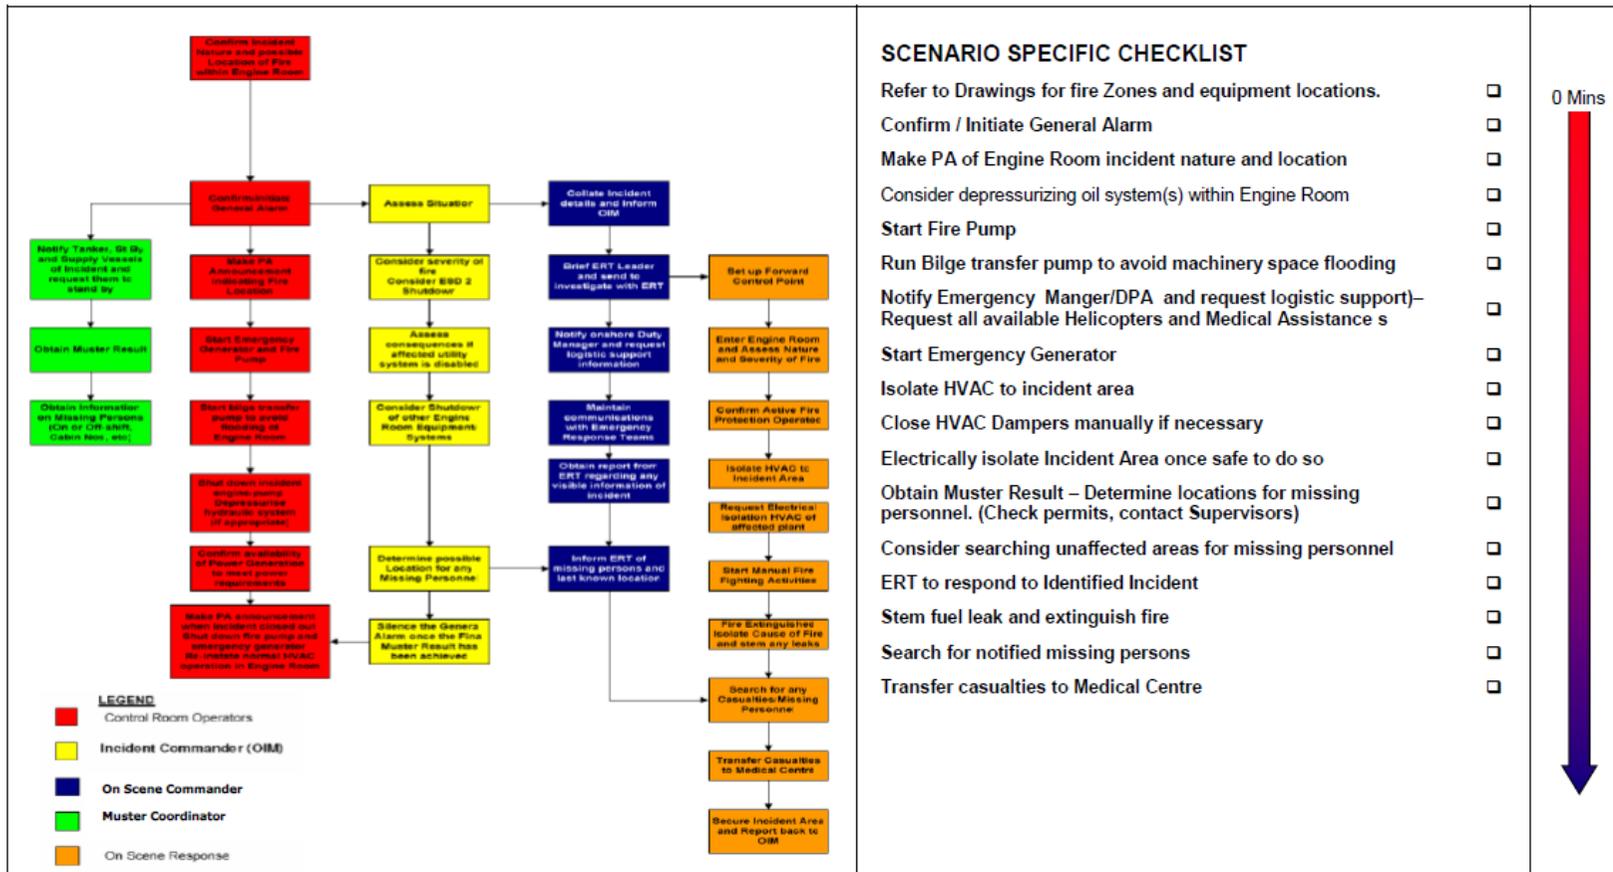
Figure 128 - Example incident management guide contained in PRE for the fire scenario in the engine room

Such lack of procedure is reflected in the absence of explosive atmosphere scenario in Incident Management Guides, the FPSO CDSM PRE members, who had the accident scenarios and a specific checklist for each, containing the full detail of the subsequent actions. Figure 128 presents an incident management guide example contained in PRE for the fire scenario in the engine room. Thus, despite the setting of the presence of gas will not be triggered contemplated in memory card, detailed procedures for this scenario were not made explicit through an incident management guide.

(iii) as to why some scenarios, like the gas leak and explosion scenarios in the pump house and engine room were not covered comprehensively (through incident management guide containing detailed actions) in that procedure.

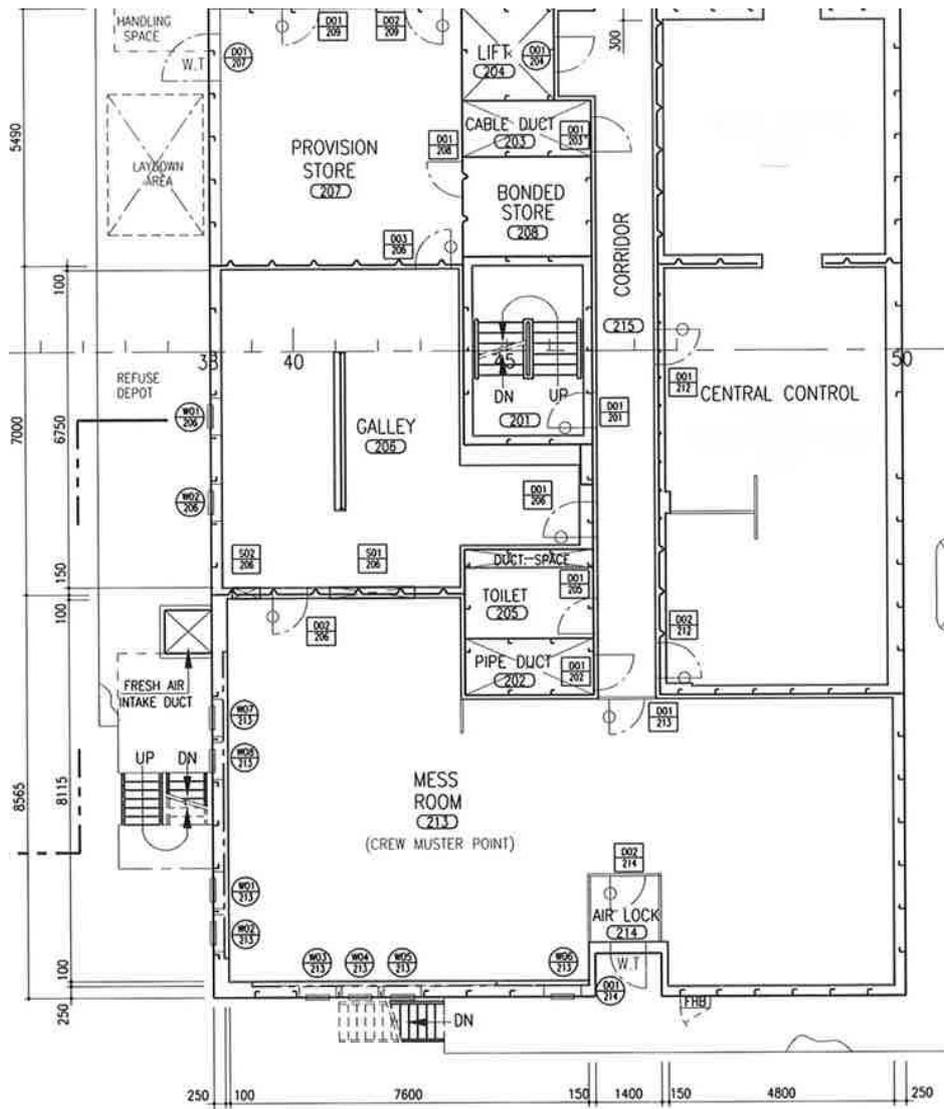
Figure 129 - temporary shelter position and response command to the emergence of FPSO City of St. Mateus

Thus, based on guidance from the offshore incident command, the meeting place of temporary refuge (cafeteria) was demobilized and the meeting points of the infirmary and the engine room control room were partially demobilized. The position of the temporary refuge of the meeting point is shown in Figure 129.

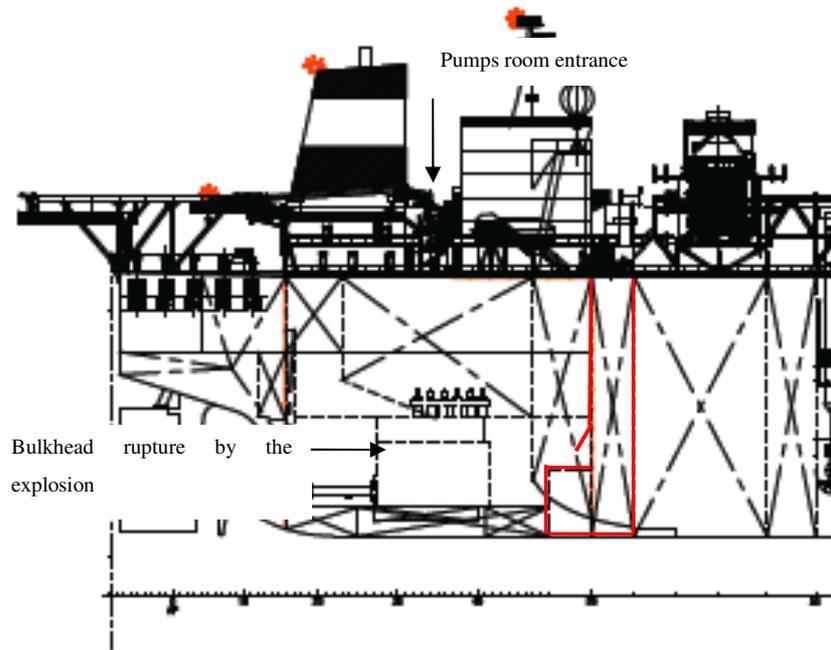
Figure 130 - Indication of the pump house on the FPSO City of St. Mateus

In the accident in question, the rupture of the bulkhead between the pump house and engine room caused the death of an operator in their meeting point in the engine room control room (ECR). In the upper deck, two people were injured seriously in their meeting point to be affected by pressure near the fast rescue boat.

The location of the ruptured bulkhead and access to pump room located on the upper deck of the installation are shown in Figure 130 and Figure 131, respectively.

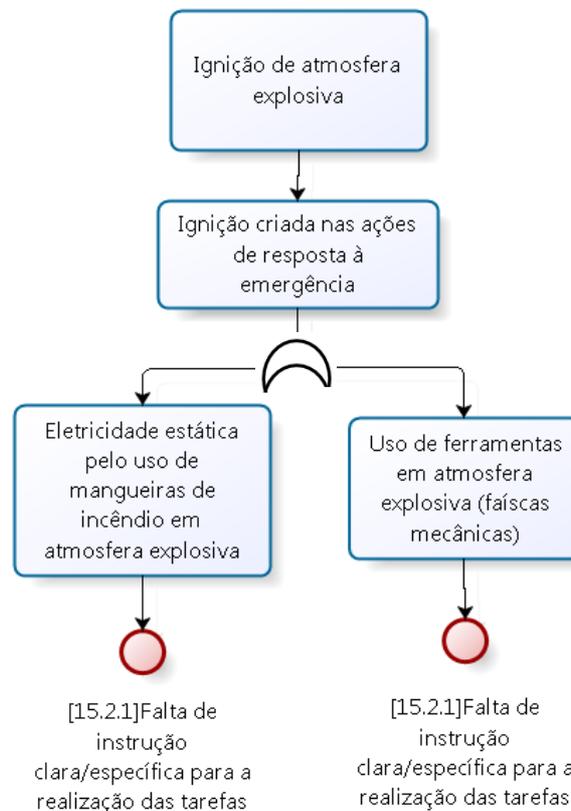
Figure 135 - causal factor # 7 - ignition of explosive atmosphere

By the facts, it was concluded that the root cause for the ignition source of this accident was introduced by the action of people in potentially explosive atmospheres.

The Causal Factor called "ignition of explosive atmosphere" is shown in Figure 135 and its cause is presented below.

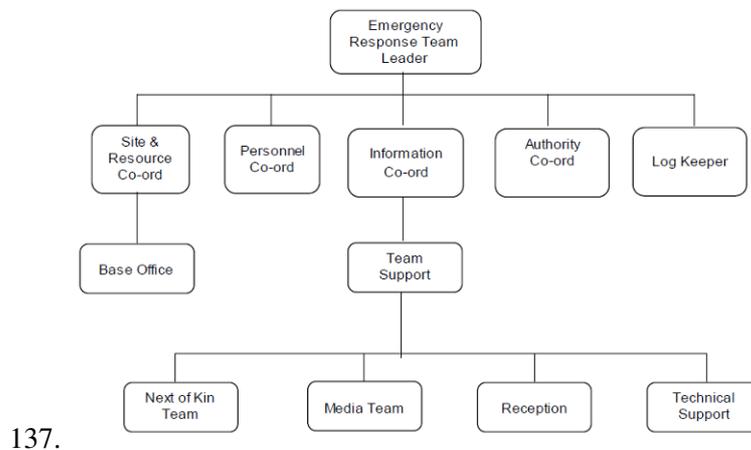
Figure 137 - Response Structure BW Offshore

Another point worth mentioning is that, considering the two response structures set up by the operator of the installation (Figure 137) and Petrobras (Figure 140), could not be identified to establish an interface between the two structures that demonstrate a systematic action joint between the two companies to manage the crisis.

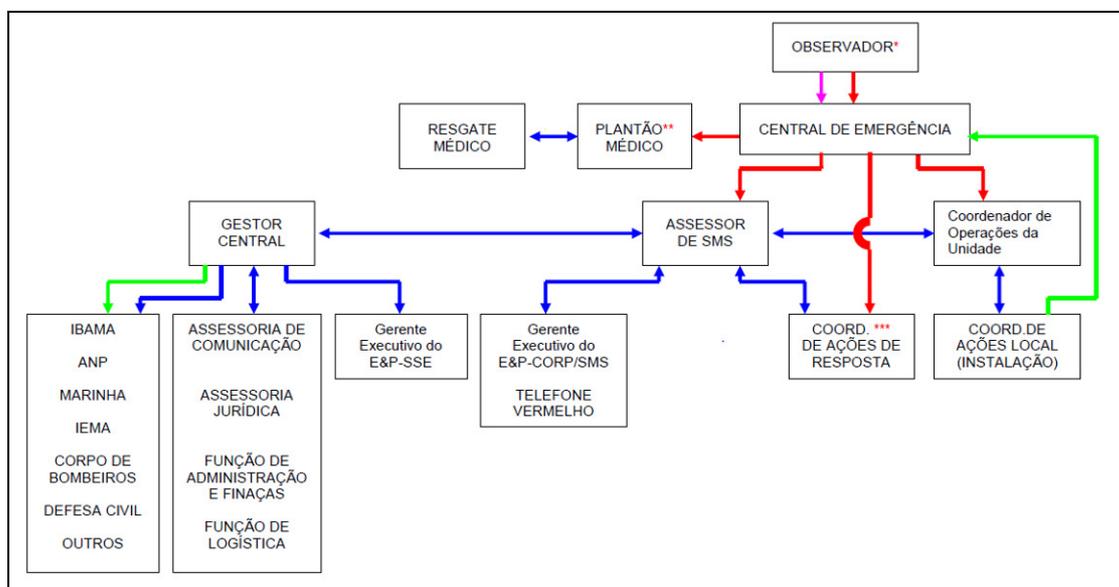
Figure 139 - Flowchart of Communication - structure should be established during an accident

In addition, as can be seen in Figure 140, Unit Operations Coordinator function is not included as part of the EOR and the PRE OU-ES does not provide the definition of who should exercise this function, only consisting on such attribution in the structure of communication of the accident (Figure 139). However, it was observed that the Operations Coordinator of the FPSO CDSM attended the EOR in managing the accident on 02.11.2015.

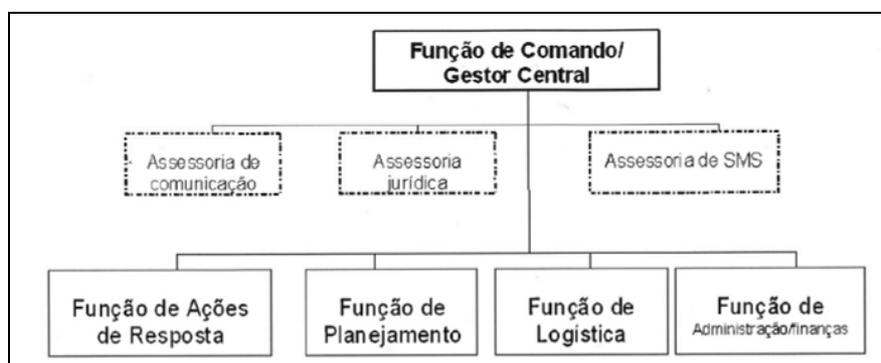
Figure 140 - Communication Flowchart - organizational structure of response should be triggered

However, it was observed that in Figure 140 is not in the role of the Integrated Operations Coordinator (CIOP), although it provided the actuation by the Emergency Call Center and it has been triggered during the emergency of the day 02.11.2015.
